## Home Inspection Report

PROPERTY INSPECTED:  
**243 Bain Avenue**  
**Toronto, ON M4K 1G2**

**Date of Inspection: 10/18/2021**

Inspection No. 141126-1371

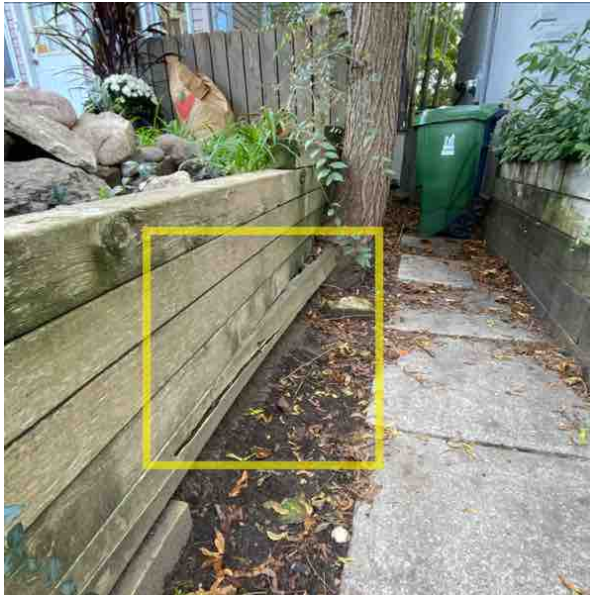
2.6.2 Constructed planter is functional, some movement/rot noted. No improvement is required at this time. Monitor over the years.

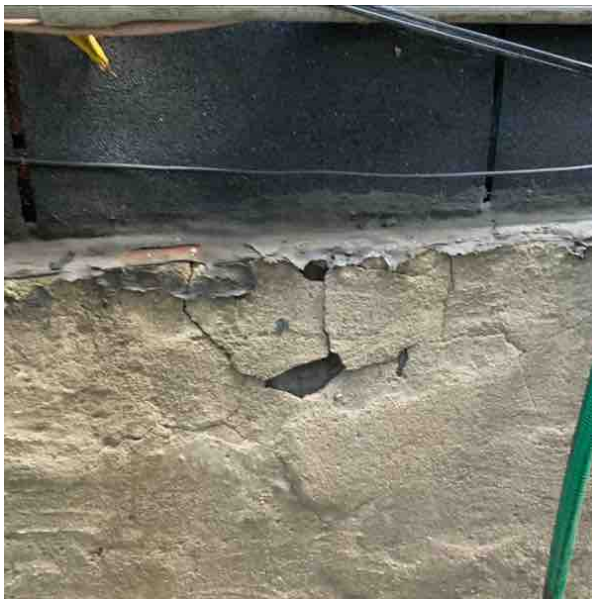
3.3.1 Parging has deteriorated. Reparge as needed

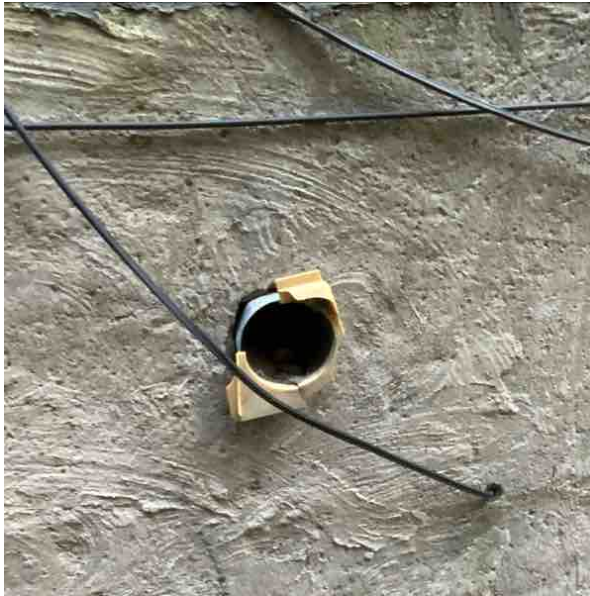
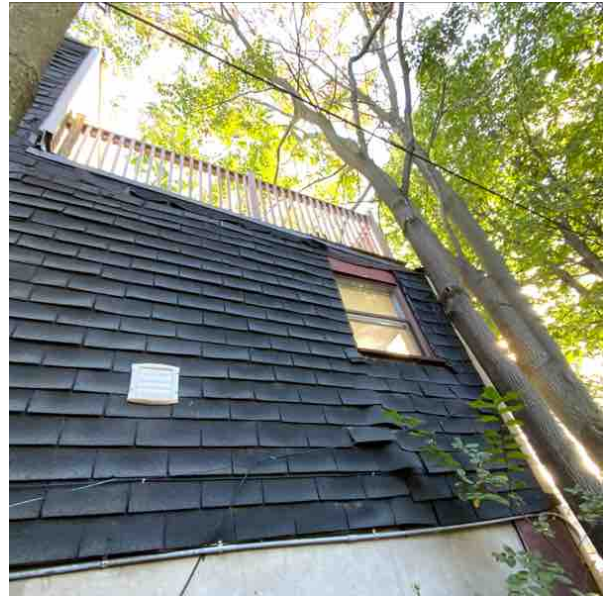
Areas of shingle siding is worn, deteriorated and missing, this should be repaired or replaced to keep water out of the building envelope

3.4.2 Seal openings in wall surface, replace broken wall vents, caulk to prevent water entry.

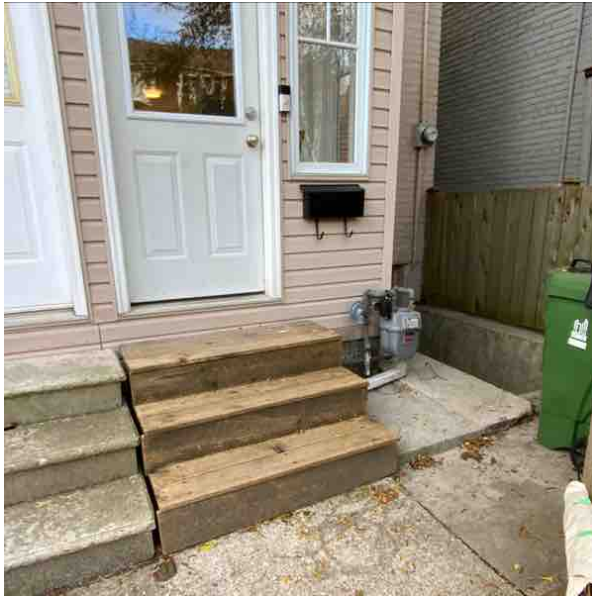
**(Exterior Front)**

Limitation: There is no access to inspect the underside of the steps including the stairs structural elements.

### 3.8.2 Provide handrail for improved safety.

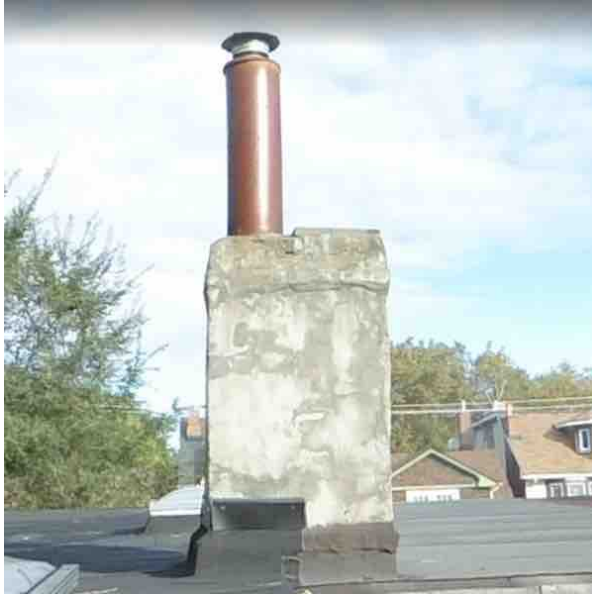
4.8.2 Ventilation for hot water heater.

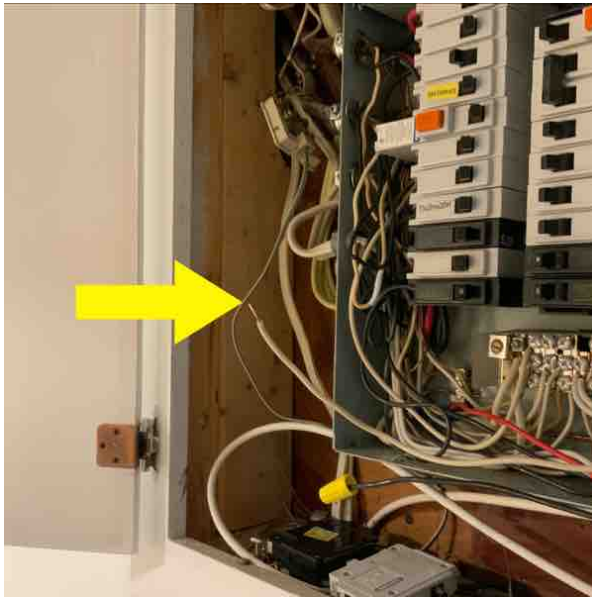
7.5.2 Exposed wire inside panel should be terminated or removed for improved electrical safety **(Basement)**

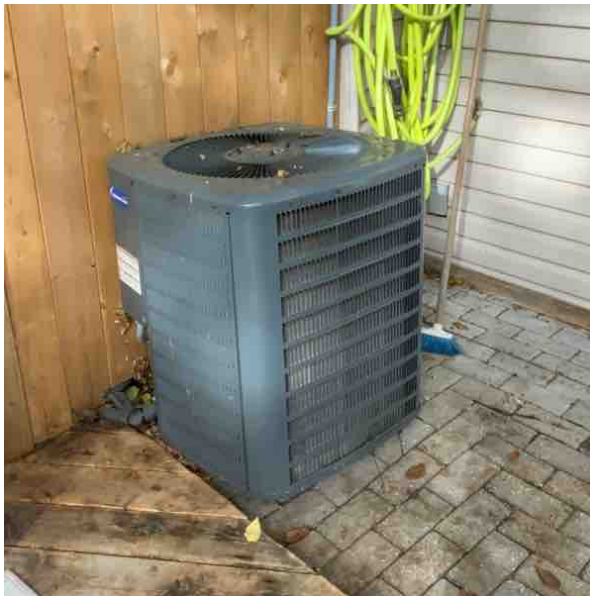
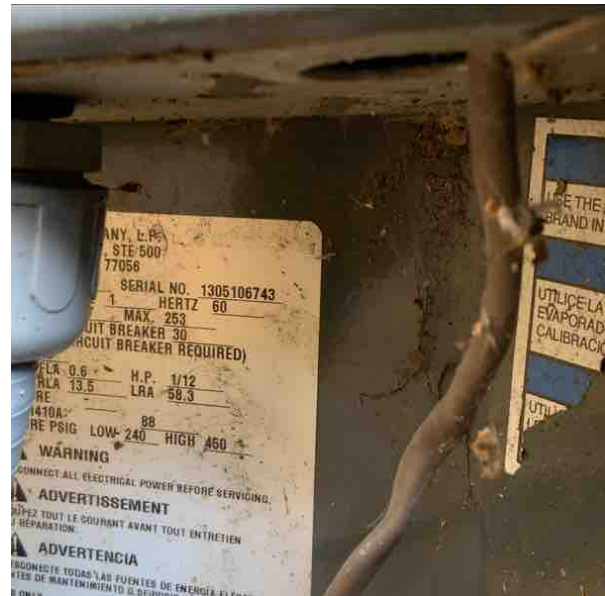
8.6.1 Air conditioner is 8 years old. . System not tested due to low outdoor temperature. Determine function in cooling season. (**Exterior Back**)

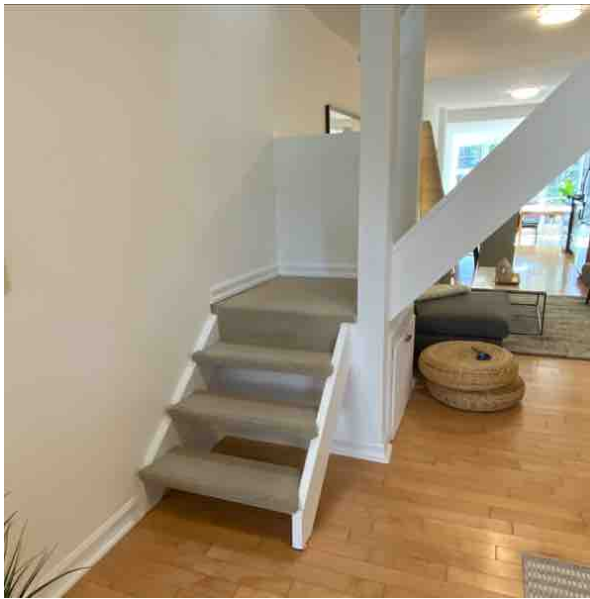
10.6.1 There is no handrail on the stairs. Provide one for improved safety. **(Main floor)**

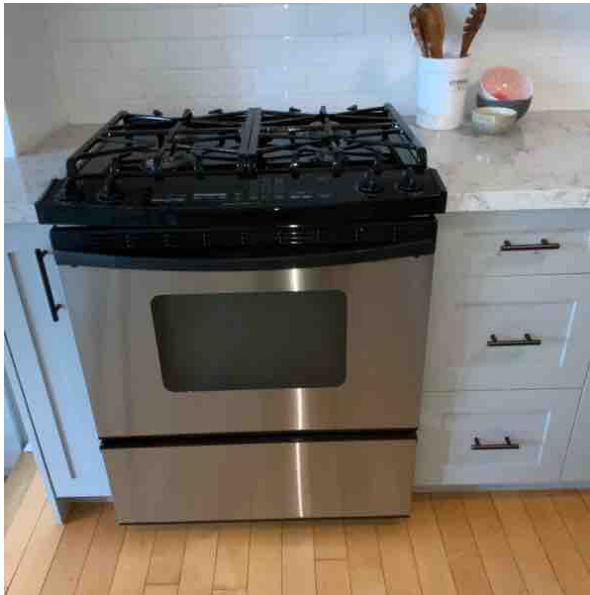
11.3.1 KitchenAid gas stove was not tested, not connected to power source
