# **Your Inspection Report**

# 68 Brookfield St Toronto, ON M6J 3A9

INSPECTION DATE: Saturday, May 1, 2021

RE: Report No. 76974 68 Brookfield St Toronto, ON M6J 3A9

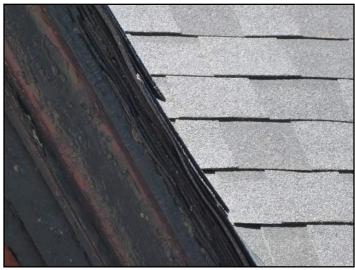
### Condition: • Multiple layers

When replacing a roof covering, it is common to apply a second layer over the first to minimize costs. Best practice however, is to remove the old roof covering before installing the new roof. Adding a third layer of roofing is not recommended. It is common when re-roofing to find concealed damage to roofing boards, sheathing and other hidden components. There is no practical way to predict the presence or extent of the damage.

Multiple layers of shingles noted

Time: When re-roofing.

**Cost**: Removal /disposal fee is minor, to replace \$ 2 - \$ 4 per sq. ft. for conventional shingles / \$ 4 - \$ 8 per sq. ft. for premium quality shingles

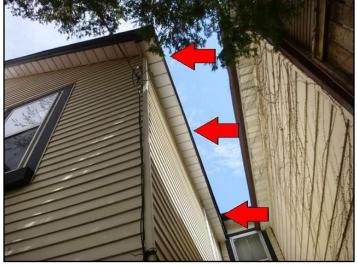
Condition: • Missing Location: Rear Exterior Task: Provide Time: As soon as practical Cost: Minor

Missing Gutters and downspouts

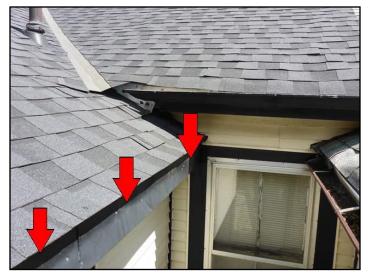
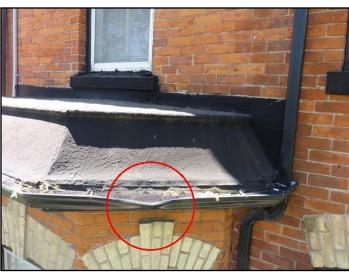
Condition: • Damage Location: Front Bay Task: Repair Time: Less than 1 year Cost: Minor

Damaged gutter at front bay

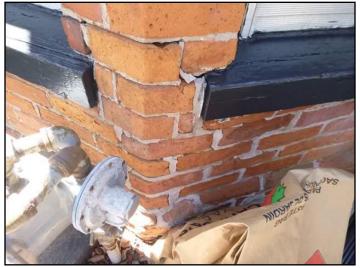
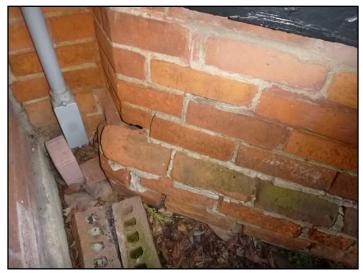
### Condition: • Mortar deterioration

Cracks and loose mortar was noted towards the bottom of the front wall. Some of the bricks here are loose as well. Some re-pointing and general clean up is needed.

Mortar deterioration, a few damaged bricks

Task: Improve

Time: Less than 1 year Cost: Minor

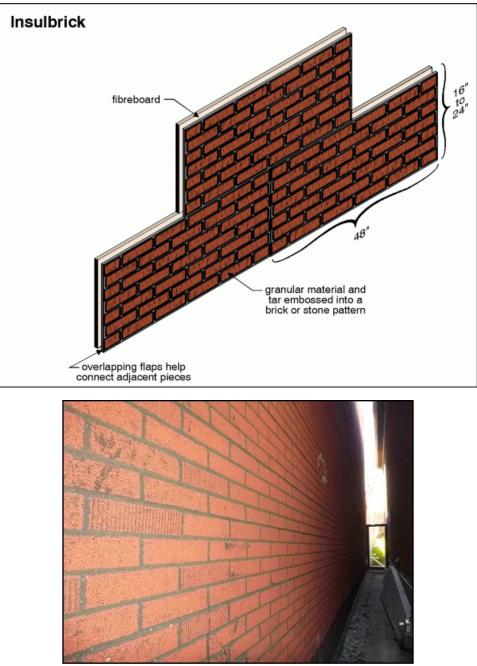
**Condition:** • Insulbrick has not been manufactured for some time, and installations are quite old, often showing damage or deterioration. Water penetration and damage to the walls behind the siding are potential problems where there are imperfections. Some insurance companies are reluctant to offer insurance for homes with this type of siding.

Insulbrick cladding at side wall

Replacement with aluminum siding, for example, may cost \$4 to \$8 per square foot, depending on several variables. **Location**: North Exterior Wall

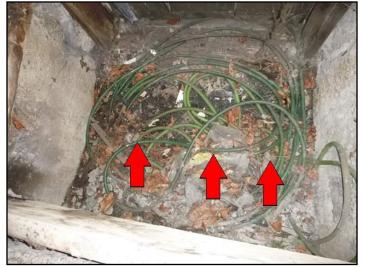
Condition: • Drains not visible at window wells

no drain visible, window close to grade level

Time: As necessary

Cost: Depends on work needed

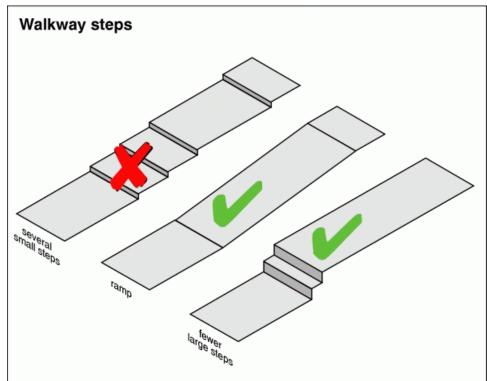
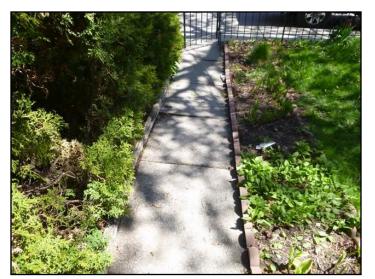
Condition: • Uneven (trip hazard)

Walkways have settled (or heaved) in places, creating a number of trip hazard at the front and rear. General clean up is needed to improve drainage as well as to reduce the trip hazard.

Uneven (trip hazard)- front

Task: Improve

Time: If/when making improvements

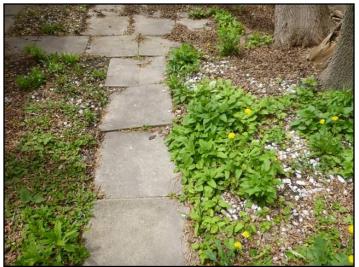
Uneven (trip hazard)- rear

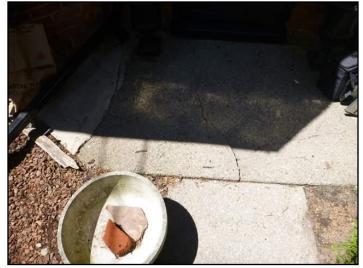
Condition: • Improper slope or drainage

Concrete slabs have cracked and settled, creating low areas that may not drain effectively as well as some trip hazards. **Location**: Throughout

Improper slope or drainage- front

Task: Improve

Time: As necessary

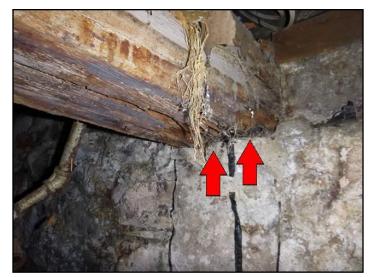
**Condition:** • There is damaged wood at the bearing portion of the front beam. The wood still appears to be in good condition here but installation of additional support (like another support post) may be desired if renovations are planned. **Location**: Front Basement

Damage at beam end

Task: Monitor / Improve Time: As necessary

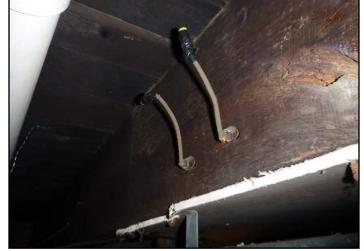
**Condition:** • Some remnants of knob-and-tube wiring found but appeared to be inactive. There is a possibility that there is active knob-and-tube in the home which maybe discovered in the future and/or during a renovation.

Old knob and tube components and wiring was noted in the basement and attic. None of the older wiring was energized. The knob and tube appears to have been taken out of service completely but this could not be confirmed.

Remnants of knob-and-tube (not energized)

**Task**: Replace (if found active) when remodeling. In the short term, ground fault circuit interrupters (GFCIs) are an inexpensive way to help protect against electric shocks. Further evaluation.

**Cost**: Typically \$1,000 to \$2,000 per room to replace. Note: Additional costs may be incurred for other electrical improvements and cosmetic repairs. In the short term, GFCI protection typically costs \$100-\$200 per circuit.

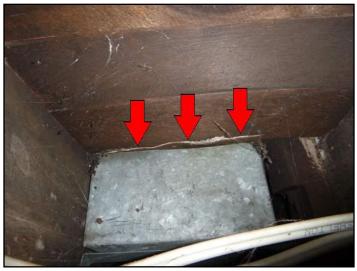
Condition: • Insulation on or above the ducts may contain asbestos. Health Canada recommends the insulation be left in place undisturbed unless there is a risk of asbestos fibers being released into the house air. If this is a concern, a

specialist should be consulted. If the insulation is damaged or is to be disturbed, and if it contains asbestos (confirm with laboratory test), precautions should be taken that asbestos fibers are not released into the house air. Please see the Asbestos article in the Supplementary section of the digital Home Reference Book located in the REFERENCE section of this report.

Insulation material at register not determined

Location: Various Task: Remove Time: If desired

**Cost**: \$200 - per location

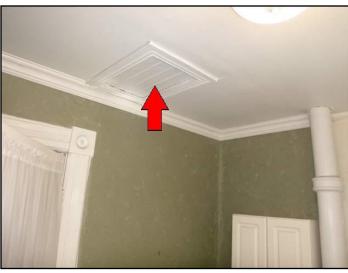
Condition: • Access hatch location poor The attic access hatch is in the bathroom. This is a poor location for the hatch as warm, moist air can easily leak into the attic from this area. Relocate the hatch to another part of the second floor ceiling. Location: Second Floor Task: Improve Time: If/when making improvements

Hatch location poor (in bathroom)

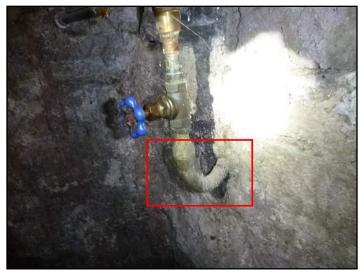
Condition: • Lead Task: Upgrade Time: If/when making improvements **Cost**: \$2,000 - and up

Lead supply pipe from utility

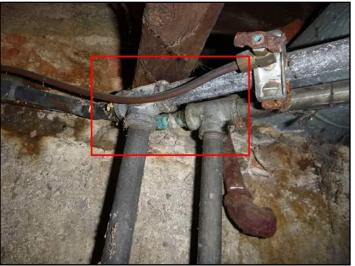
### Condition: • Galvanized steel

Galvanized steel supply piping noted

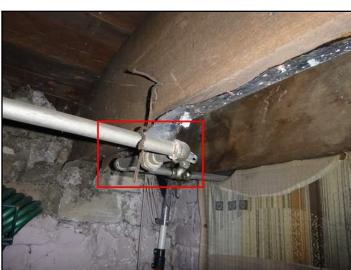
Condition: • Leak Location: Front Basement Task: Repair Time: As soon as practical

Leak at pipe support

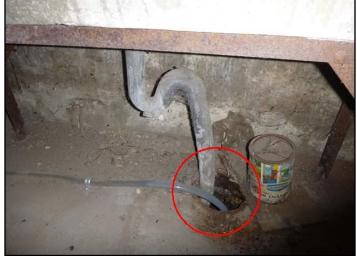
Condition: • Open drain connections?

Drain at the laundry tub discharges to something that looks like a floor drain. This type of arrangement is not allowed in a house and should be checked out by a plumber to determine the best way to correct conditions here.

Tub drain discharges to floor drain?

Task: Further evaluation / Repair

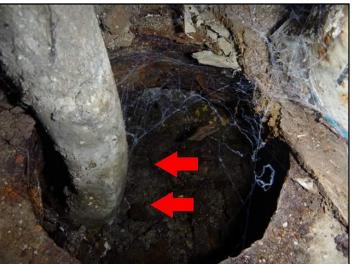
Drain arrangement not visible

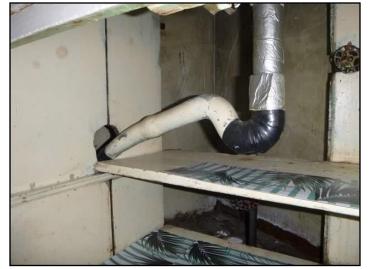
Condition: • Piping (Lead) - near end of lifespan / old Location: Throughout Task: Replace Time: When renovating

Lead drain piping at kitchen sink (typ.)

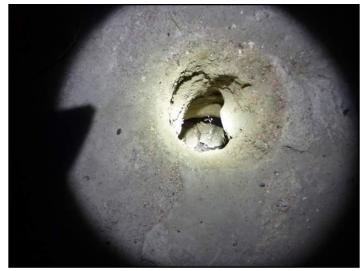
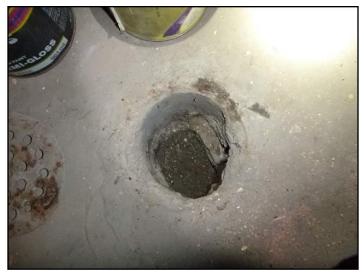
Condition: • Dry floor drain

None of the drains in the basement floor had water in the traps. This may be due to evaporation or deterioration in the piping itself. Evaluation by a plumber is recommended to ensure the drains are in good condition and set up properly. **Task**: Further evaluation / Improve

Dry floor drain

Time: Less than 1 year

Cost: Depends on work needed

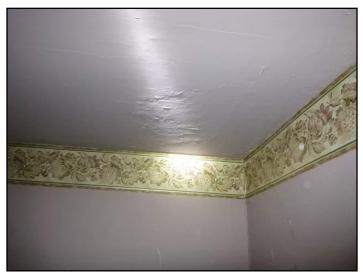
Condition: • Damage Location: Rear Second Floor

Damage- dry at inspection

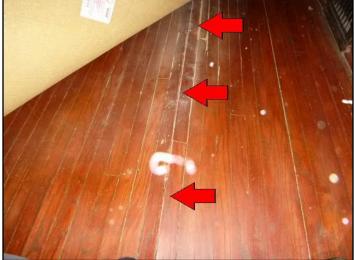
Condition: • Damage Flooring has buckled in one area and will need to be replaced. Location: Middle Living Room Task: Improve Time: As necessary

Damage (buckled flooring)

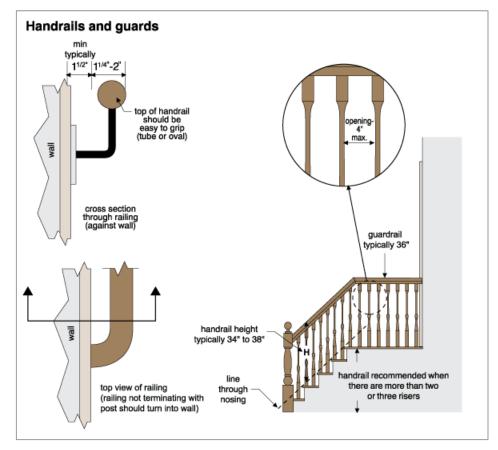
Condition: • Missing Location: Basement Staircase Task: Protect Time: As soon as practical Cost: Minor

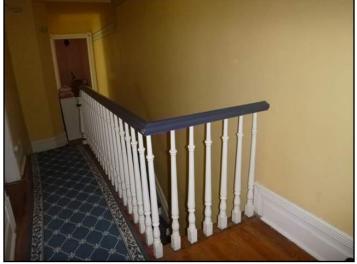
### Condition: • Too low

Railings are typical for a house of this age but low by modern standards. Location: Second Floor Hall

Too low

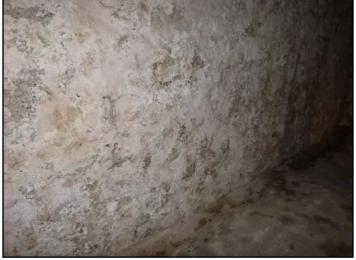
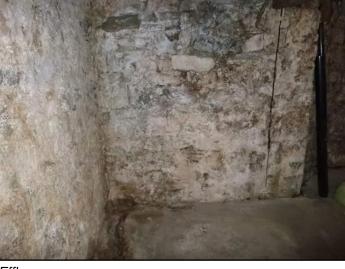
Condition: • Efflorescence Efflorescence and loose/crumbling plaster was noted at various locations around the foundation. Some amount of efflorescence is common in older houses that don't have a waterproofing system installed. Location: Throughout Task: Monitor

Efflorescence
