Home Inspection Report

PROPERTY INSPECTED:
1412 Farmstead Drive
Milton, ON L9E 0A5

Date of Inspection: 02/12/2022

Inspection No. 141126-1478

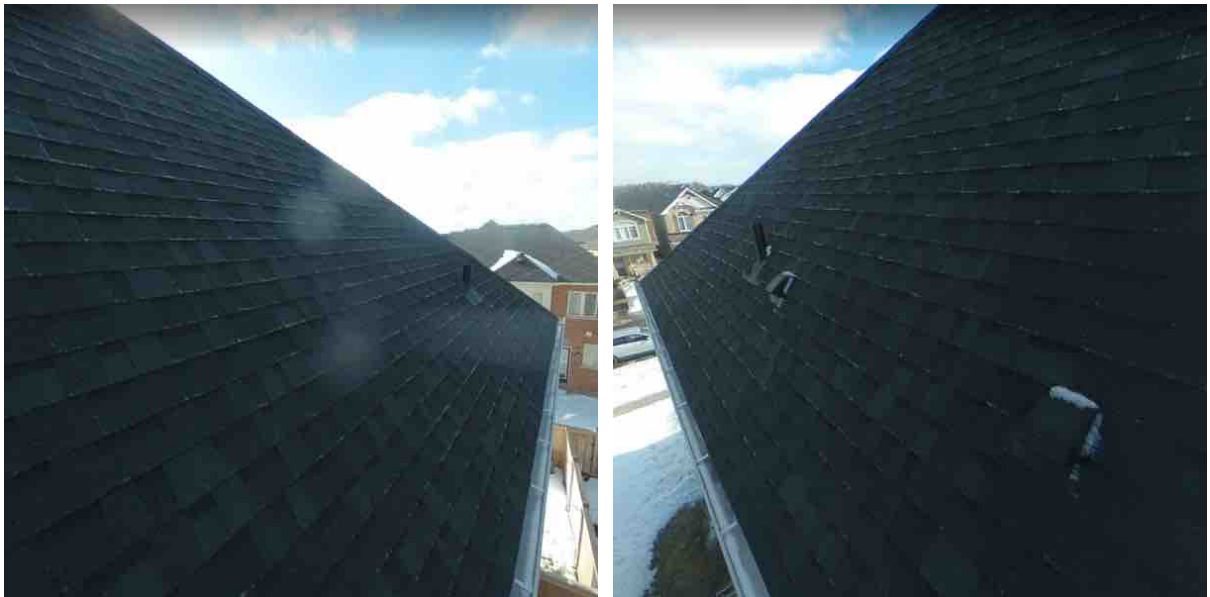
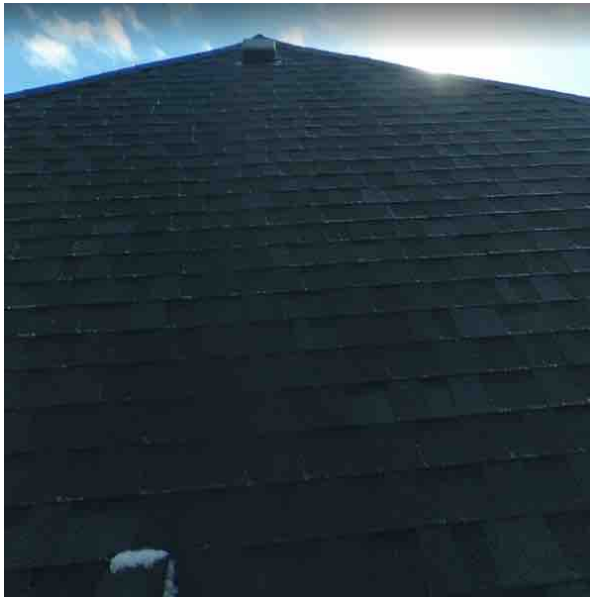
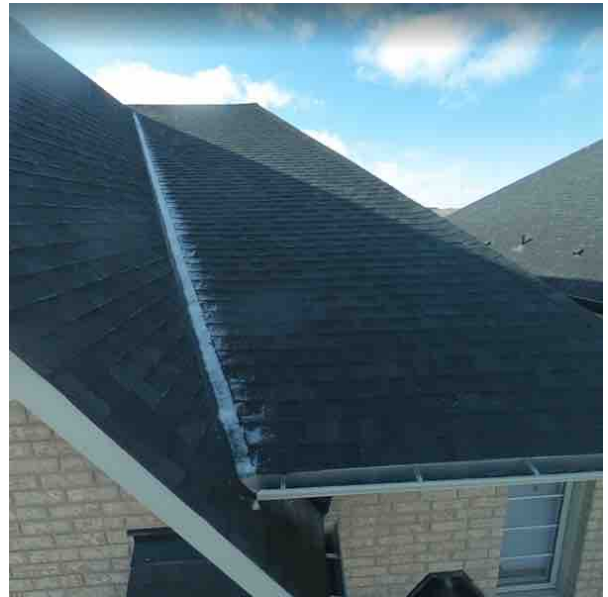
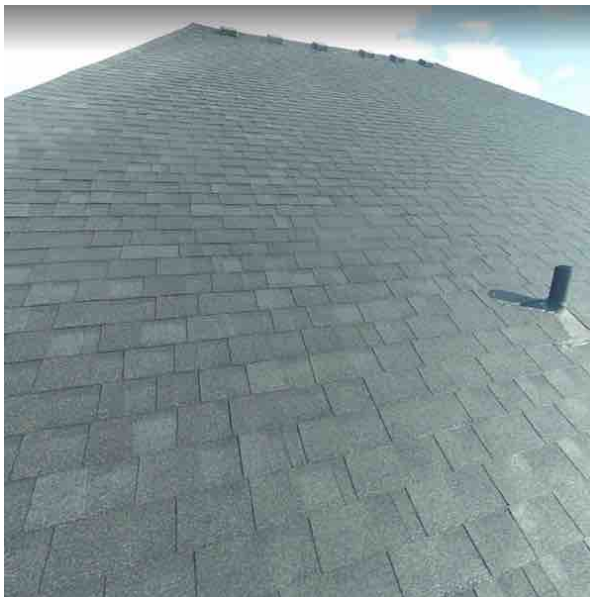
4.3.1 **Architectural shingles are in good condition Estimated age is less than 5 years.**

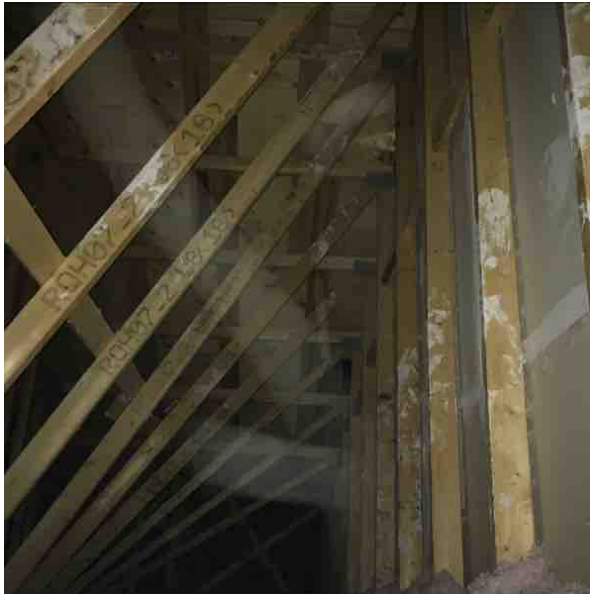
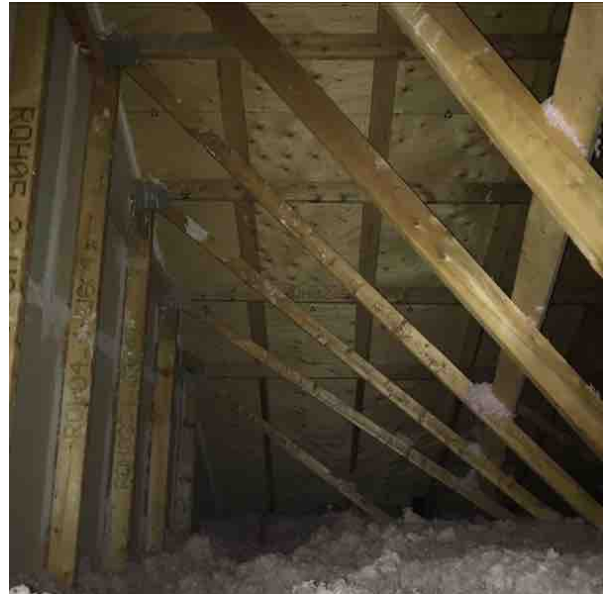
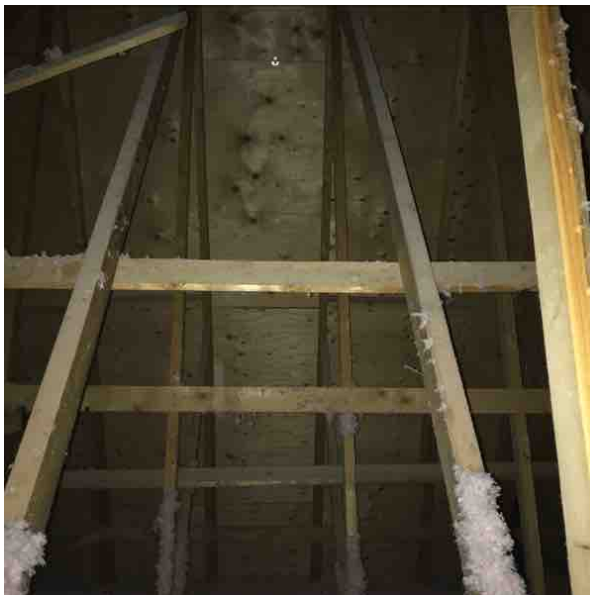
5.4.1 **Approximately 22 inches of fibreglass insulation**

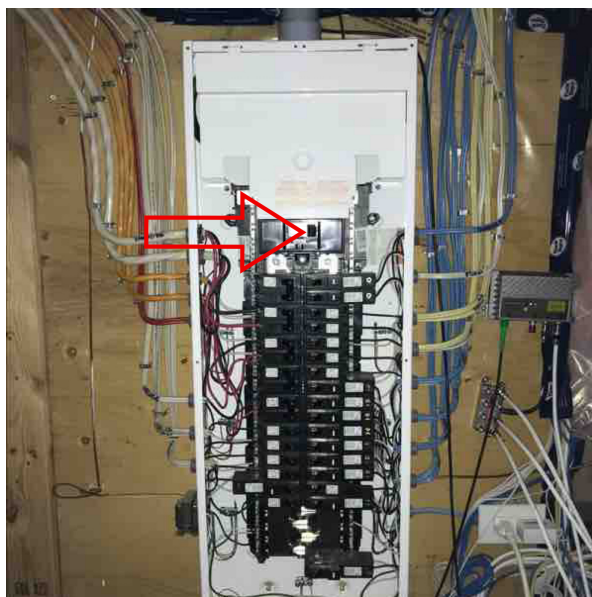
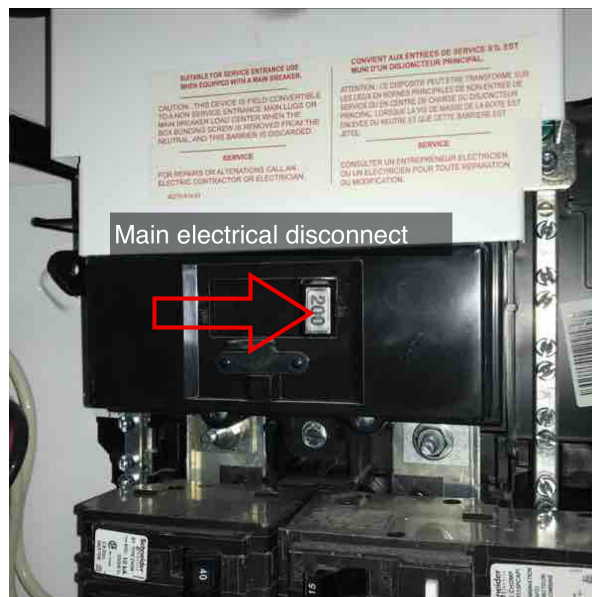
8.4.2 Main disconnect noted in picture

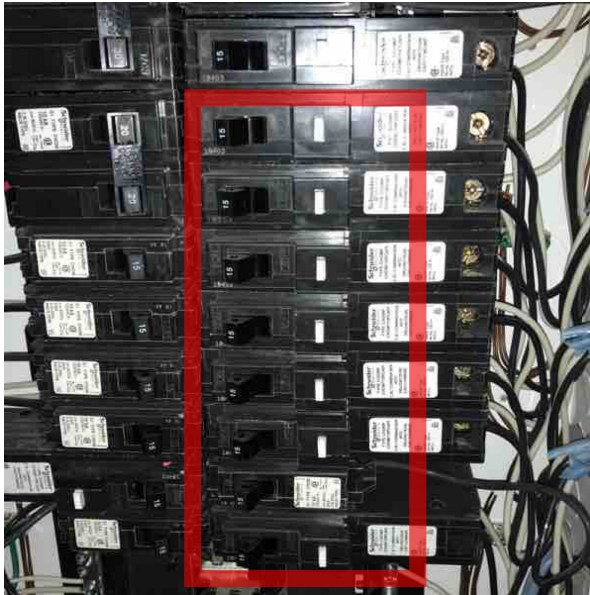
8.12.2 There is a type of circuit breaker that promises to reduce the number of electrical fires in homes. The 'arc fault circuit interrupter' or 'AFCI' is reported to detect sparking in the electrical system and can shut the affected circuit down before it causes a fire. The installation of ARC fault circuit interrupter protected circuits is recommended at all living area locations.

New electrical standards require AFCI circuits for all bedrooms. Add AFCI breaker(s) for safety. As per manufacturers recommendations you should test AFCI breakers monthly and replace them if they fail to trip when tested.

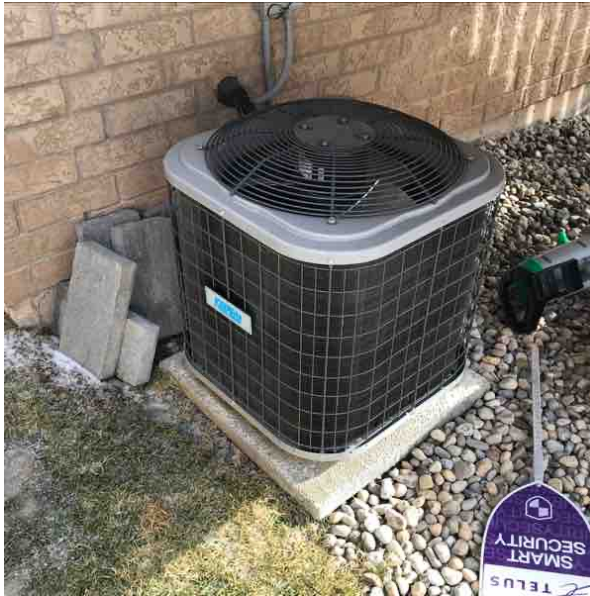
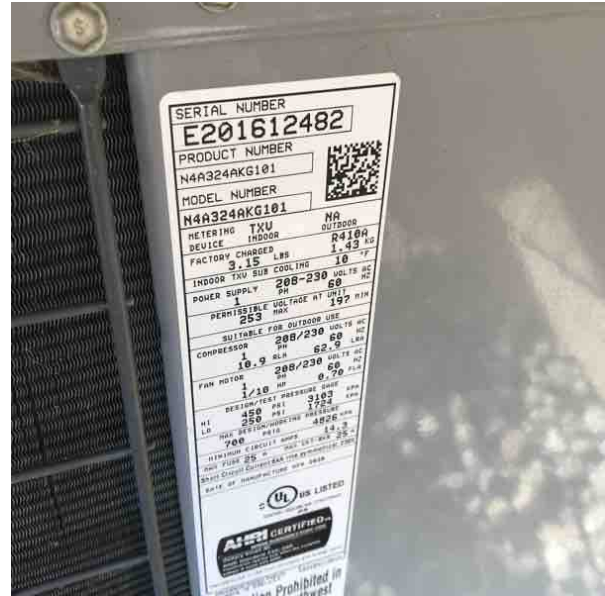
9.5.1 Air conditioner is dated 2020. System not tested due to low outdoor temperature. Determine function in cooling season. (Exterior Back)

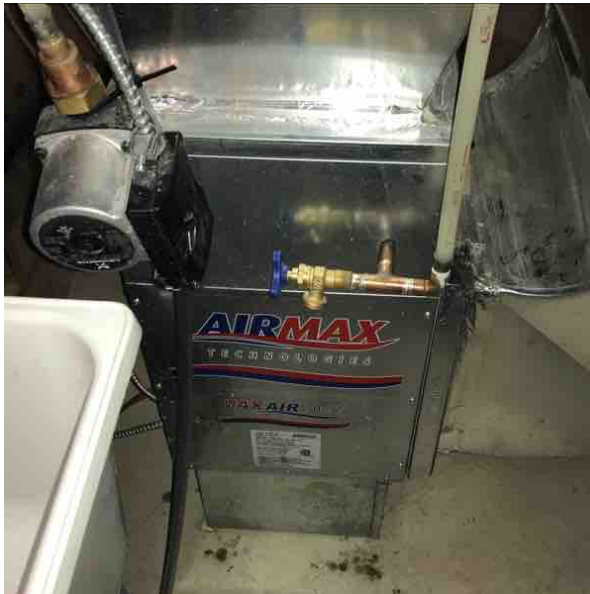
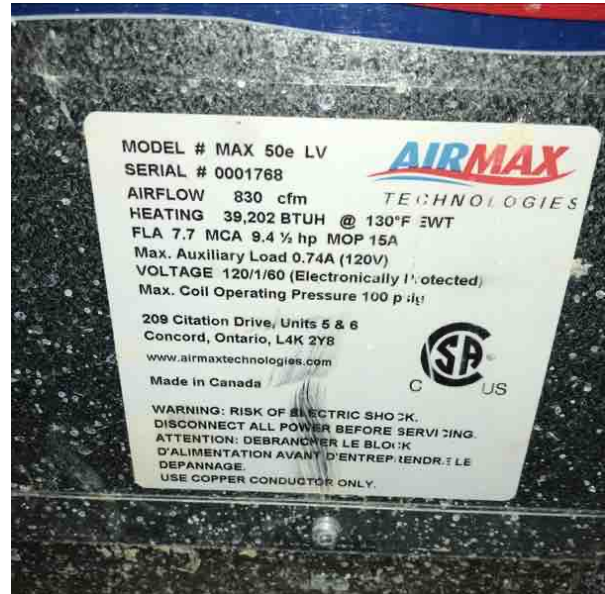
9.6.2 Hydronic furnace is functional

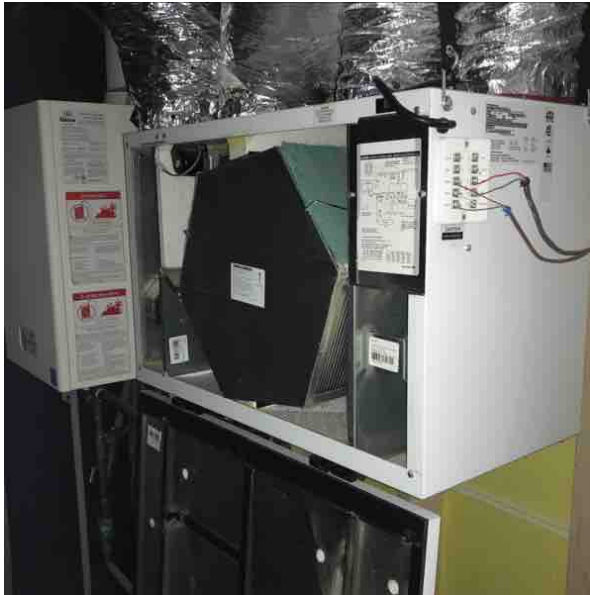
9.9.2 HRV is approximately 3 years old and functional

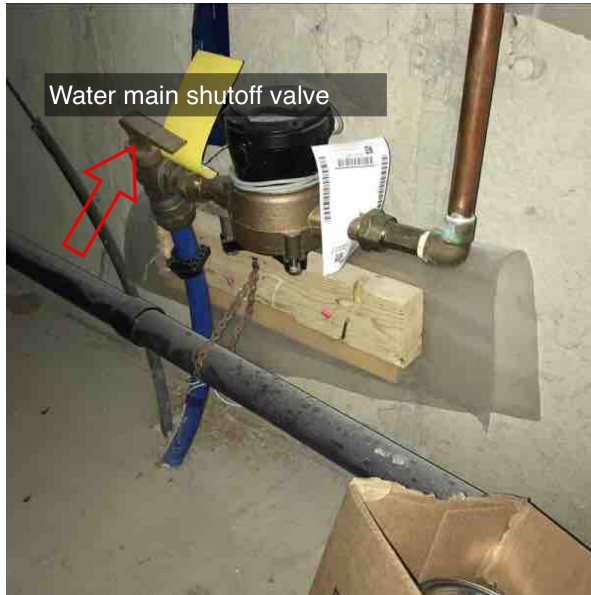
10.3.2 Plastic water main

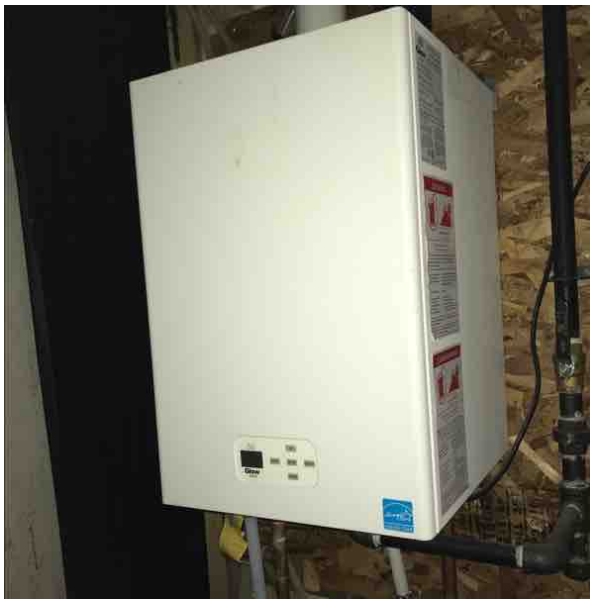
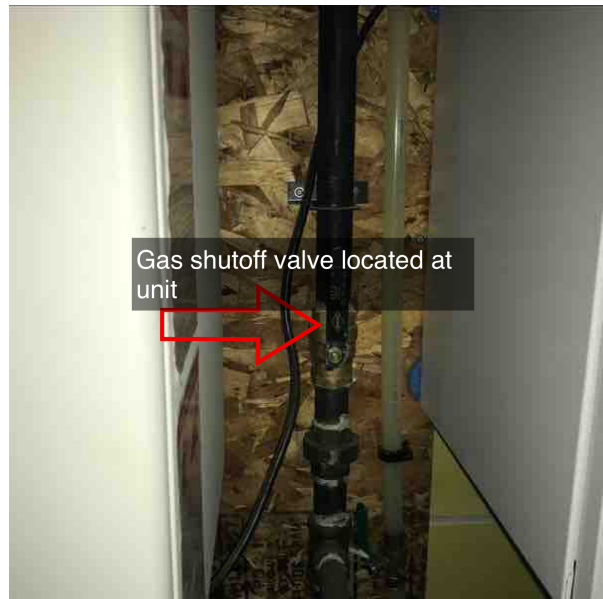
10.6.2 Tankless water heater is approximately 3 years old and functional

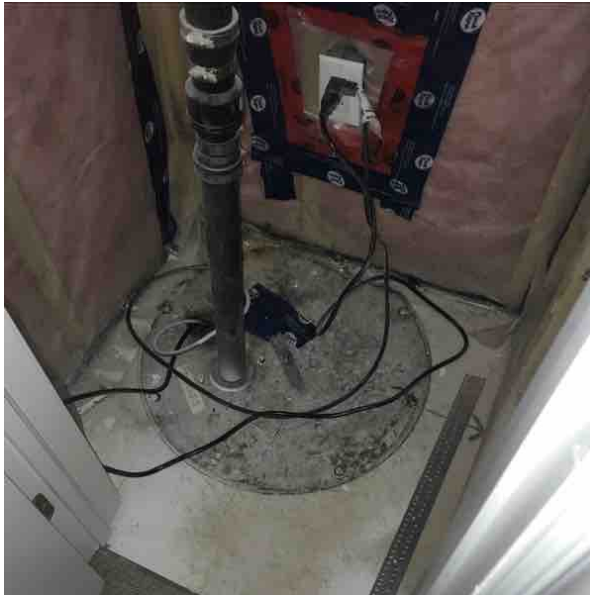
10.13.1 **Home is equipped with a sump system**
