Home Inspection Report

**87 Markham Street
Toronto, ON M6J 2G4**

Date of Inspection: 05/13/2022

Inspection No. 141126-1660

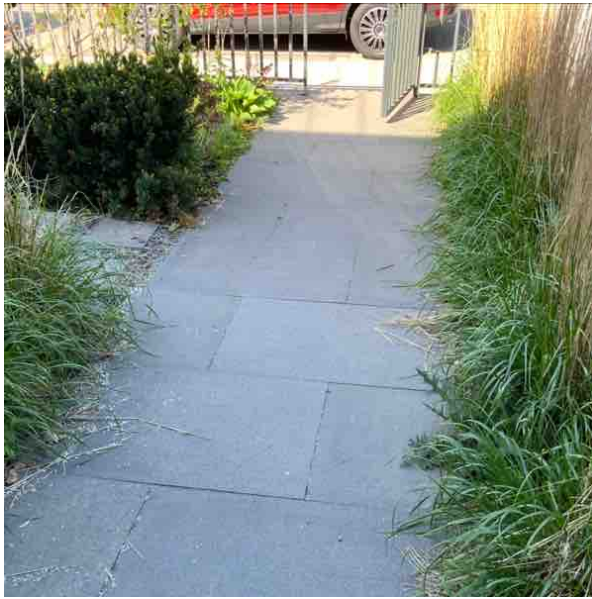
2.3.2 Walkway and gate new as of 2020

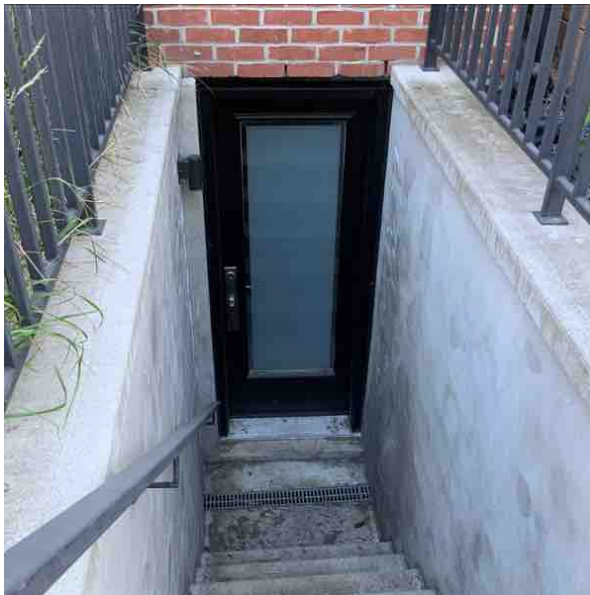
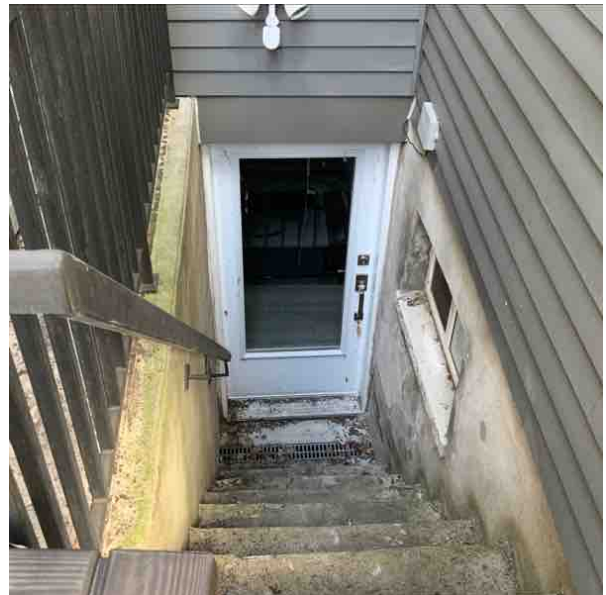
3.8.1 **Home has a separate entrance to the basement in the front and the rear of the home**

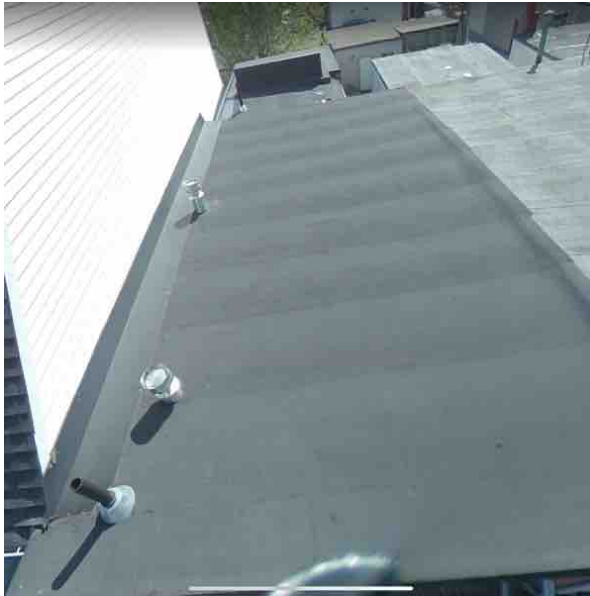
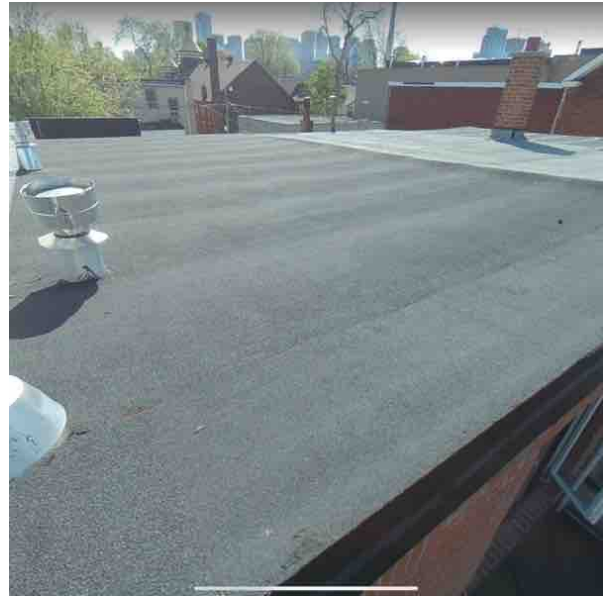
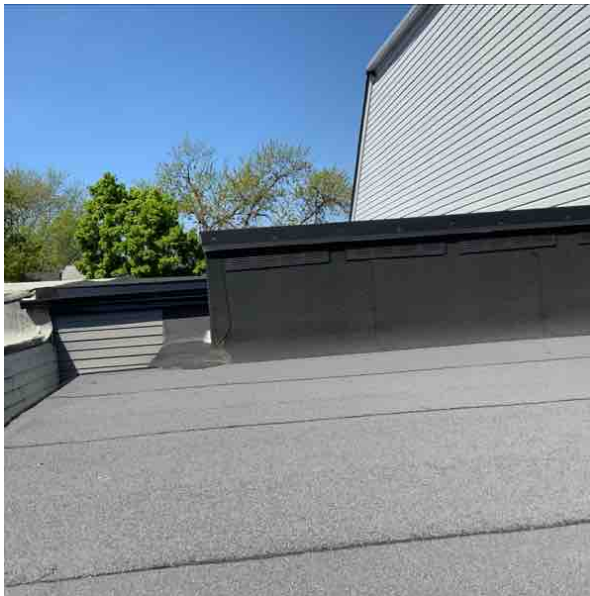
4.3.1 **Flat roof membrane is in adequate condition . Estimated age provided by seller is 5 years. Regular maintenance is required to prolong the life of the surface and the flashings**

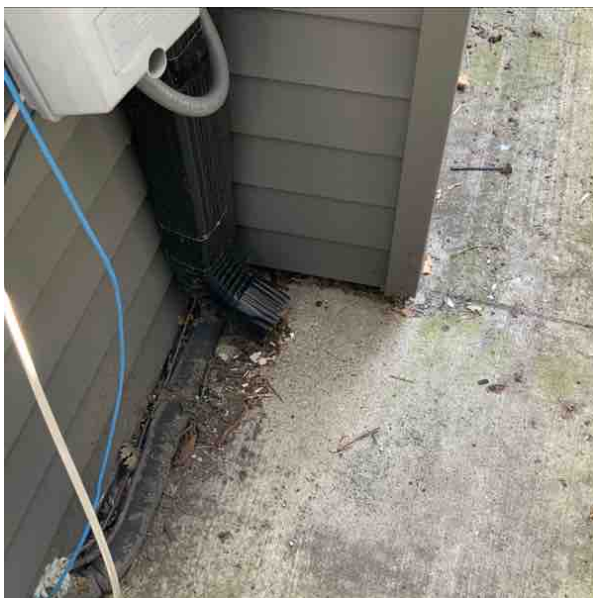
4.5.1 Downspouts discharging too close to the foundation is the number one reason for basement leaks. Keep the eaves clear, monitor underground discharges for clogs. It's important that water drains well away from the foundation. **(Exterior Back)**

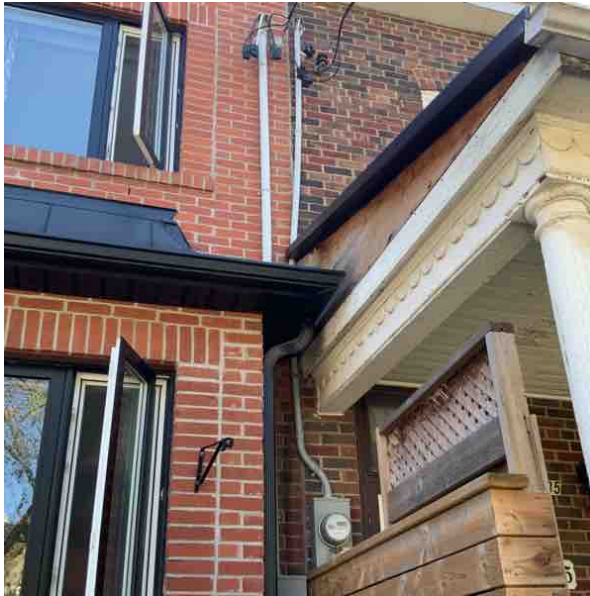
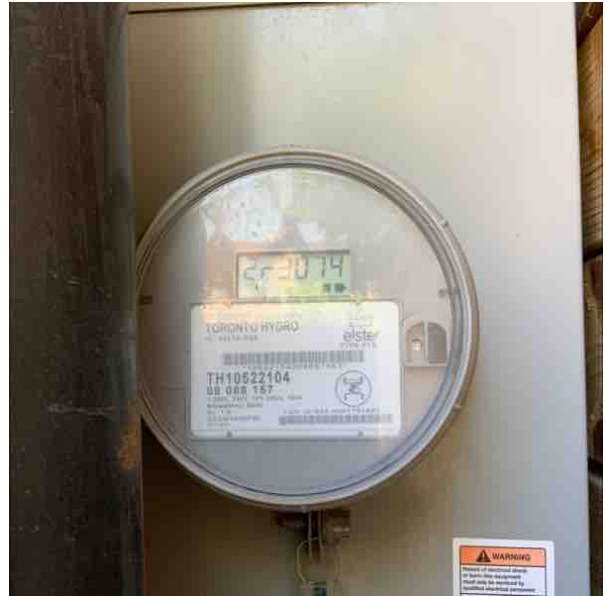
8.2.1 Electrical service to home is by overhead cables. **(Exterior Front)**

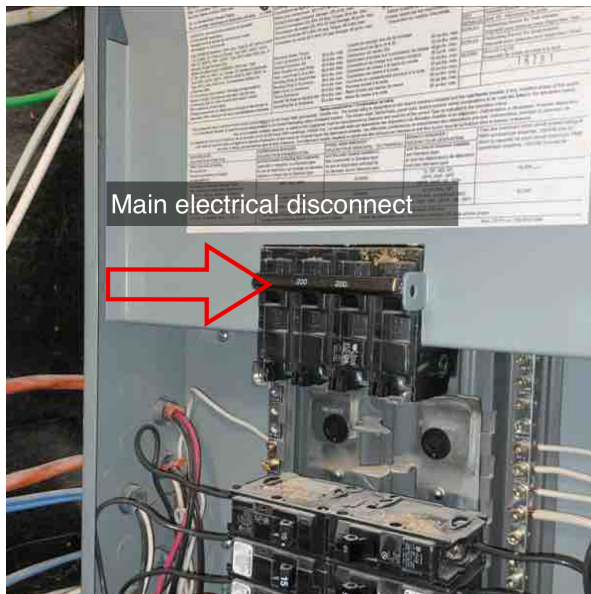
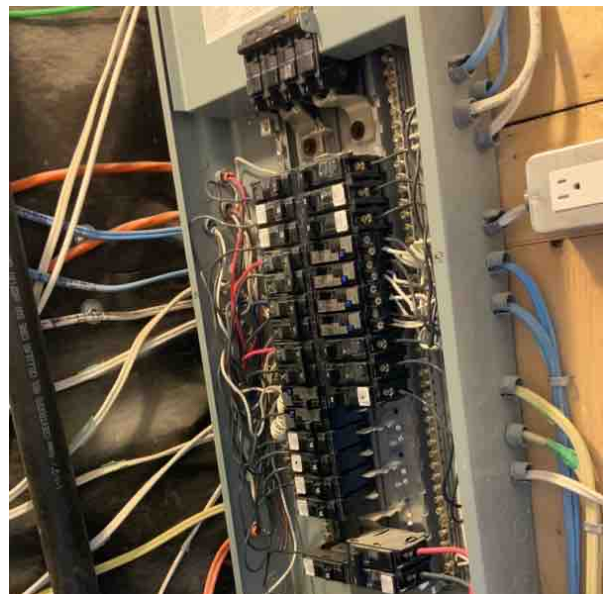
8.4.2 Main disconnect noted in picture

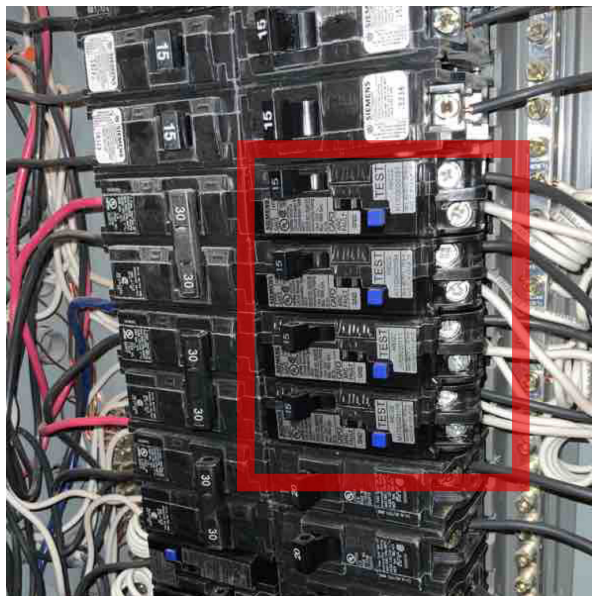
8.12.2 There is a type of circuit breaker that promises to reduce the number of electrical fires in homes. The 'arc fault circuit interrupter' or 'AFCI' is reported to detect sparking in the electrical system and can shut the affected circuit down before it causes a fire. The installation of ARC fault circuit interrupter protected circuits is recommended at all living area locations.

New electrical standards require AFCI circuits for all bedrooms. As per manufacturers recommendations you should test AFCI breakers monthly and replace them if they fail to trip when tested.

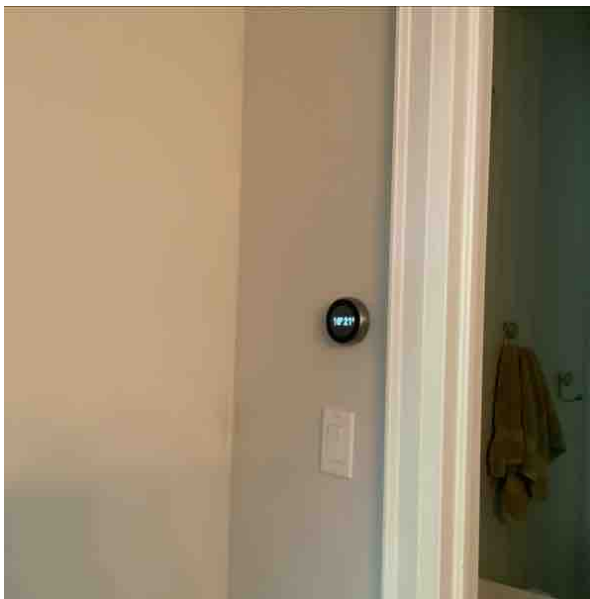
9.2.1 Nest thermostat located on main floor

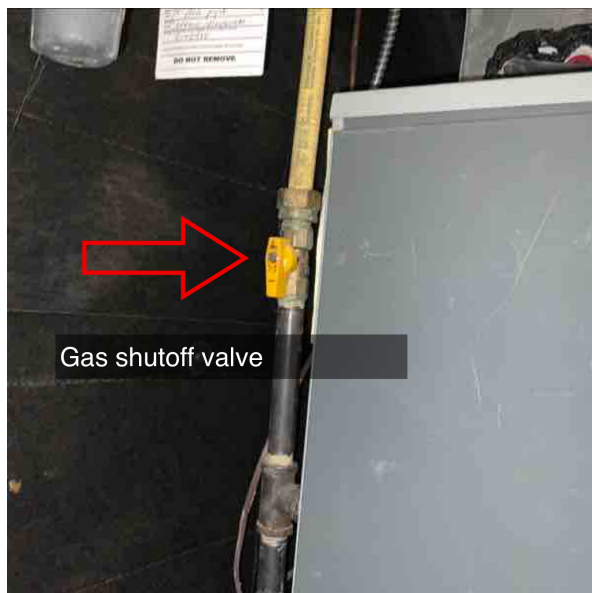
9.3.1 Gas shutoff valve is located at the unit. **(Basement)**

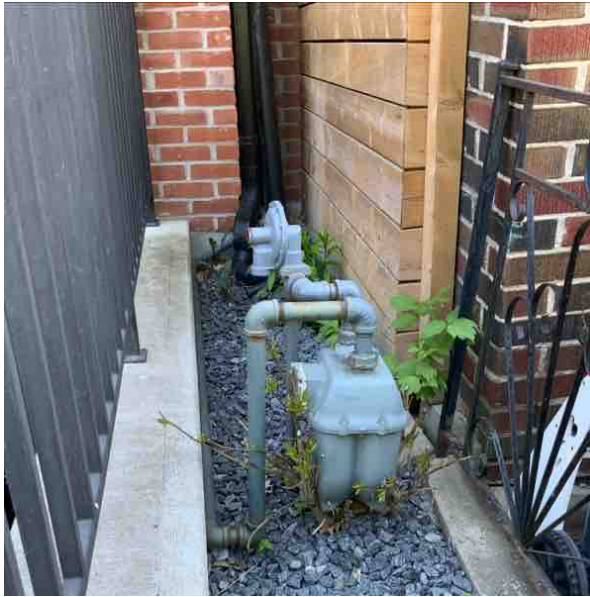
9.4.1 Located at front of home

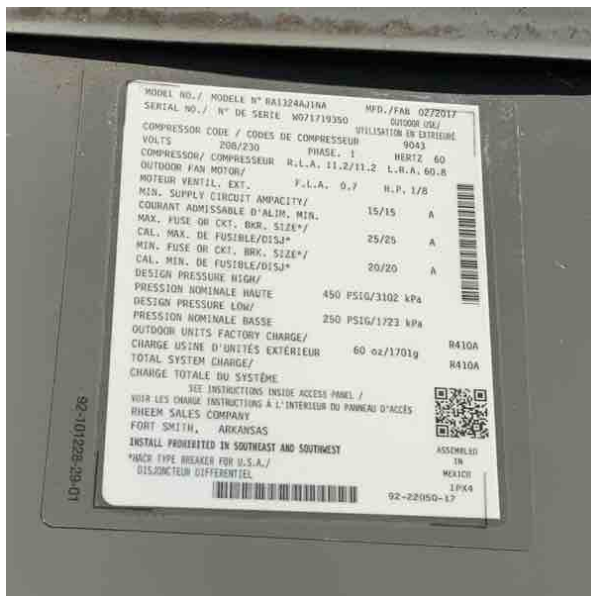
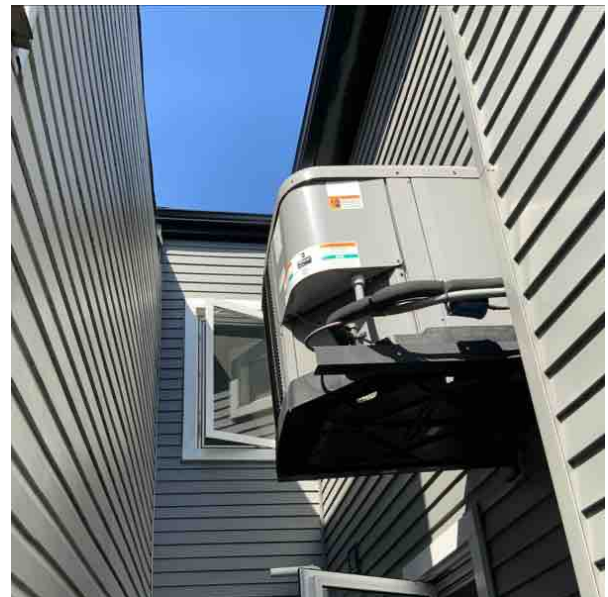
9.5.2 Air conditioner is dated 2017 and is functional

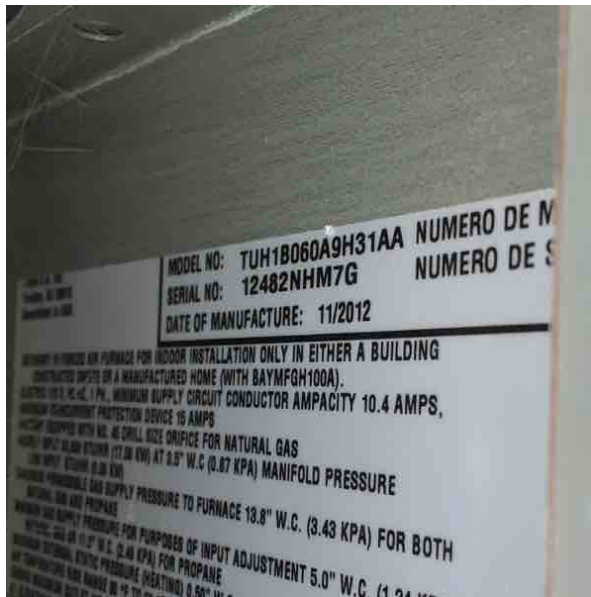
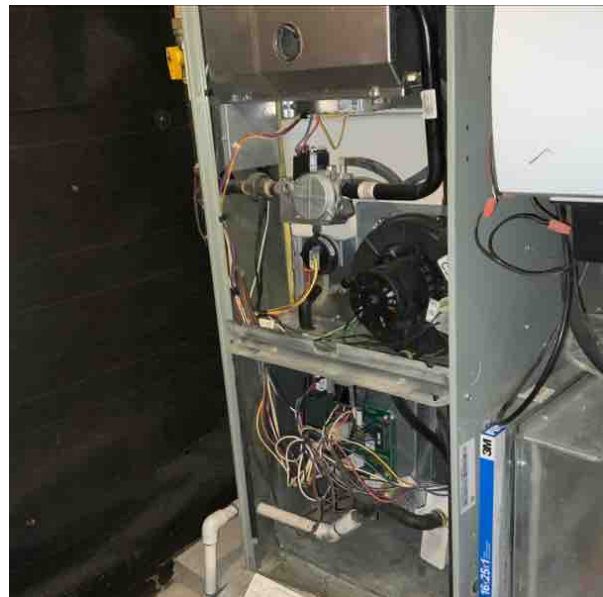
9.6.2 High efficiency furnace is dated 2012 and is functional

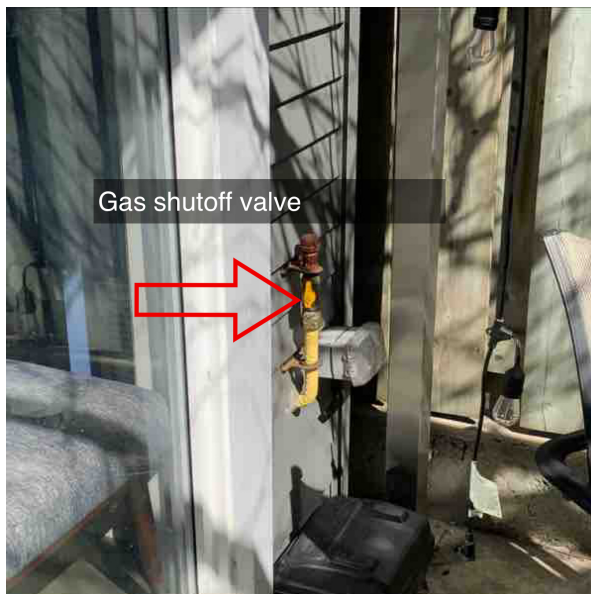
9.8.1 External gas connection (Exterior Back)

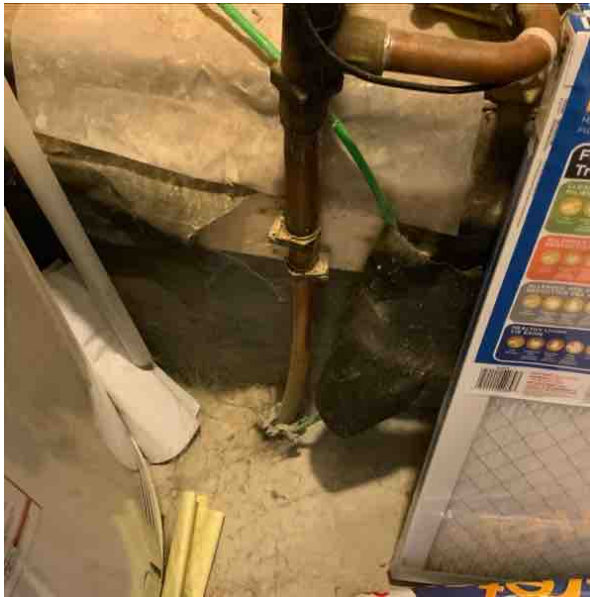
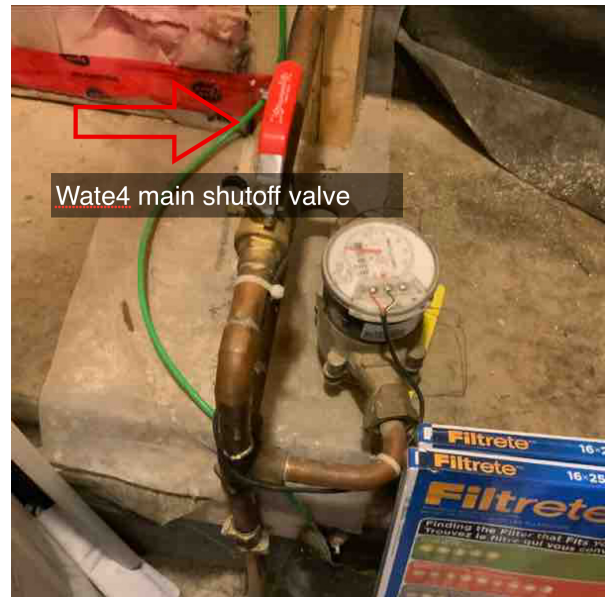
10.3.2 Copper water main.

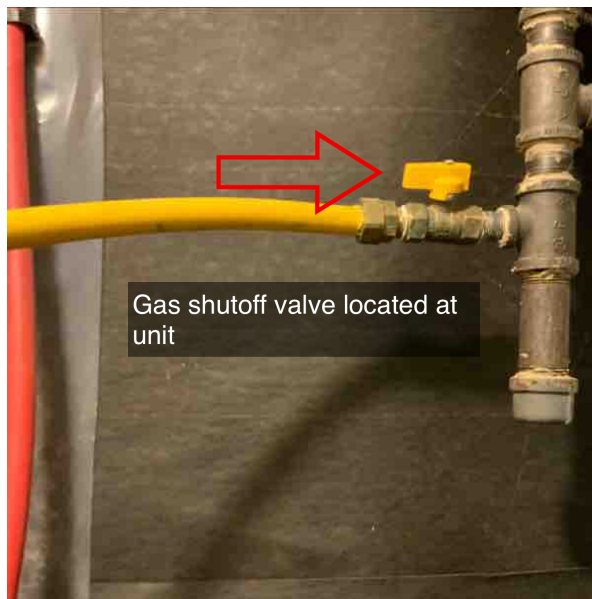
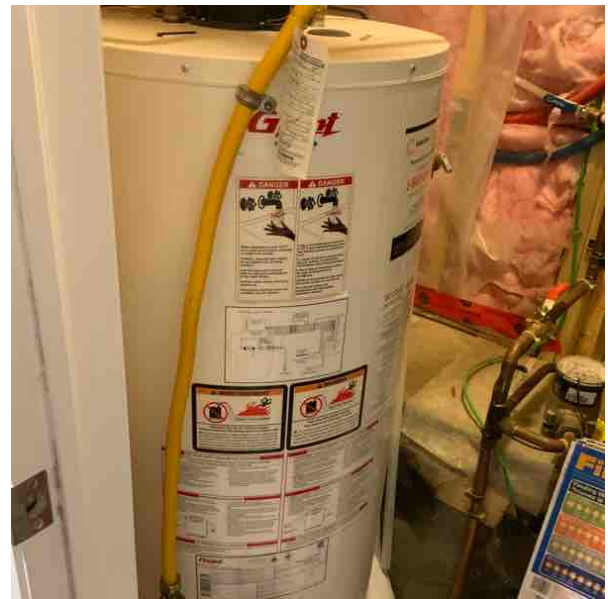
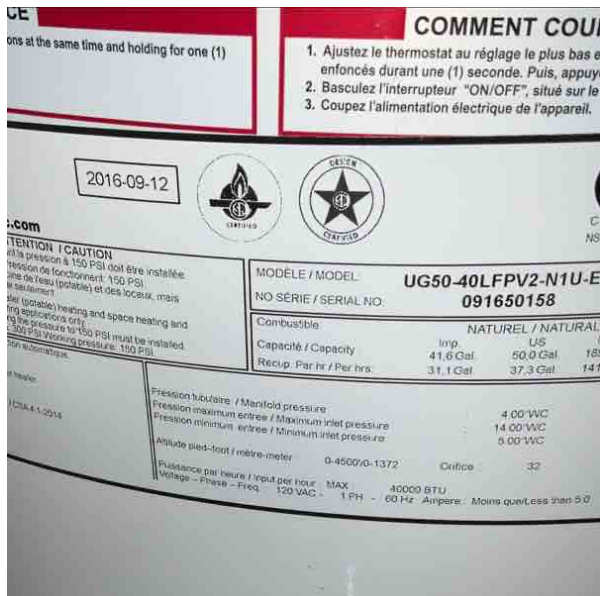
10.6.2 Water heater is dated 2016 and is functional

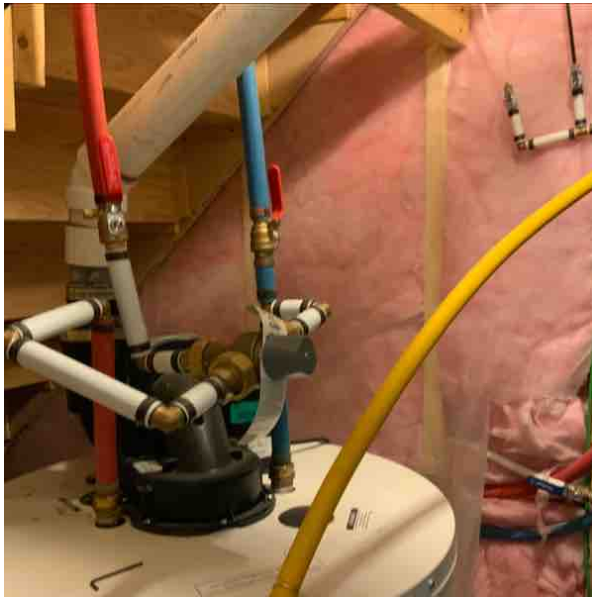
10.7.2 Power vented to exterior. Pipe is secured and in good condition.

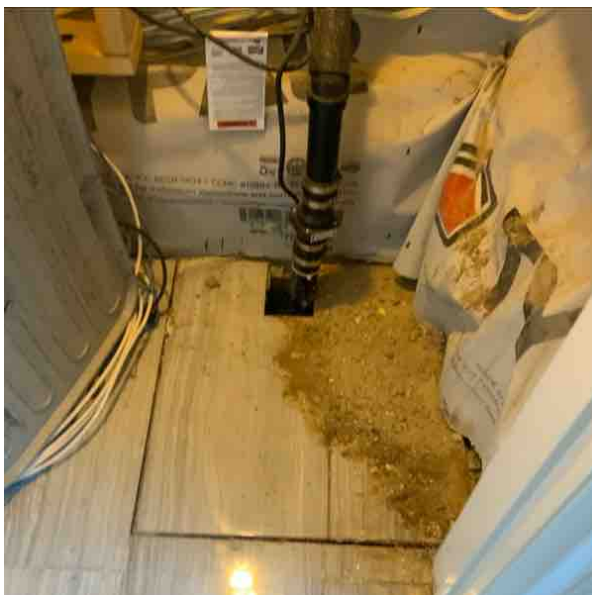
10.13.1 Home is equipped with a functional sump system
