Home Inspection Report

PROPERTY INSPECTED:
1009 Hedge Drive
Mississauga, ON L4Y 1G3

Date of Inspection: 07/08/2022

Inspection No. 141126-1737

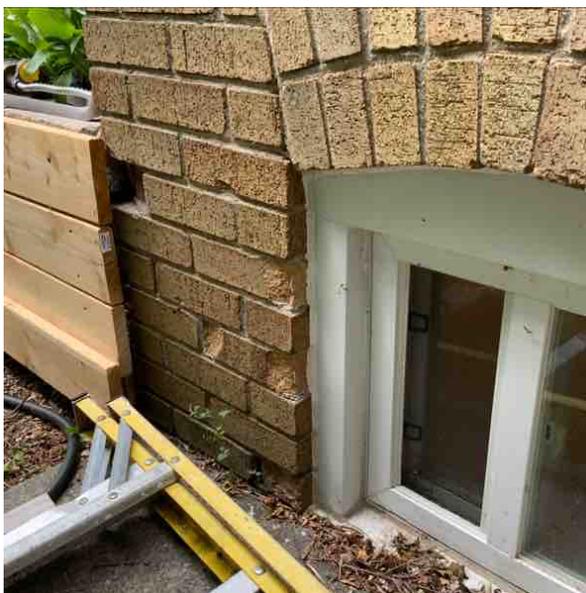
3.3.2 Surface deterioration of brick/mortar noted is common at this age. Repair worn areas, repoint open joints to repel water, reduce further deterioration. Anticipate occasional repairs as part of owning an old property.

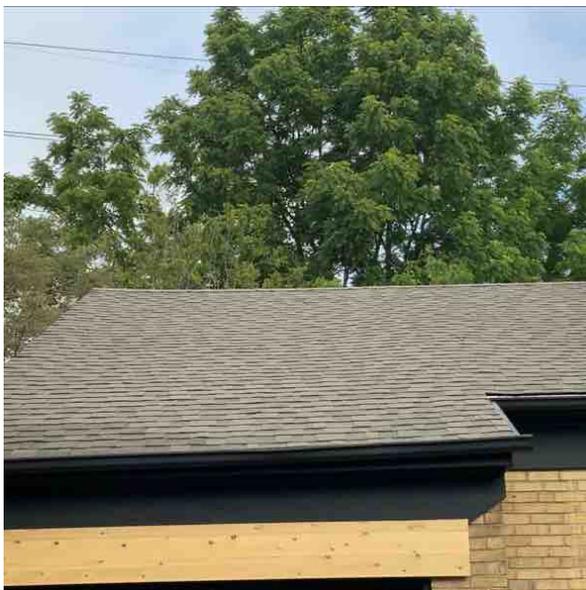
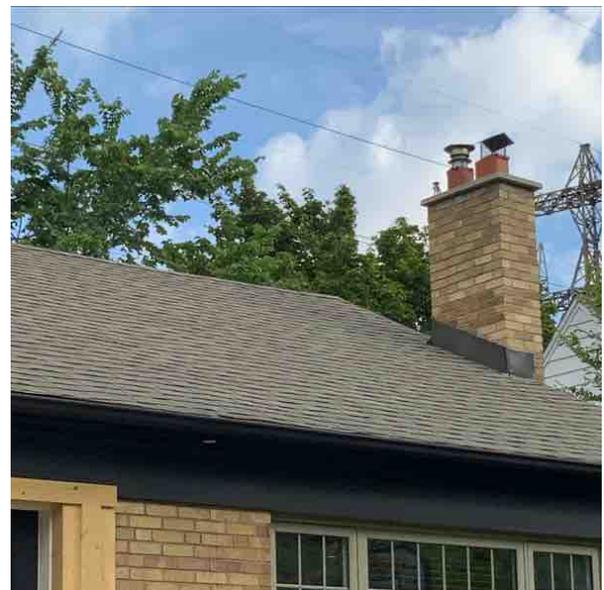
4.3.1 **Architectural shingles are in good condition . Estimated age is 4years**

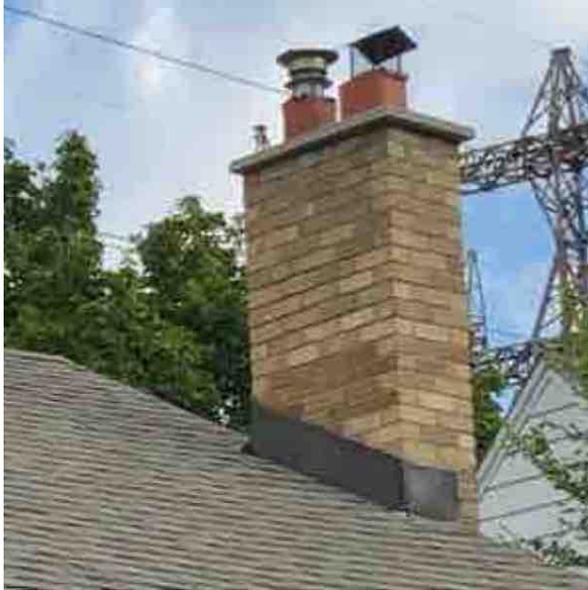
4.6.2 Brick is in good condition

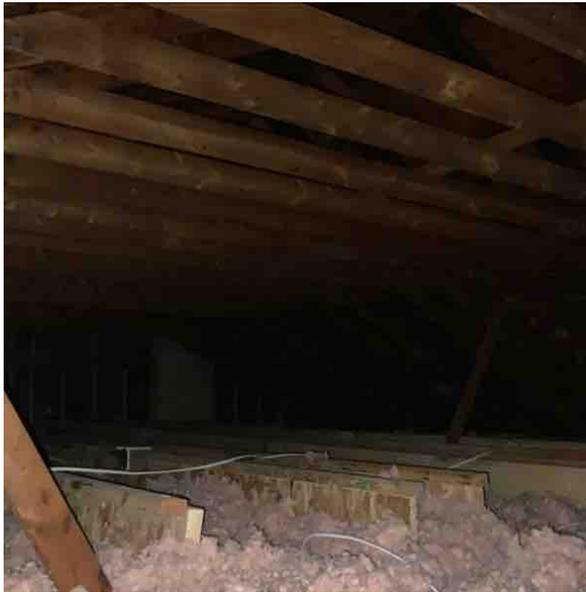
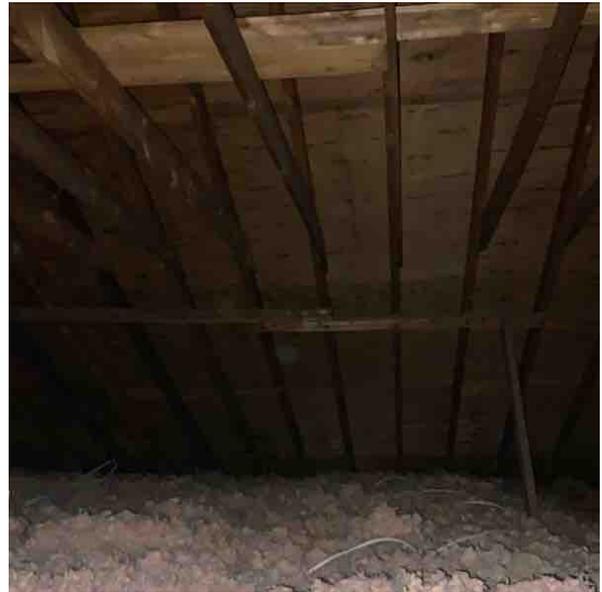
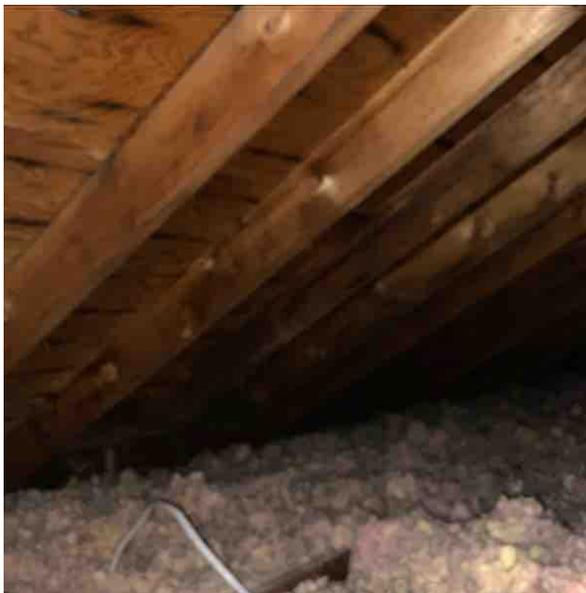
5.3.1 **Approximately 12 inches of fibreglass insulation**

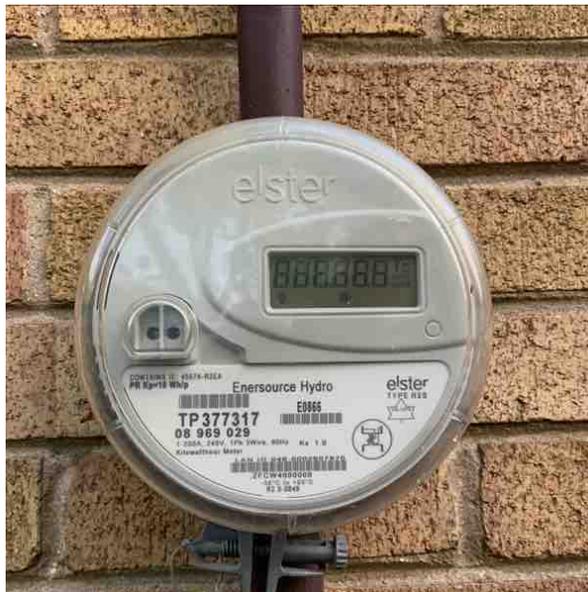
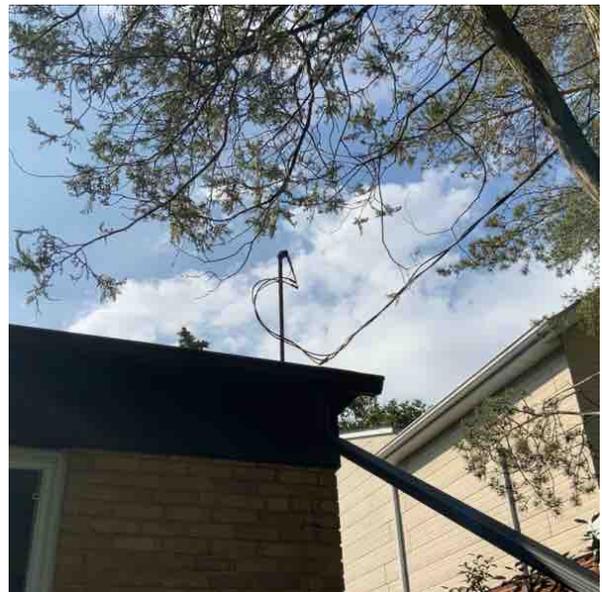
8.2.1 Electrical service to home is by overhead cables. **(Exterior Left)**

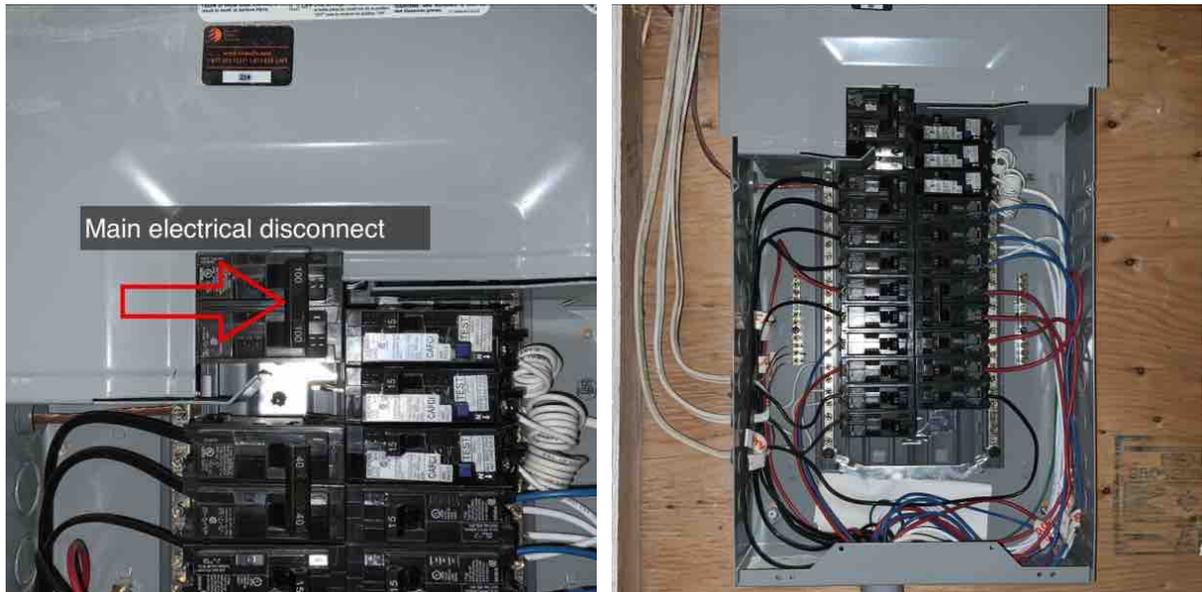
8.4.2 Main disconnect noted in picture

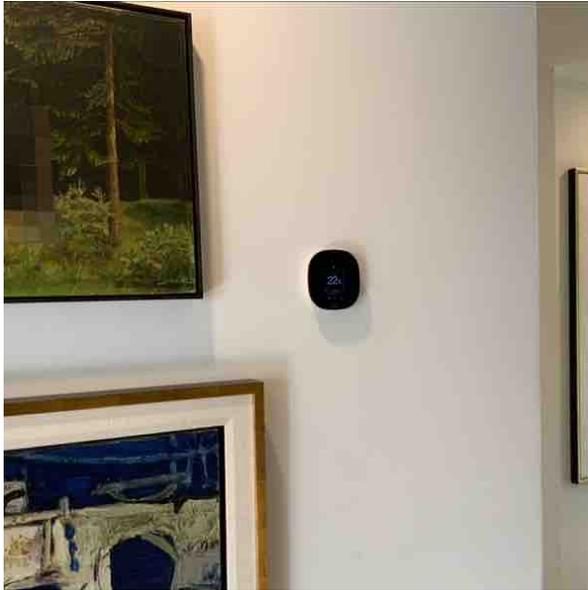
9.2.1 Smart thermostat located on main floor

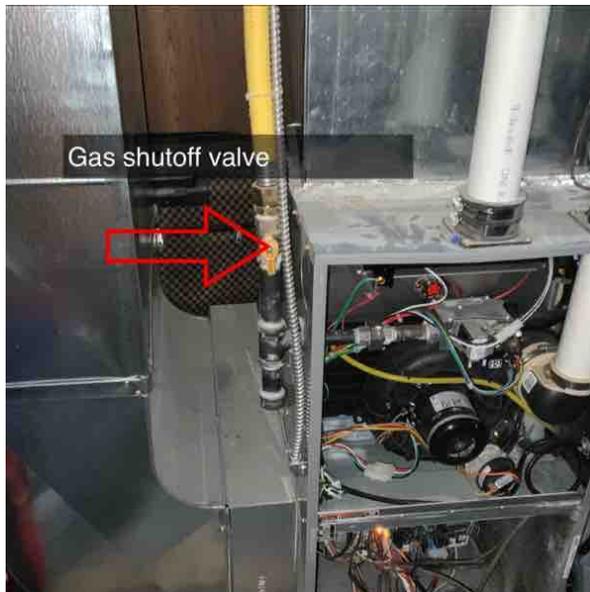
9.3.1 Gas shutoff valve is located at the unit.

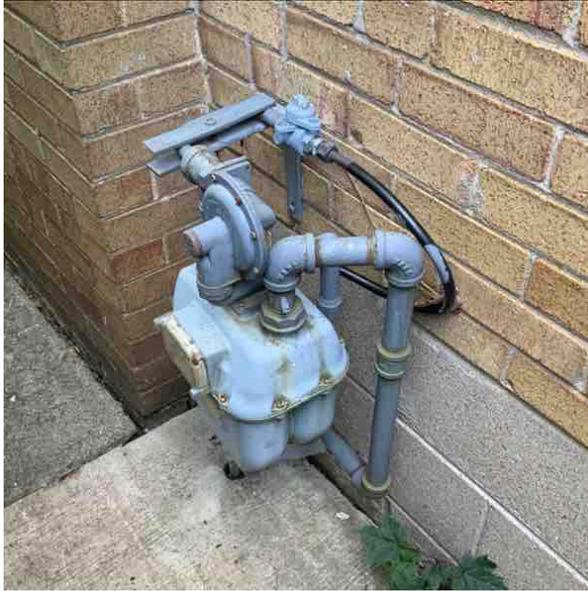
9.4.1 Located at right side of home

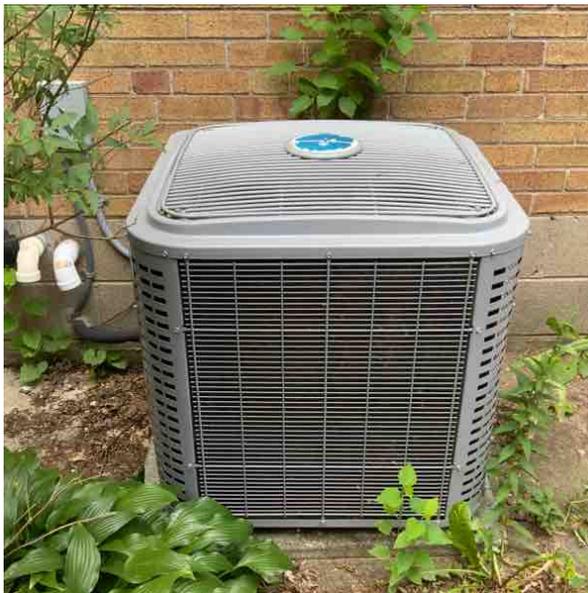
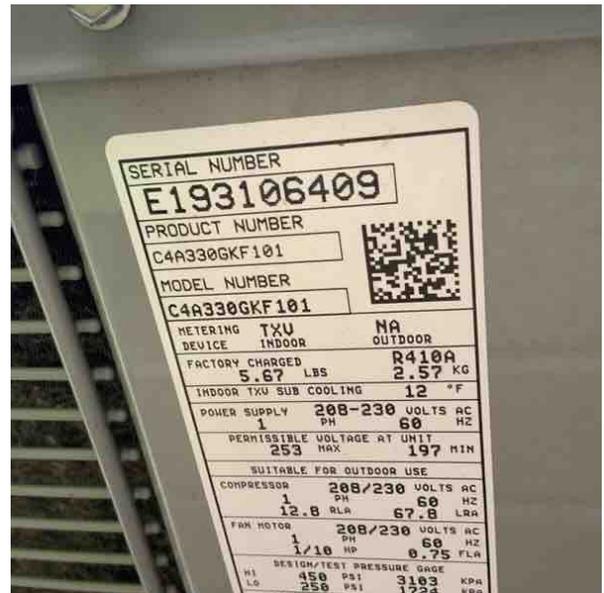
9.5.2 Air conditioner is dated 2019 and is functional (Exterior Right)

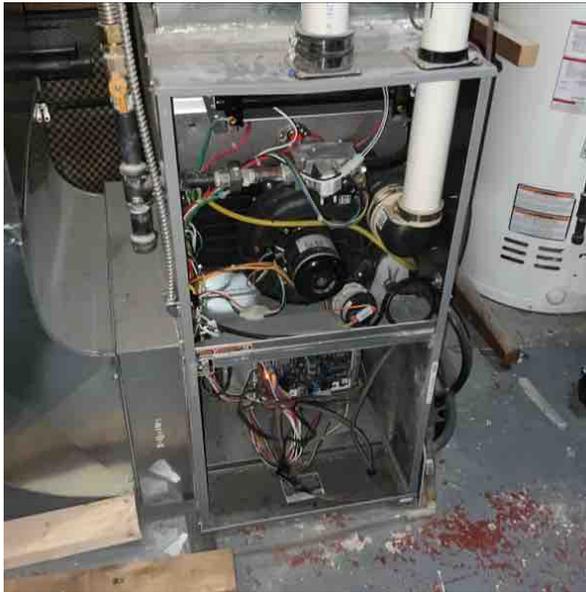
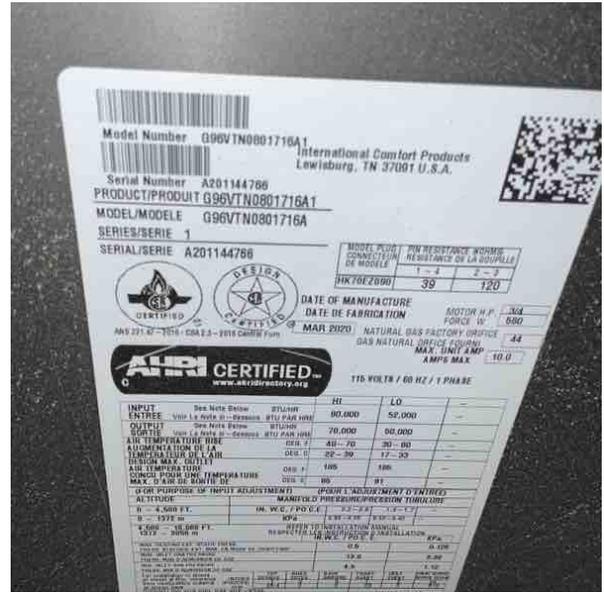
9.6.2 High efficiency furnace is dated 2020 and is functional

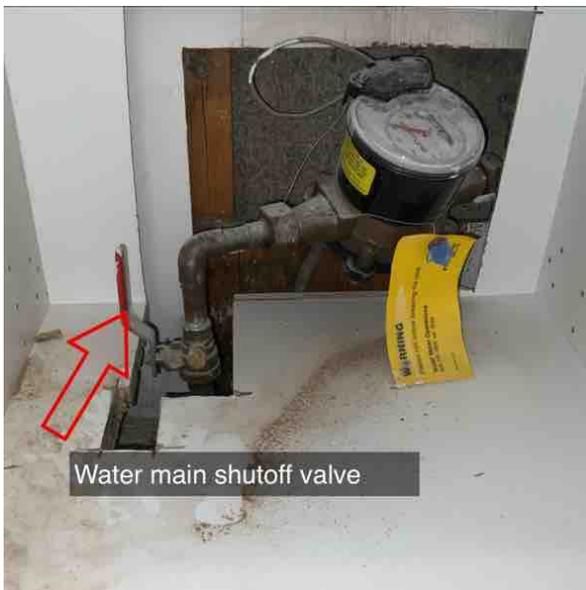
10.2.2 Copper water main.
