Home Inspection Report

PROPERTY INSPECTED:
16 Mid Pines Road
Toronto, ON M1G 2L6

Date of Inspection: 01/28/2023

Inspection No. 141126-1920

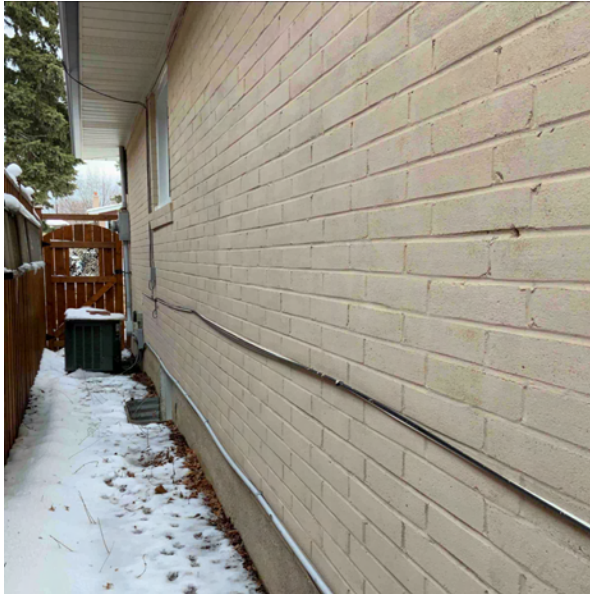
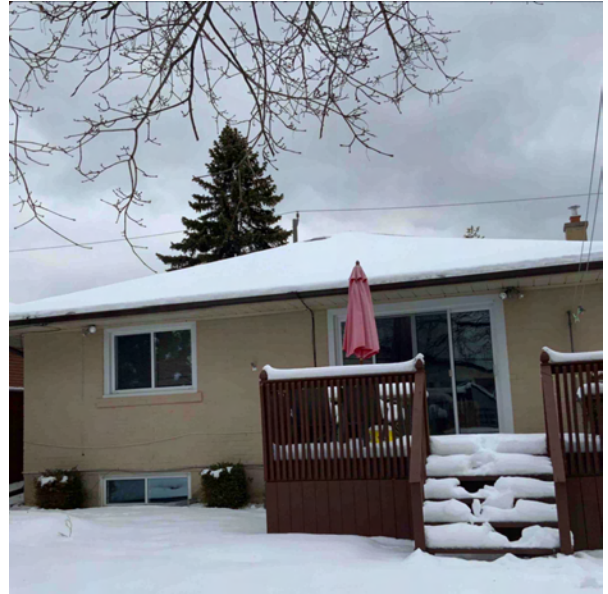
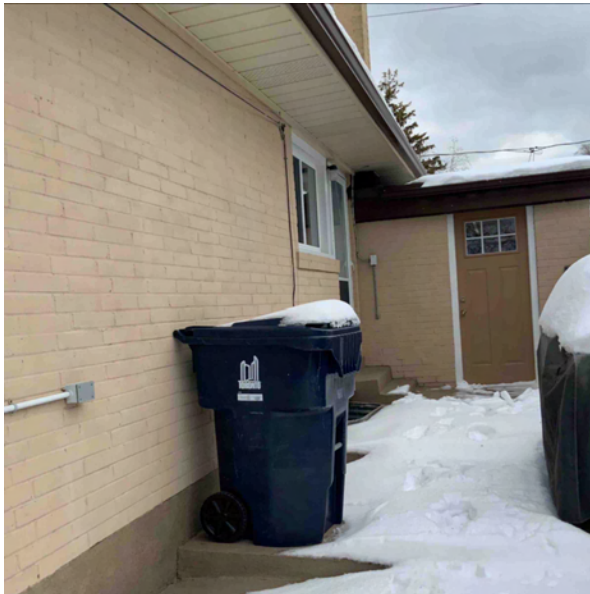
Example views of the exterior can be seen in the picture(s) below.

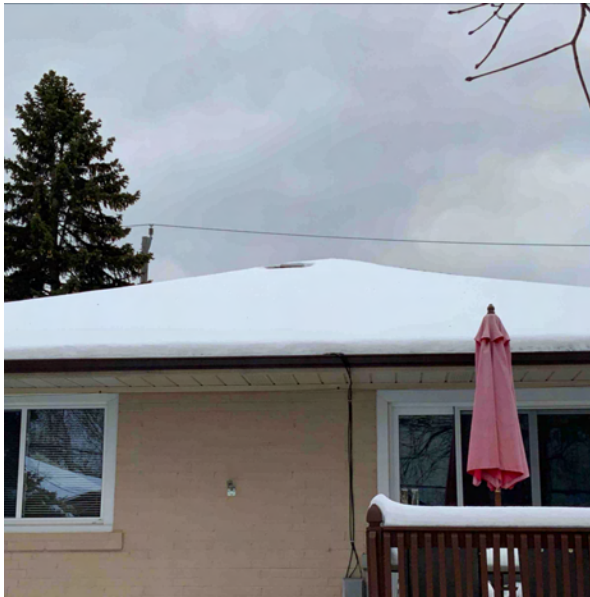
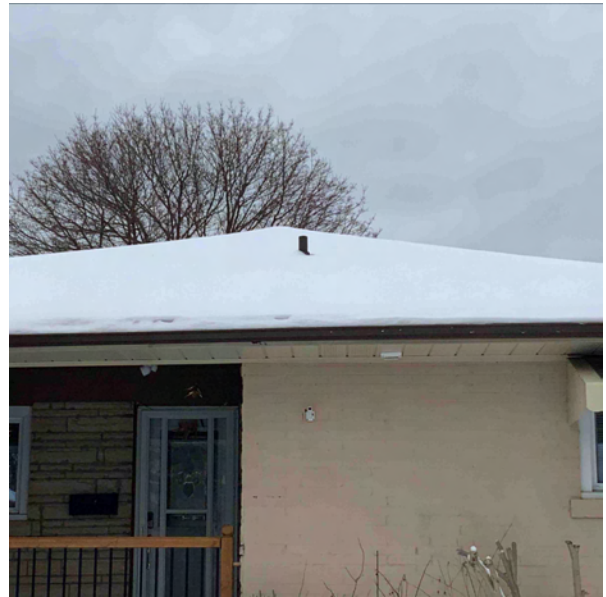
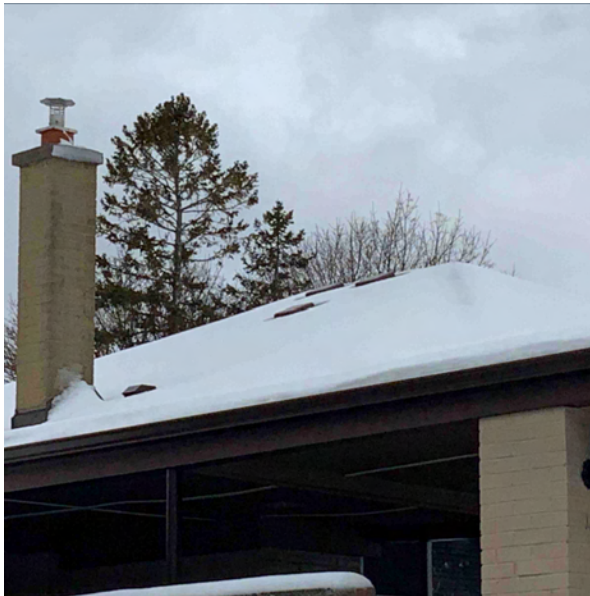
4.2.2 Example view(s) of the roof can be seen in the pictures below

4.4.1 Roof is completely snow covered limiting the inspection. Seller advises shingles are approximately 10 years old.

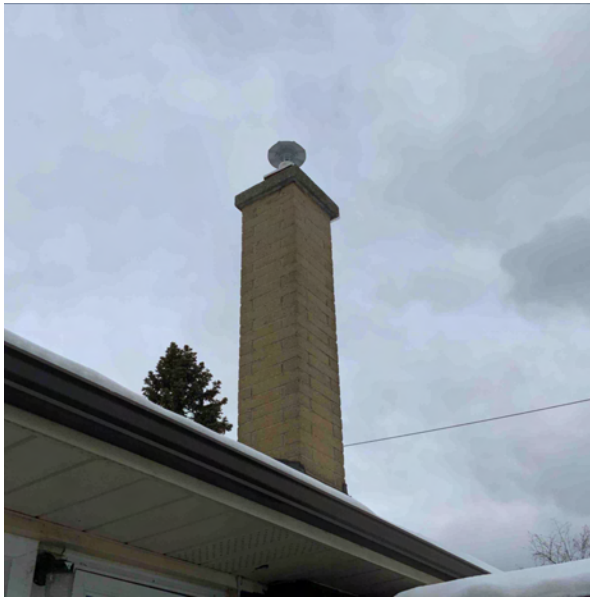
4.7.2 Brick chimney vents water heater

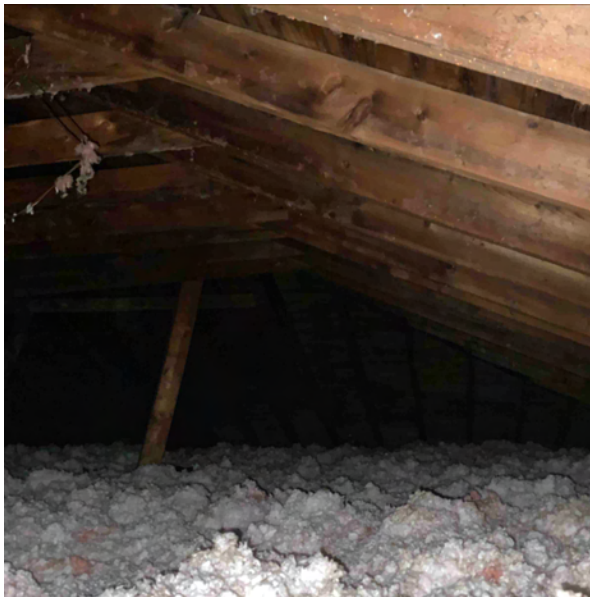
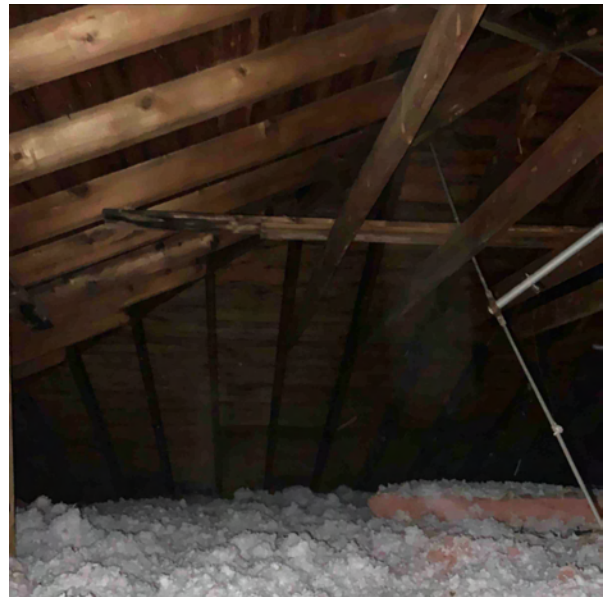
5.2.2 Example views of the attic can be seen in the picture(s) below.

5.4.1 Approximately 10 inches of fiberglass insulation

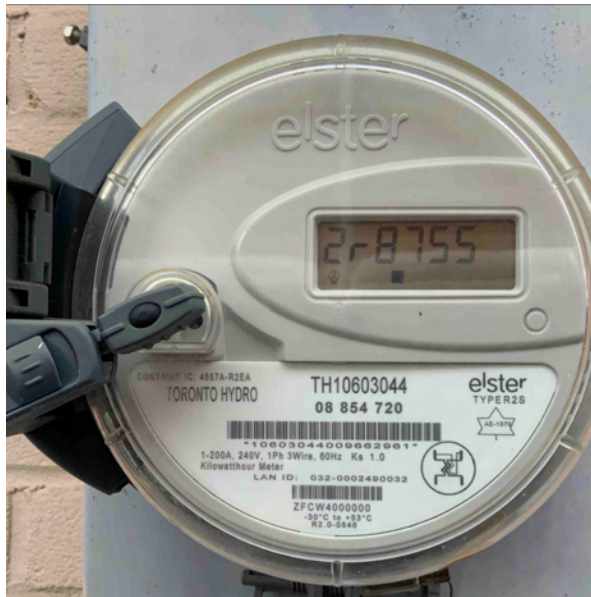
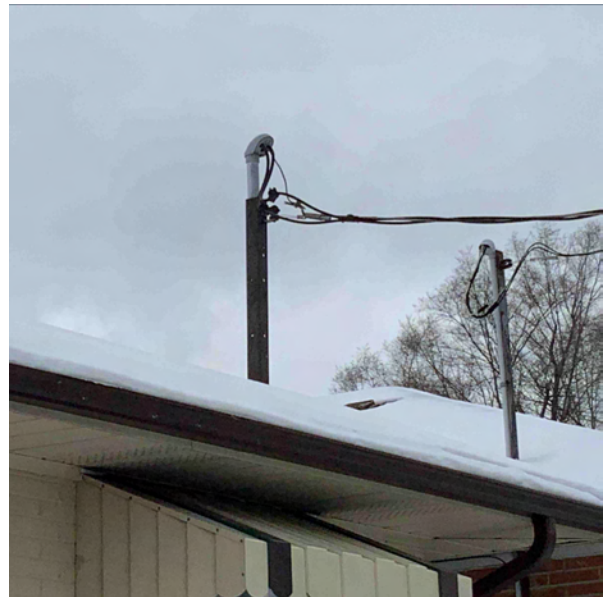
8.2.1 Electrical service to home is by overhead cables.

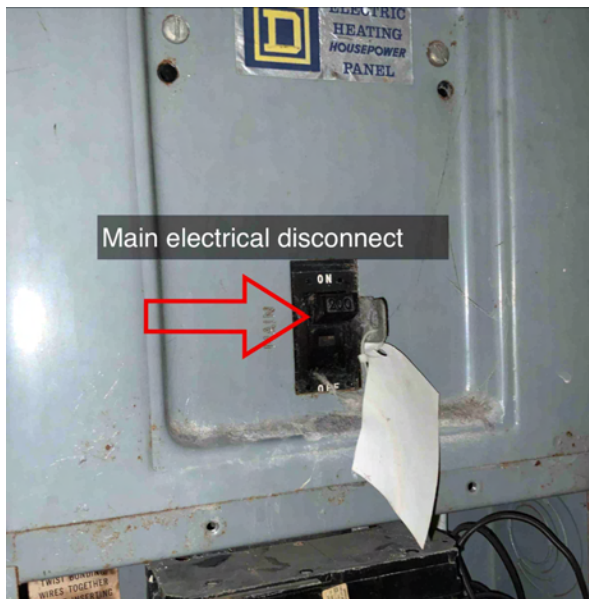
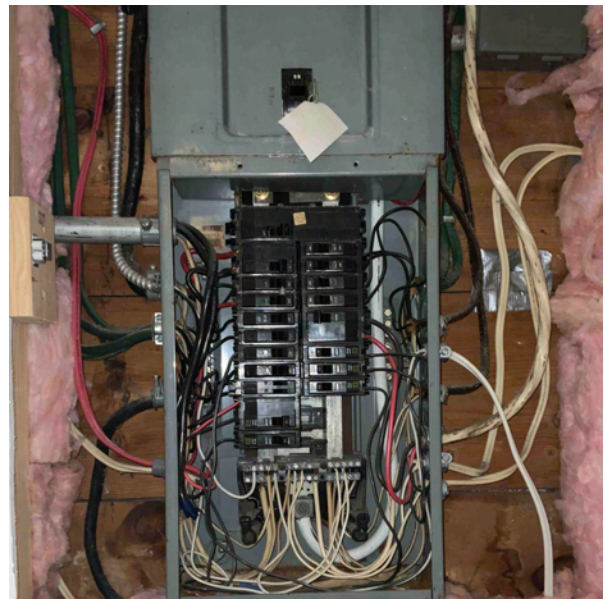
8.4.2 Main disconnect noted in picture

8.5.1 **200 amp service. Breaker panel approximately 30+ years old. Noted some corrosion on inside lower panel.**

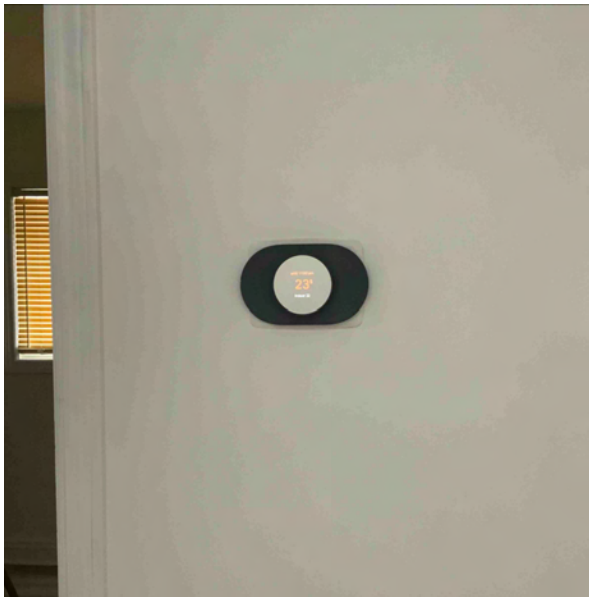
9.3.1 Nest thermostat located on main floor

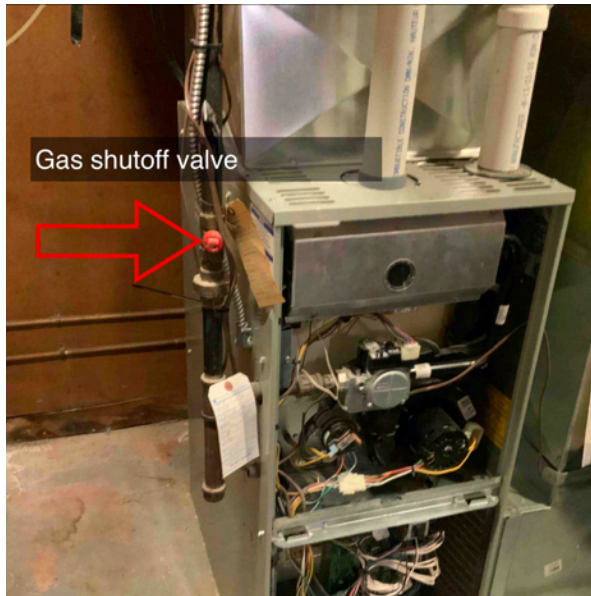
9.4.1 Gas shutoff valve is located at the unit.

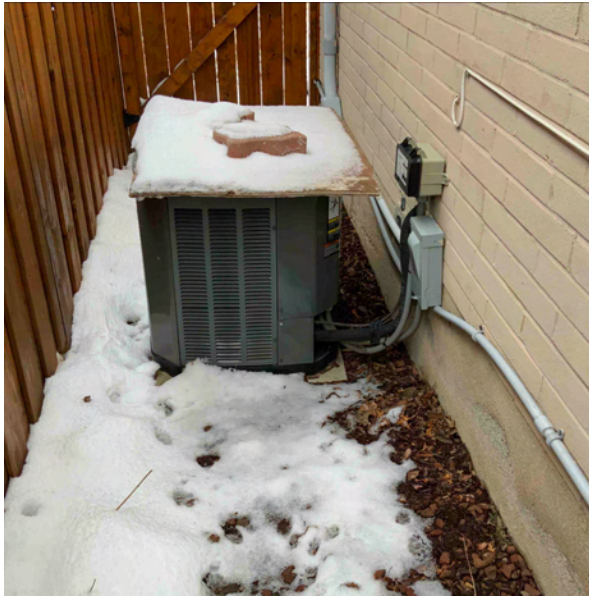
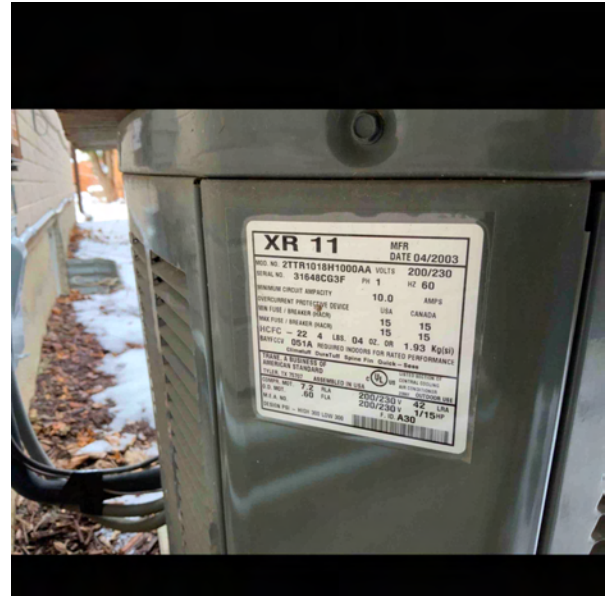
9.6.1 Air conditioner is dated 2003 and has exceeded its typical life expectancy.

System not tested due to low outdoor temperature. Determine function in cooling season

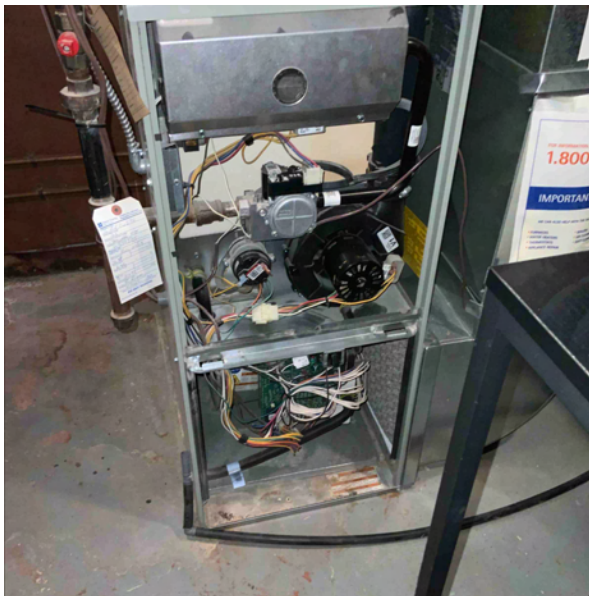
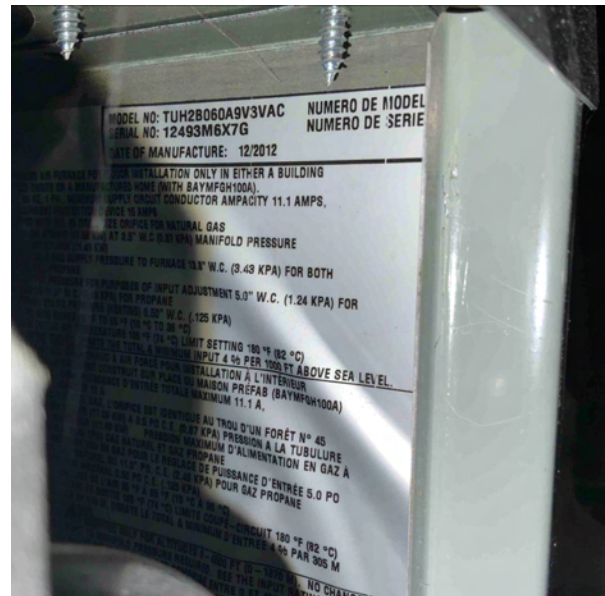
9.7.2 High efficiency furnace is dated 2012 and is functional

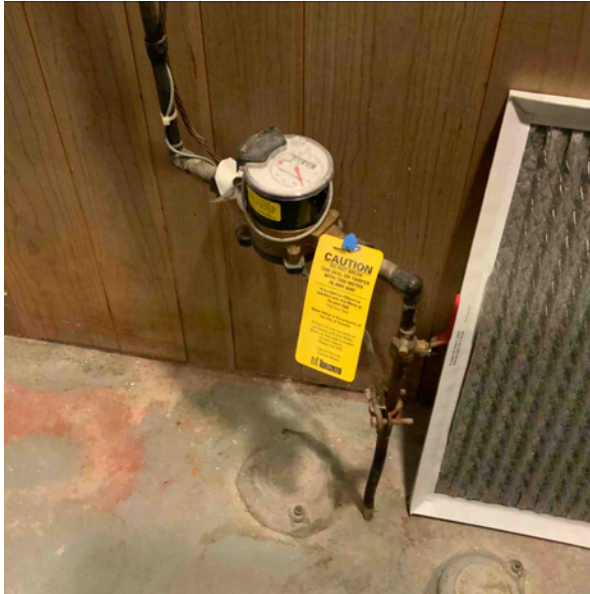
10.3.2 **Copper water main.**

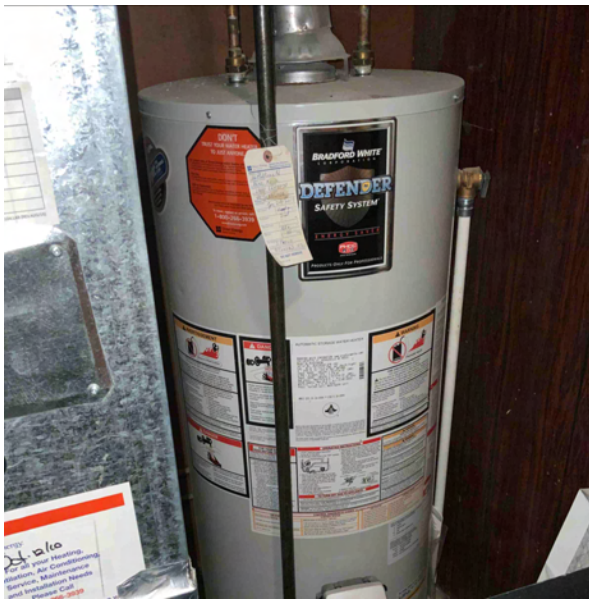
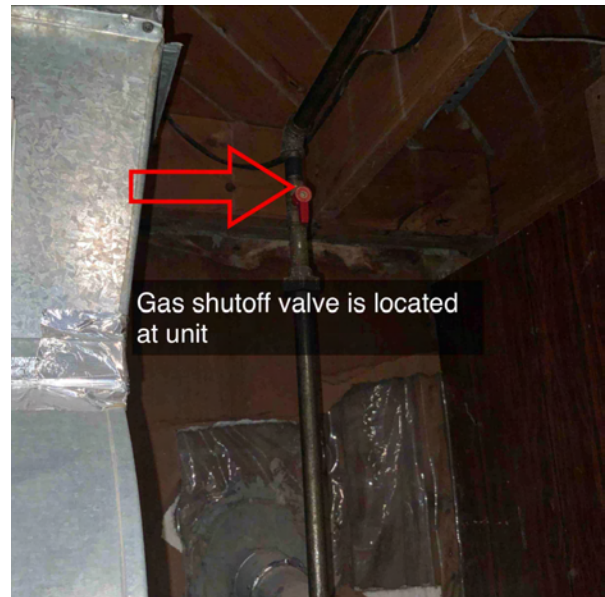
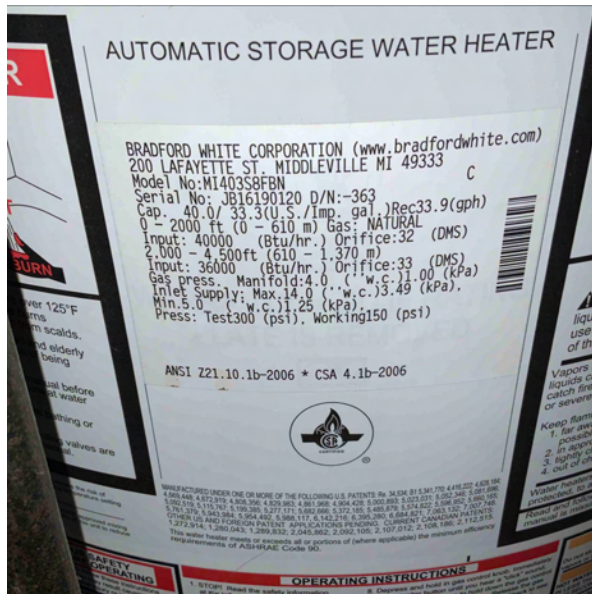
10.6.2 Water heater is dated 2012 and is functional
