## Home Inspection Report

PROPERTY INSPECTED:  
**77 Mortimer Avenue**  
**Toronto, ON M4K 2A2**

**Date of Inspection: 06/08/2023**

Inspection No. 141126-2102

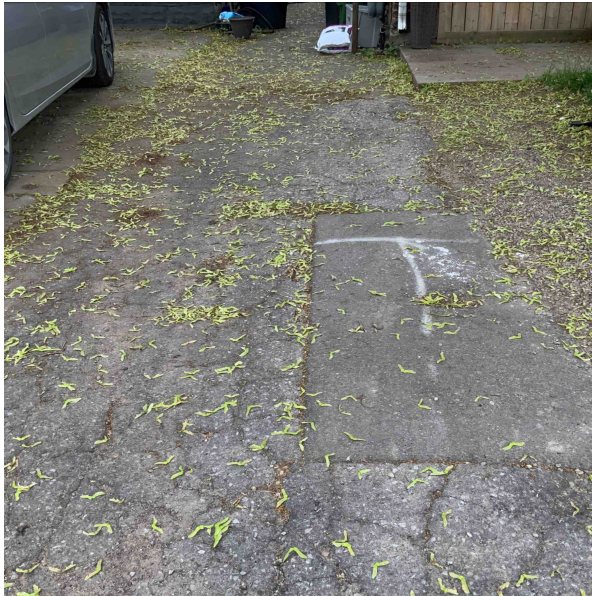
2.3.1 The driveway shows typical and surface wear and cracking. Periodic maintenance may prolong the life of the surface.

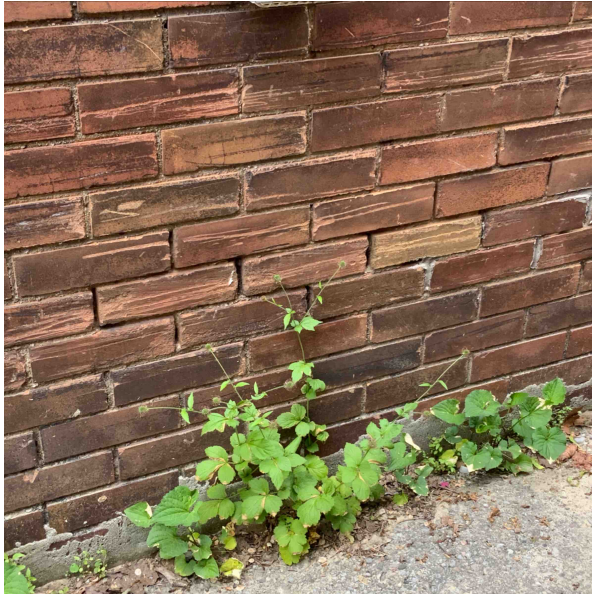
3.3.2 Surface deterioration of brick/mortar noted is common at this age. Repair worn areas, repoint open joints to repel water, reduce further deterioration. Anticipate occasional repairs as part of owning an old property.

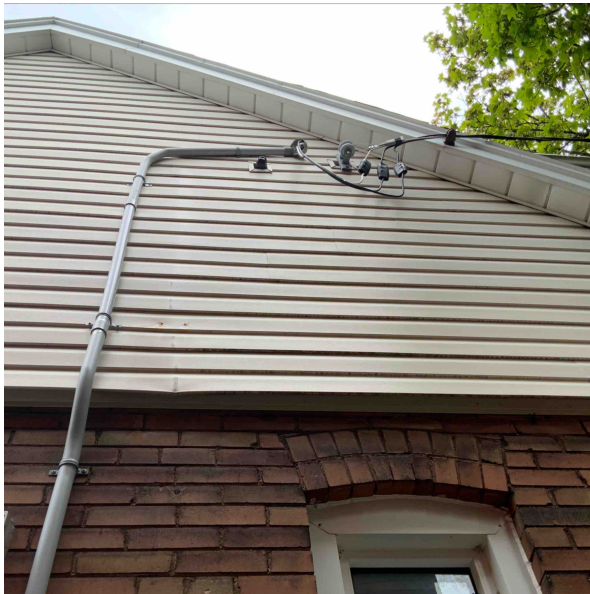
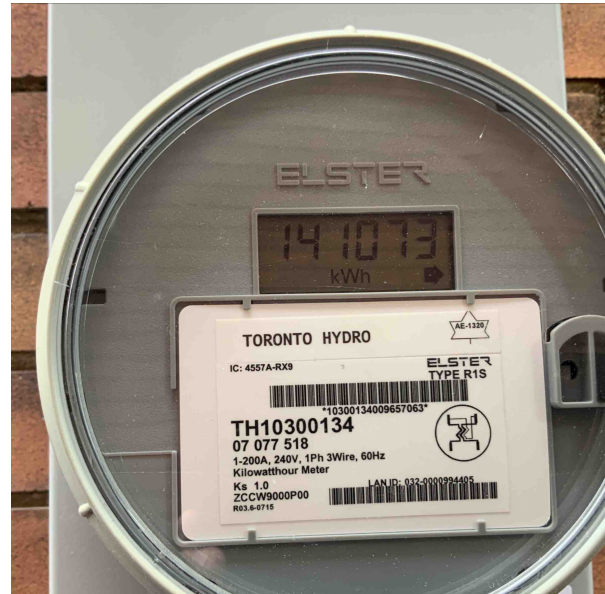
7.2.1 Electrical service to home is by overhead cables.

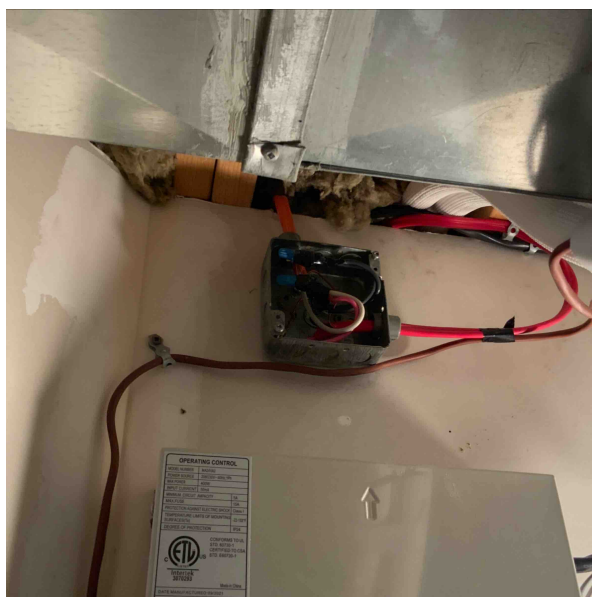
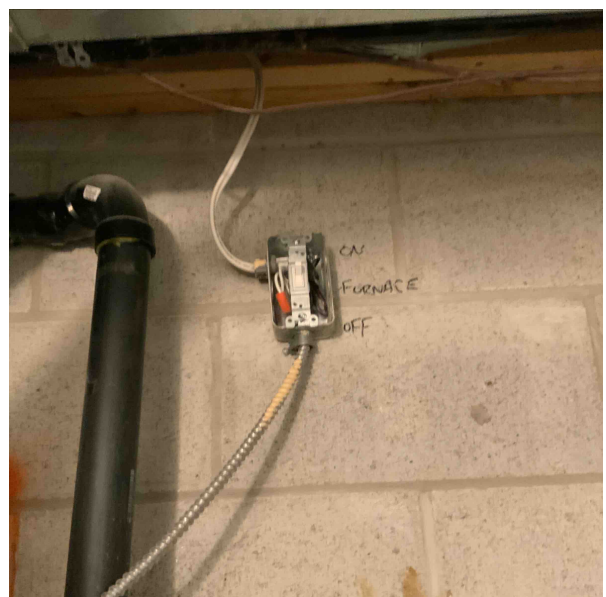
7.7.1 Install junction box cover plates to prevent hazards associated with exposed wiring. **(Basement)**

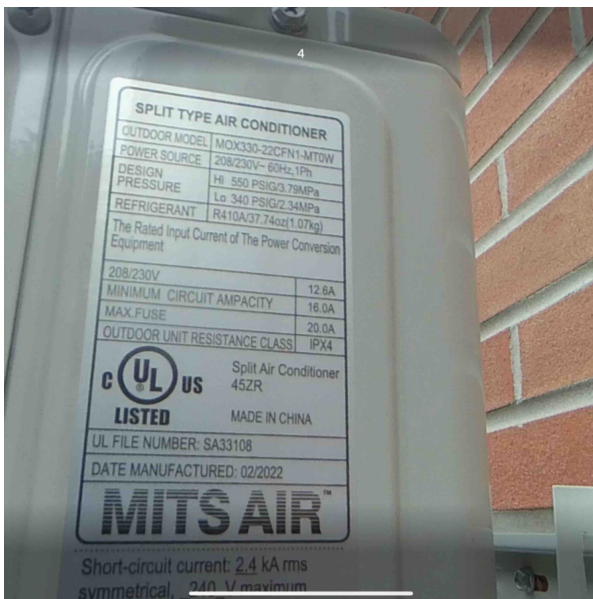
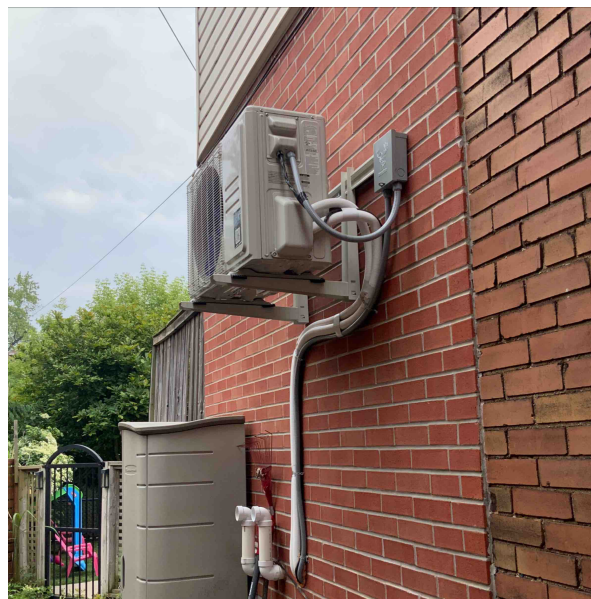
8.5.2 **Air conditioner is dated 2022 and is functional**

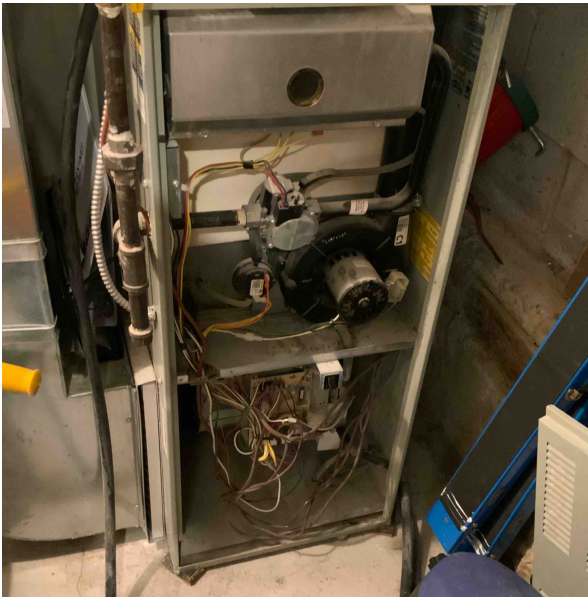
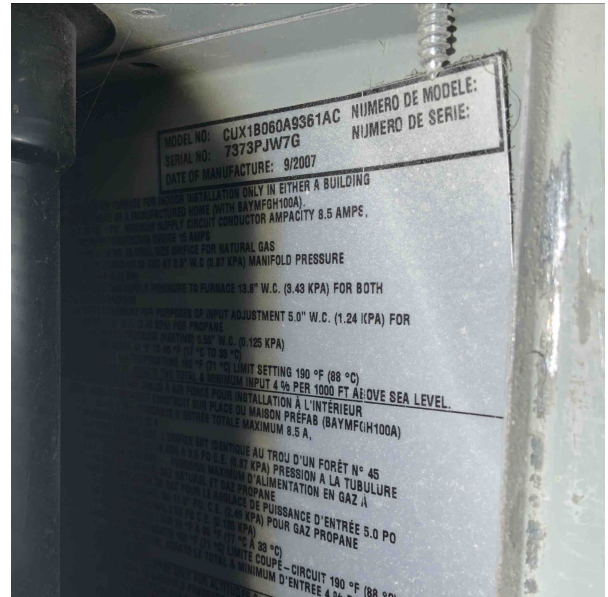
8.6.2 High efficiency furnace is dated 2007 and is functional

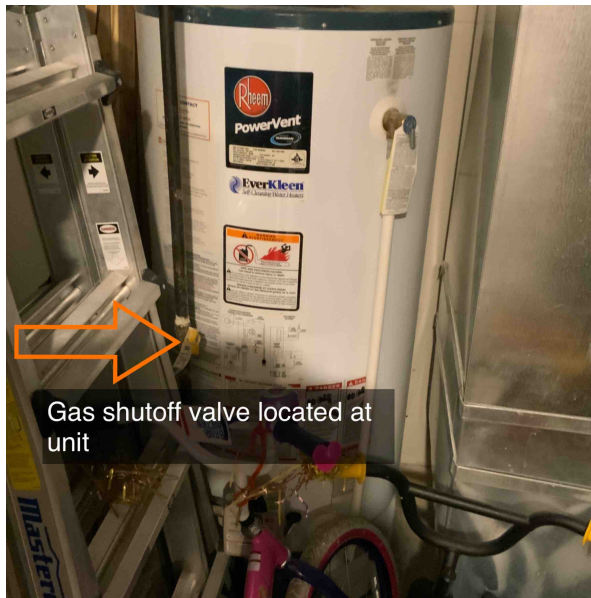
### 9.6.2 Water heater is dated 2008 and is functional

The water heater is nearing the end of its service life. The remaining life is unpredictable replace the units when it fails, when repairs are no longer cost effective, or proactively to prevent a loss of functionality.

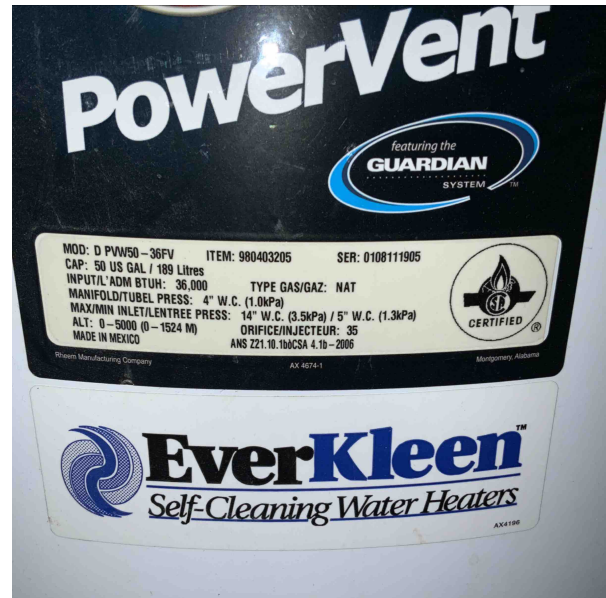
Gas shutoff valve located at unit

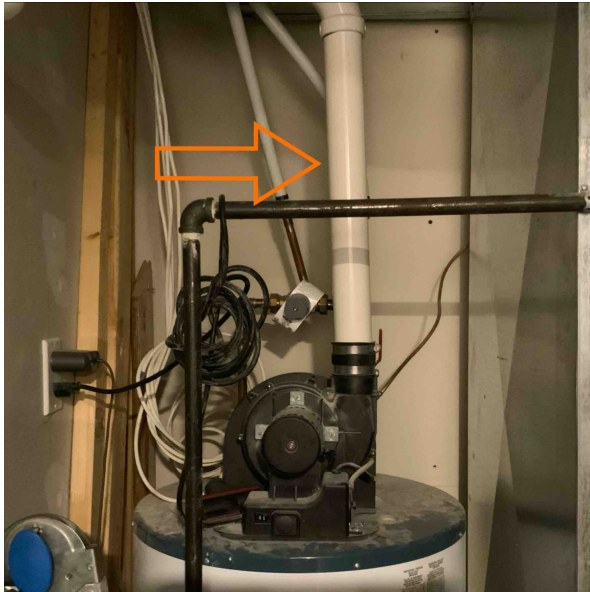
9.7.2 Power vented to exterior. Pipe is secured and in good condition.
