Home Inspection Report

20 Jessie Drive
Toronto, ON M3C 4C2

Date of Inspection: 07/10/2023

Inspection No. 141126-2148

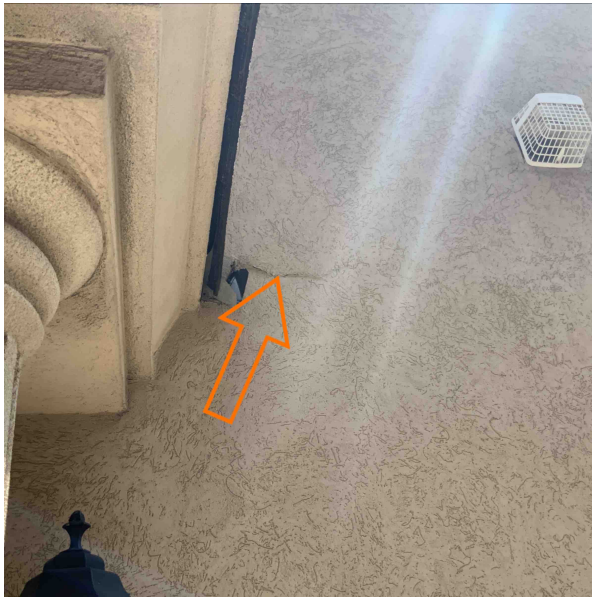
3.3.2 There is a small tear in the siding. Recommend corrective action as needed

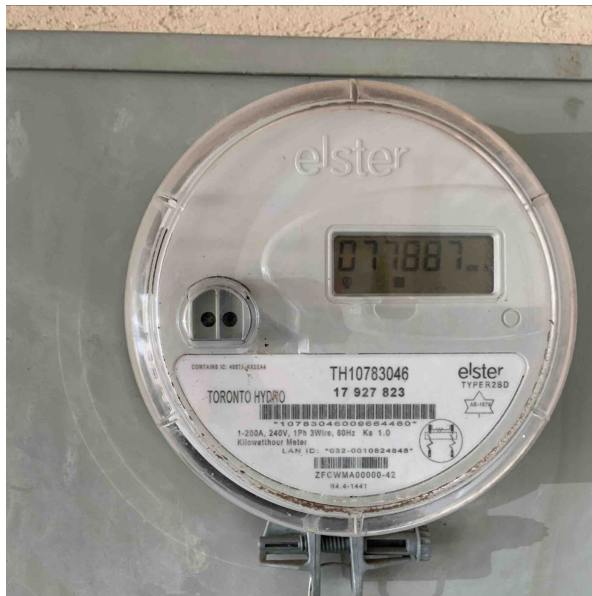
8.2.1 Electrical service to the home is by underground cables.

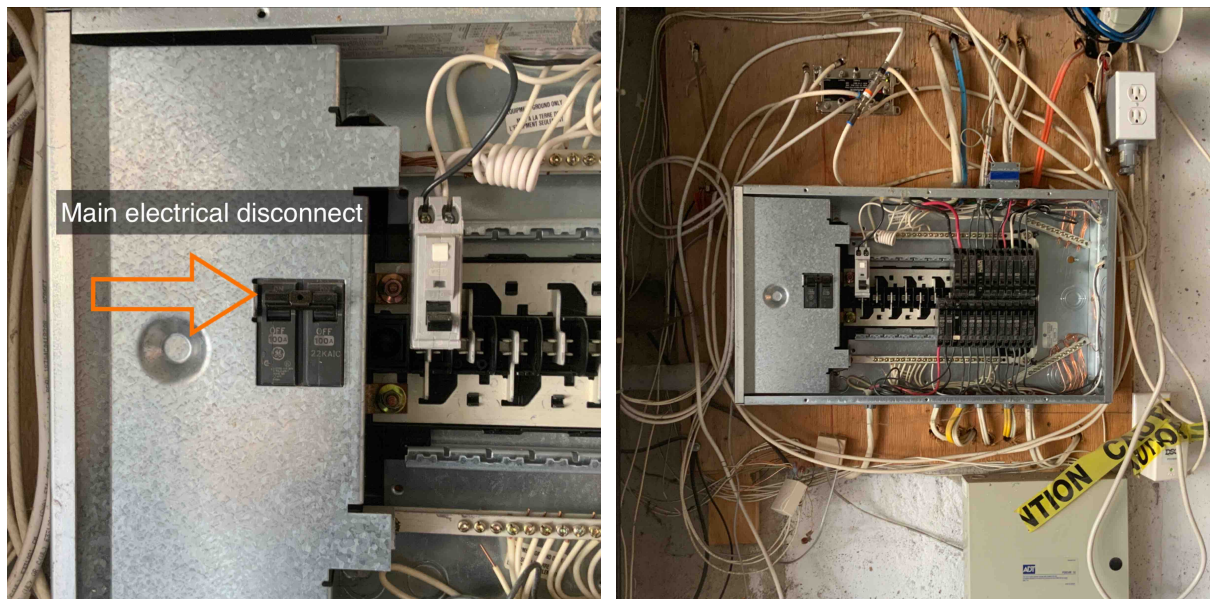
8.4.2 Main disconnect noted in picture

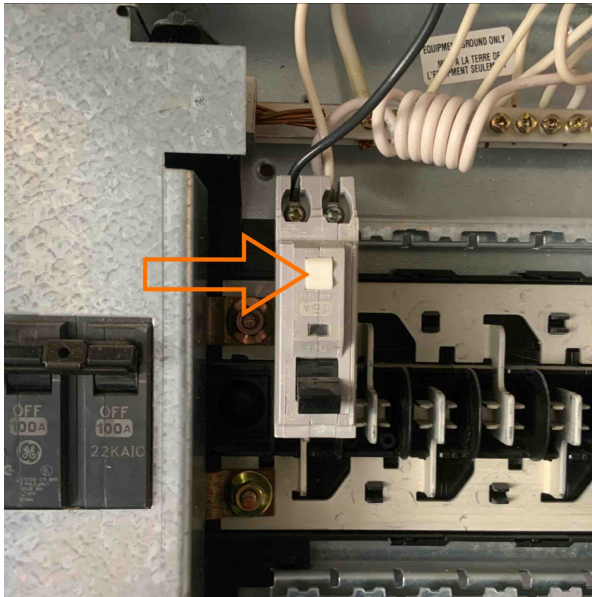
8.12.1 Tested and functional

8.12.2 There is a type of circuit breaker that promises to reduce the number of electrical fires in homes. The 'arc fault circuit interrupter' or 'AFCI' is reported to detect sparking in the electrical system and can shut the affected circuit down before it causes a fire. The installation of ARC fault circuit interrupter protected circuits is recommended at all living area locations.

New electrical standards require AFCI circuits for all bedrooms. As per manufacturers recommendations you should test AFCI breakers monthly and replace them if they fail to trip when tested.

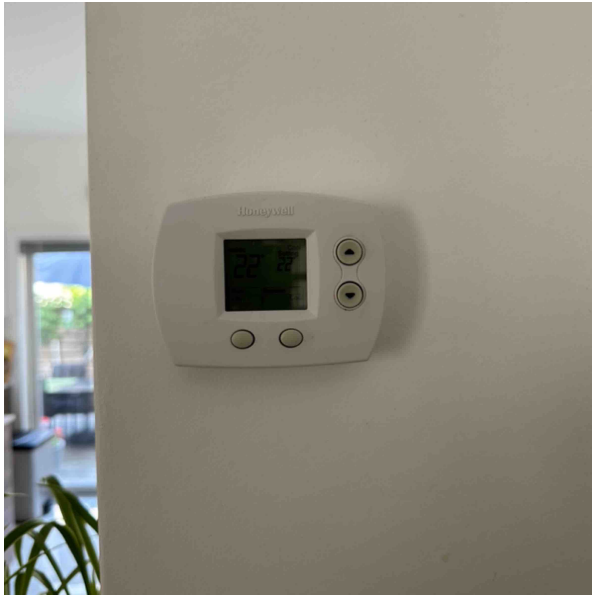
9.2.1 Located outside kitchen

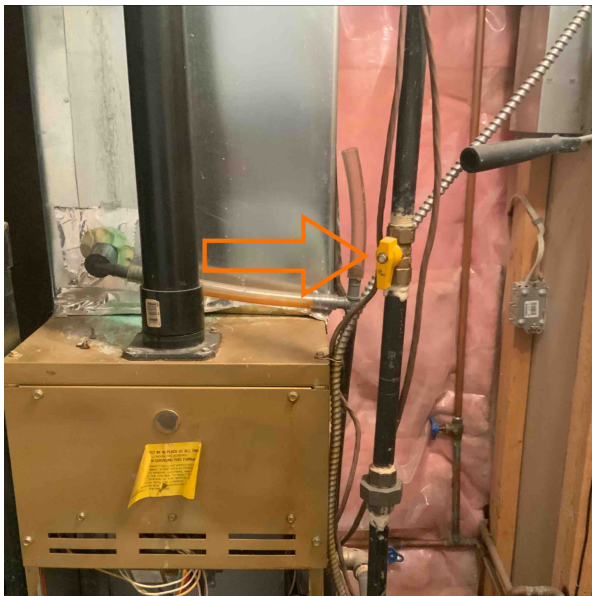
9.3.1 Gas shutoff valve is located at the unit.

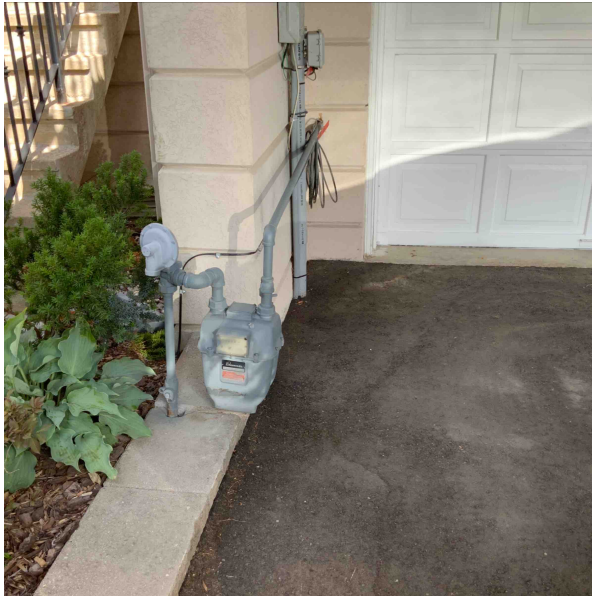
9.4.1 Recommend a barrier to prevent damage from vehicles (**Exterior Front**)

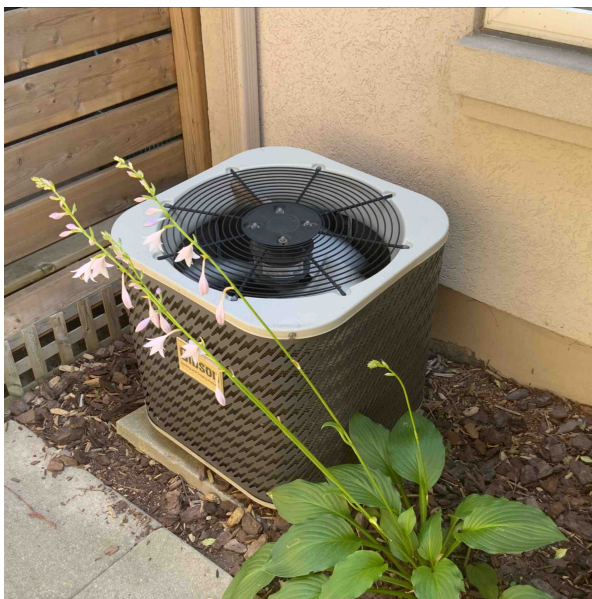
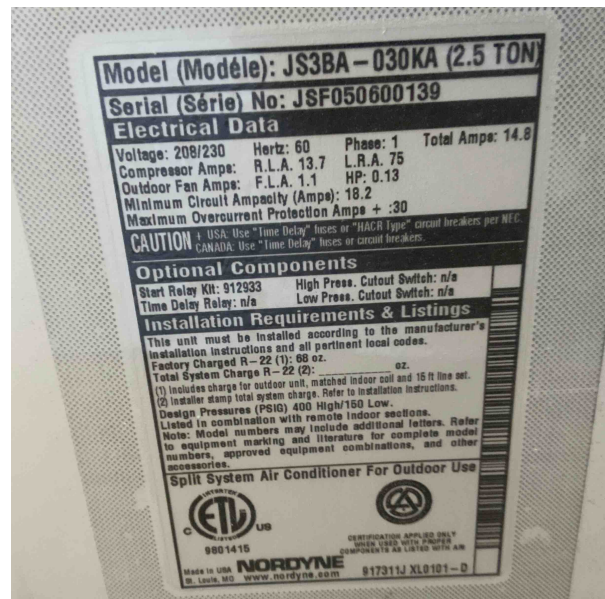
9.5.2 **Air conditioner is dated 2005 and has exceeded its typical service life. Functional at time of inspection (Exterior Left)**

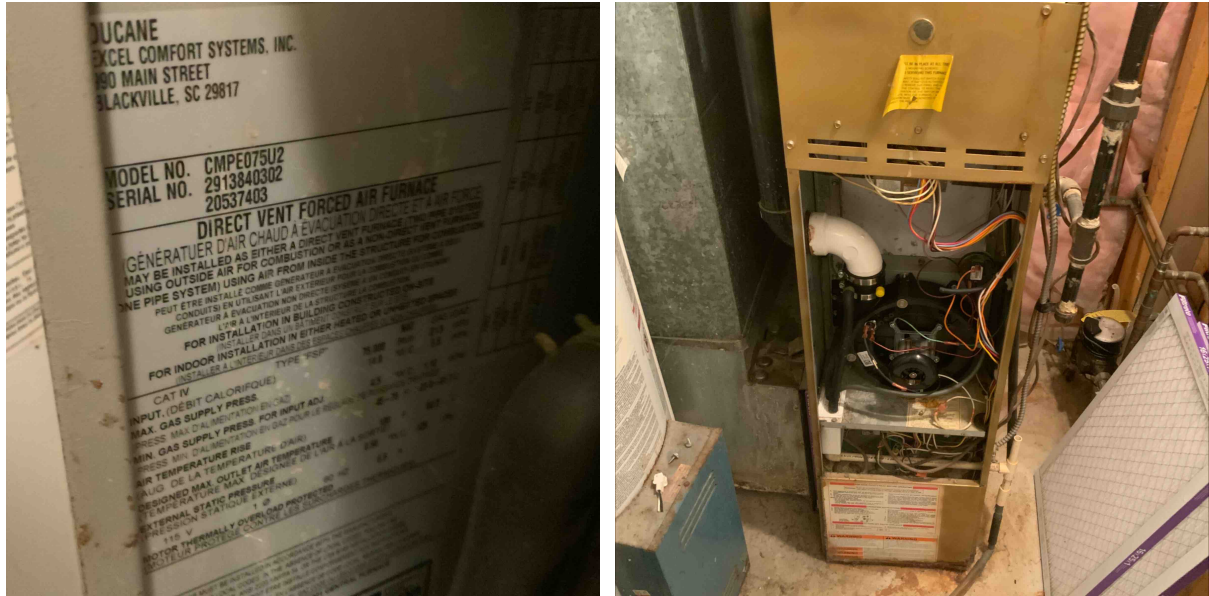
9.6.2 High efficiency furnace is dated 2002 and is functional.

The furnace is near the end of its service life. The remaining life is unpredictable. Replace the unit when it fails, when repairs are no longer cost-effective, or proactively to prevent a loss of functionality.

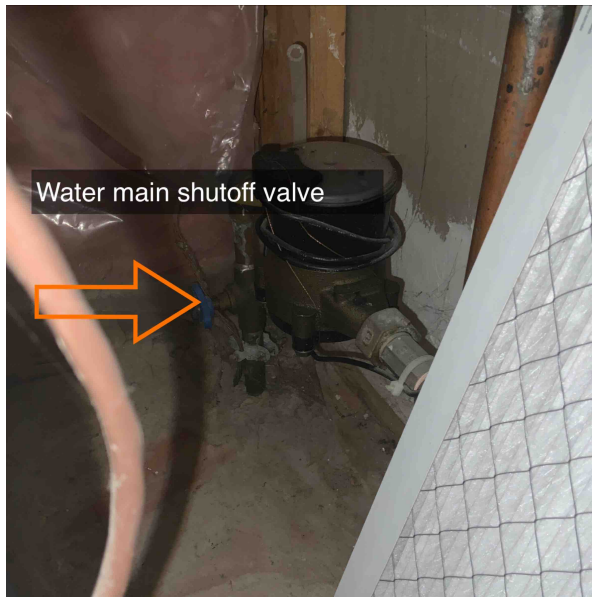
10.2.2 **Copper water main.**

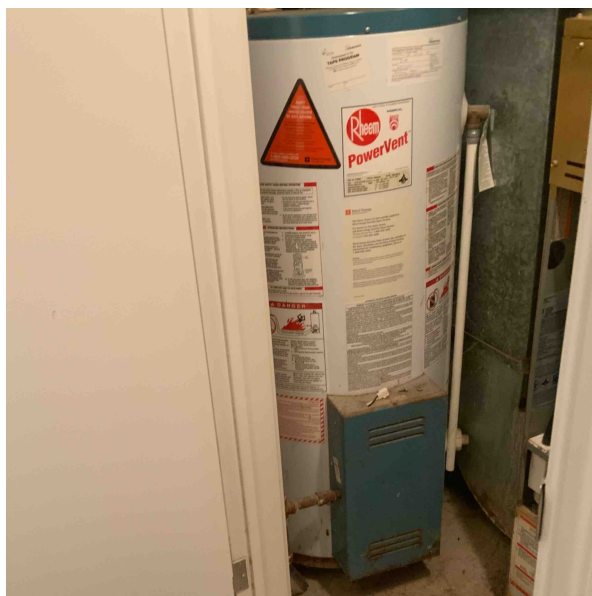
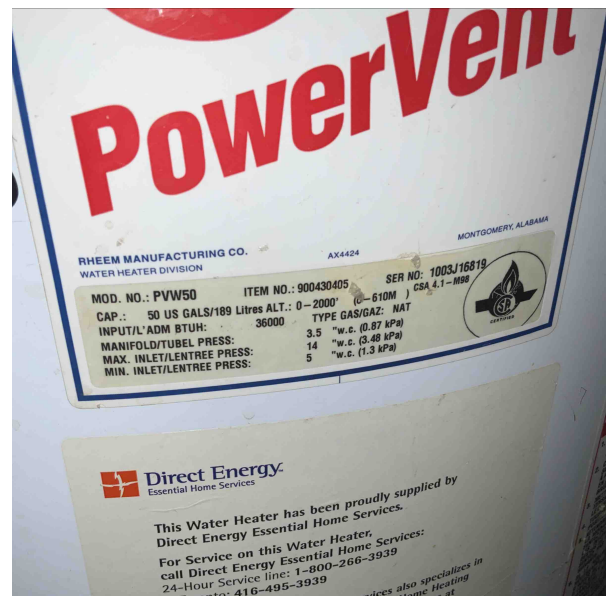
10.5.2 **Water heater is dated 2003 and has exceeded its typical service life. Functional at time of inspection**

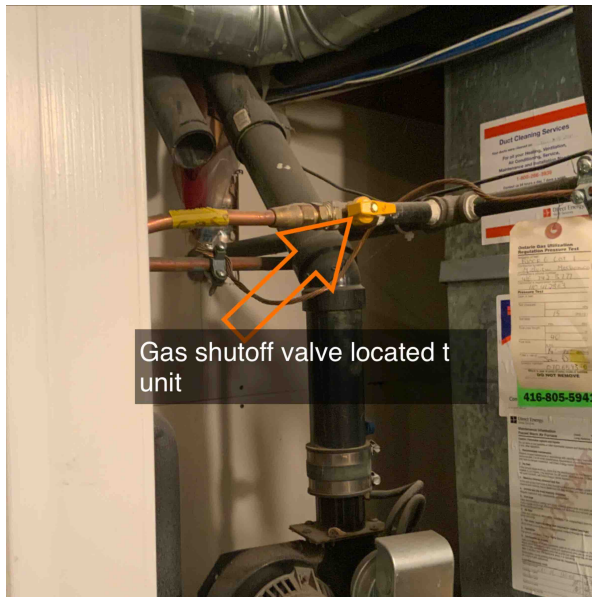
Gas shutoff valve located t
unit

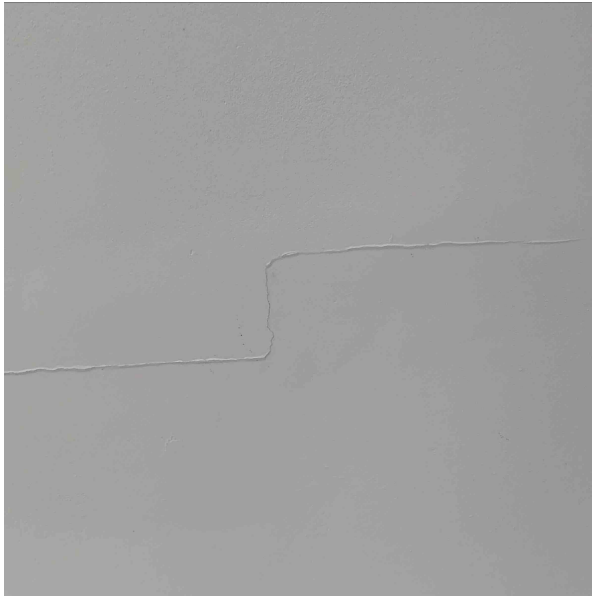
11.3.1 Cracks at corners and stress points, nail pops are common. Patch as needed
