Home Inspection Report

**8 Saint Hubert Avenue
Toronto, ON M4J 3Y9**

Date of Inspection: 06/26/2023

Inspection No. 141126-2138

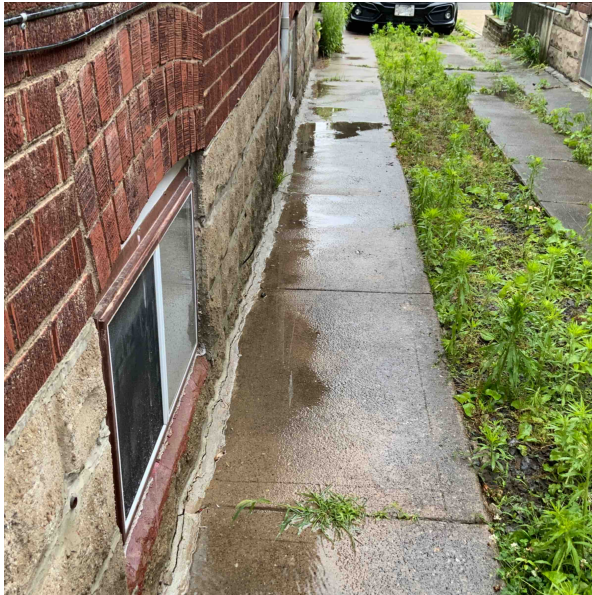
2.3.2 Walkway adjacent to home is sloped toward the house. This should be corrected to shed storm water away from the home.

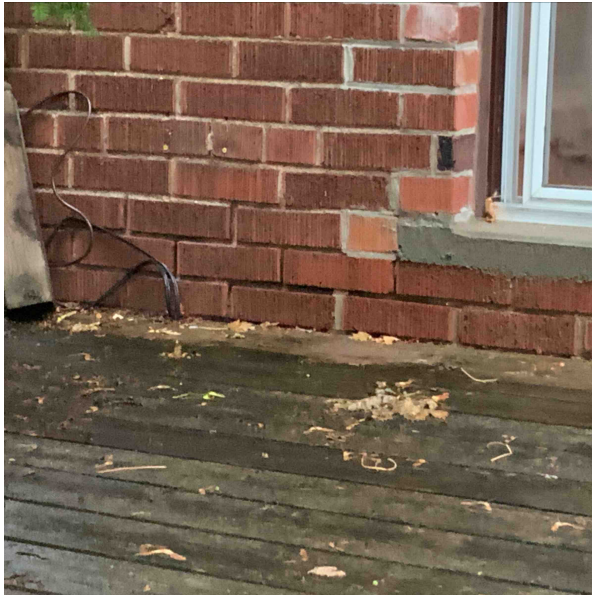
3.3.1 Surface deterioration of brick/mortar noted is common at this age. Repair worn areas, repoint open joints to repel water, reduce further deterioration. Anticipate occasional repairs as part of owning an old property.

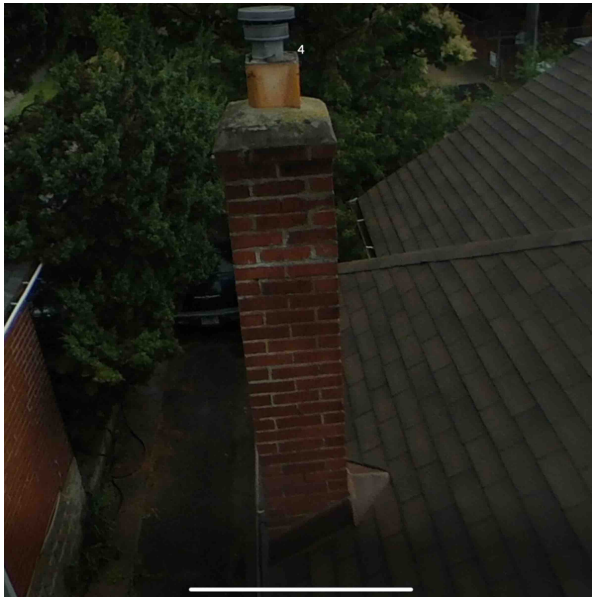
4.7.2 Brick chimney vents water heater and furnace

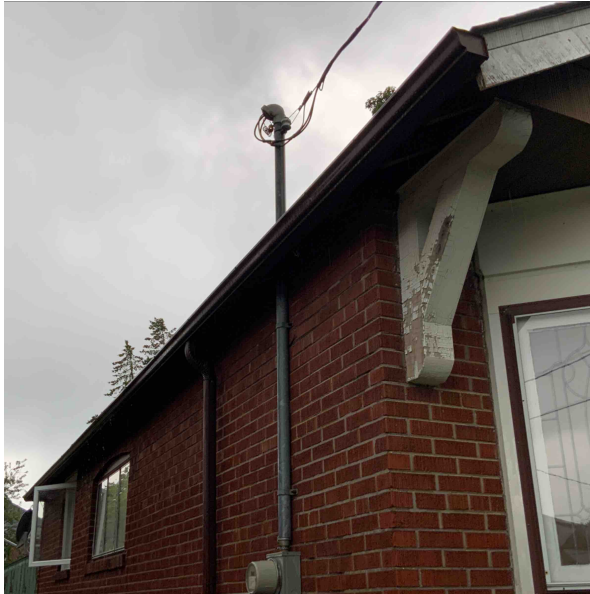
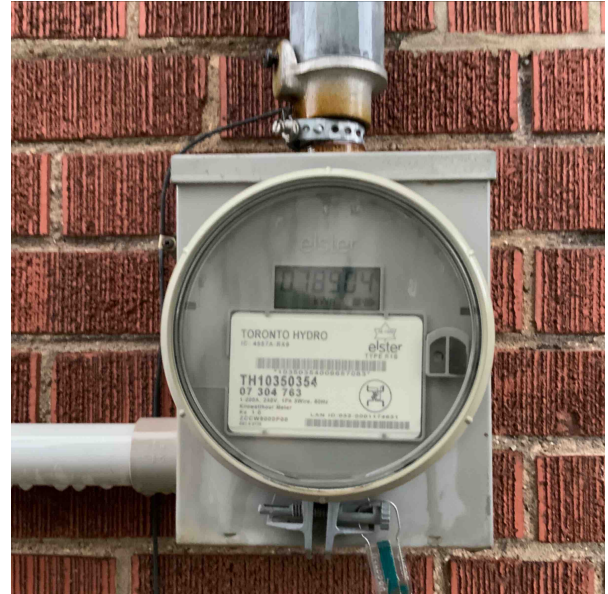
8.2.1 Electrical service to home is by overhead cables.

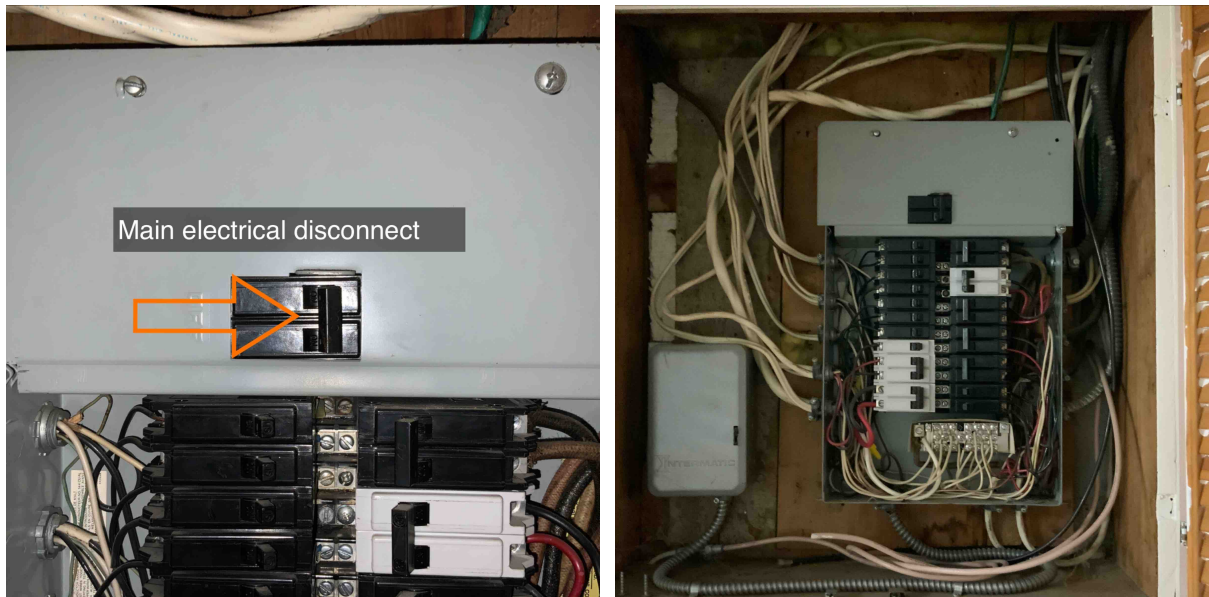
8.4.2 Main disconnect noted in picture

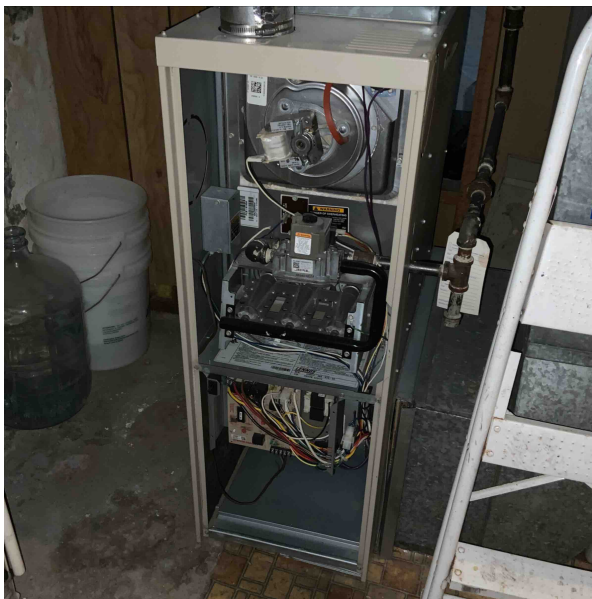
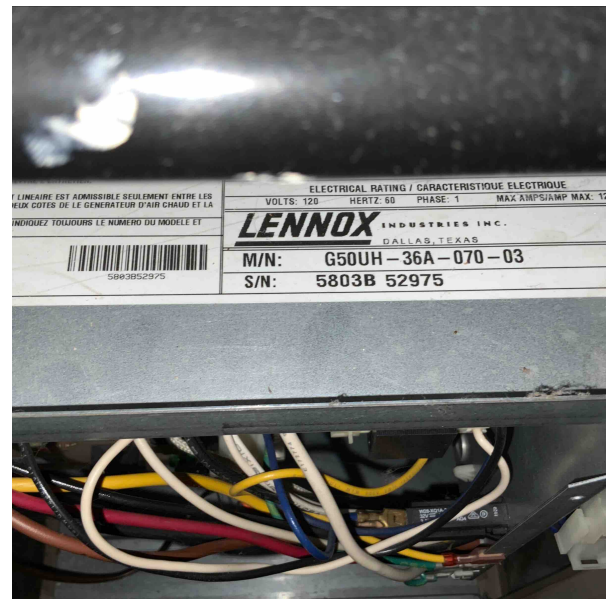
9.5.2 Mid efficiency furnace is dated 2003. Functional at time of inspection

The furnace is near the end of its service life. The remaining life is unpredictable. Replace the unit when it fails, when repairs are no longer cost-effective, or proactively to prevent a loss of functionality.

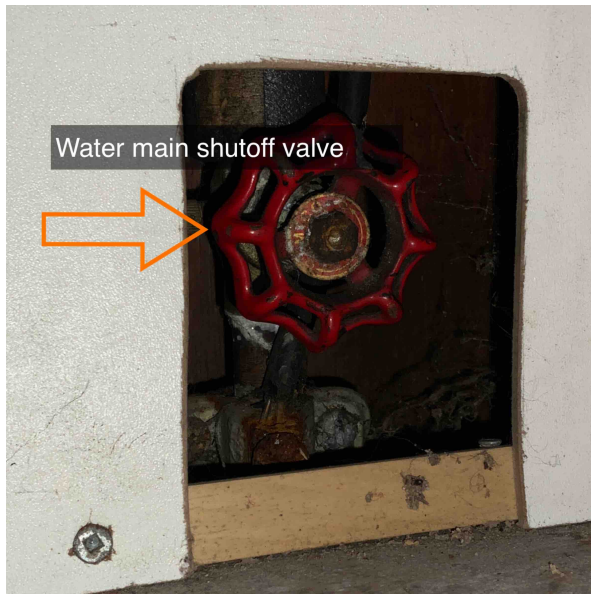
10.2.2 Copper water main.

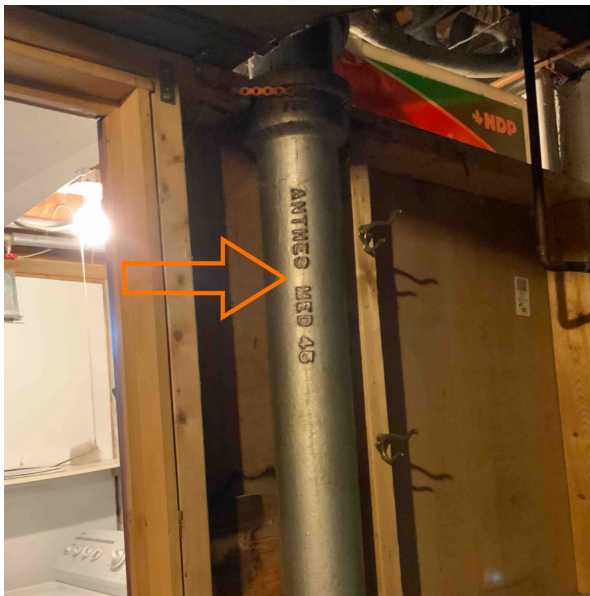
10.4.2 Cast iron drains have limited life. No active leakage detected but a budget is needed to upgrade as needed or when completing renovations.

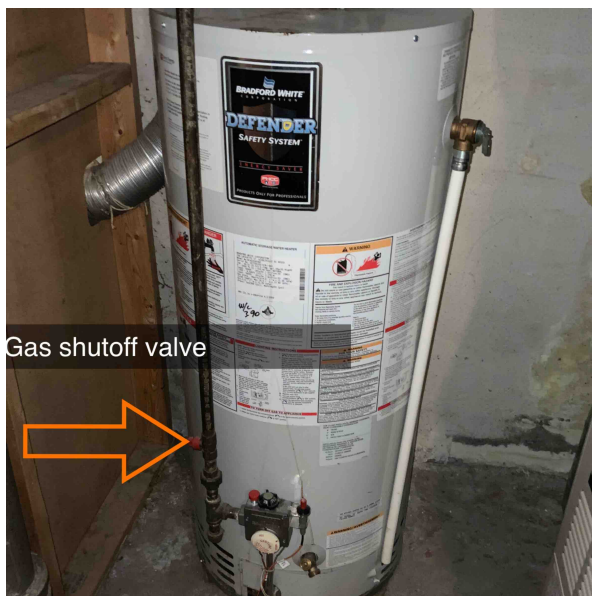
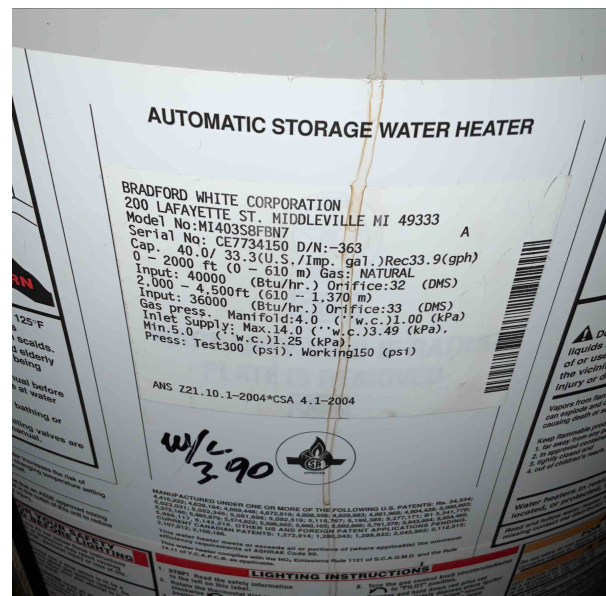
10.5.2 **Water heater is dated 2006 and has exceeded its typical service life. Functional at time of inspection**

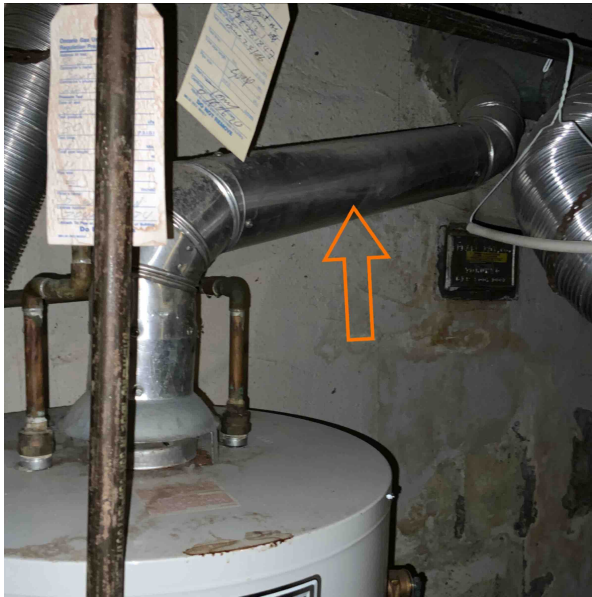
10.6.2 Pipe is secured and in good condition
