Home Inspection Report

PROPERTY INSPECTED:
72 Macdonald Avenue
Hamilton, ON L8P 4N7

Date of Inspection: 07/05/2023

Inspection No. 141126-2144

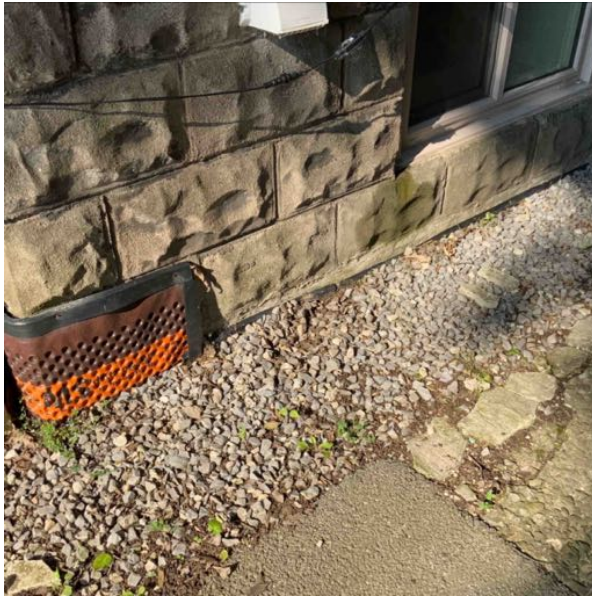
3.2.1 Exterior foundation wall is waterproofed

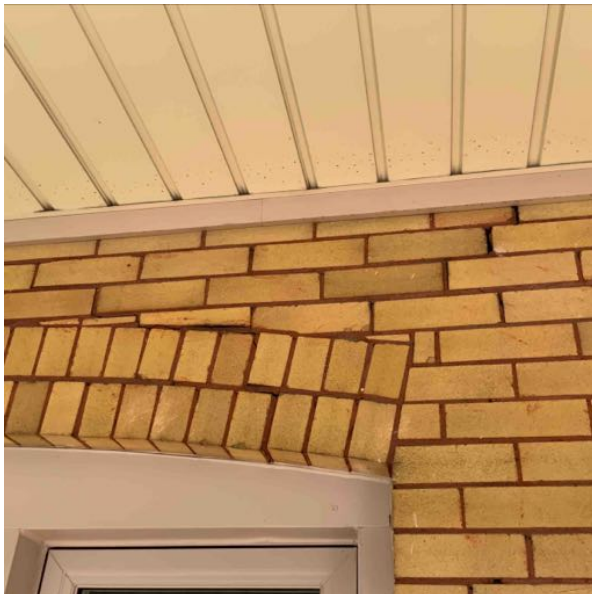
3.3.2 Cracks noted are common settlement issues. Surface deterioration of brick/mortar noted is common at this age. Repair worn areas, repoint open joints to repel water, reduce further deterioration. Anticipate occasional repairs as part of owning an old property.

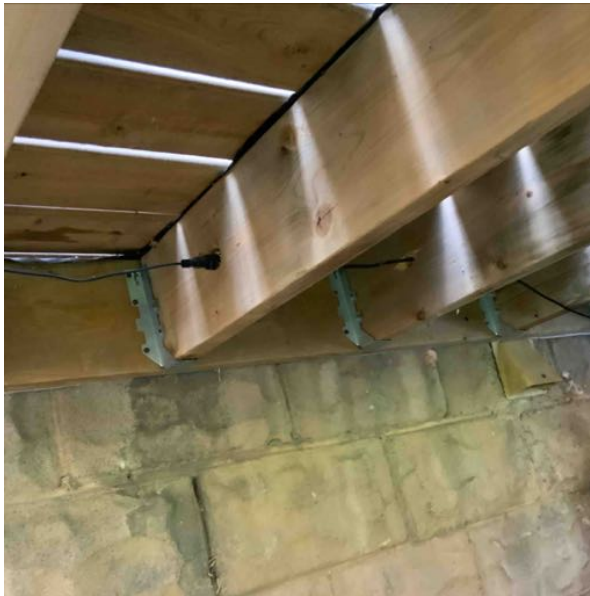
3.8.3 Ledger board appears poorly supported, no lag bolts. Contact a qualified contractor to assess and repair if needed (**Exterior Back**)

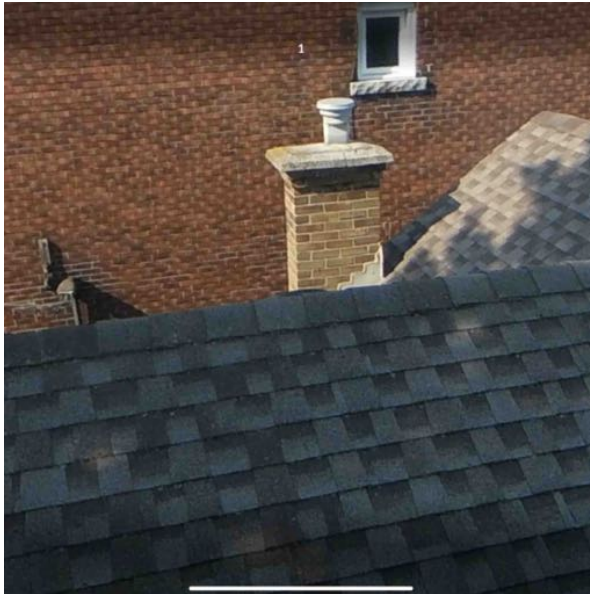
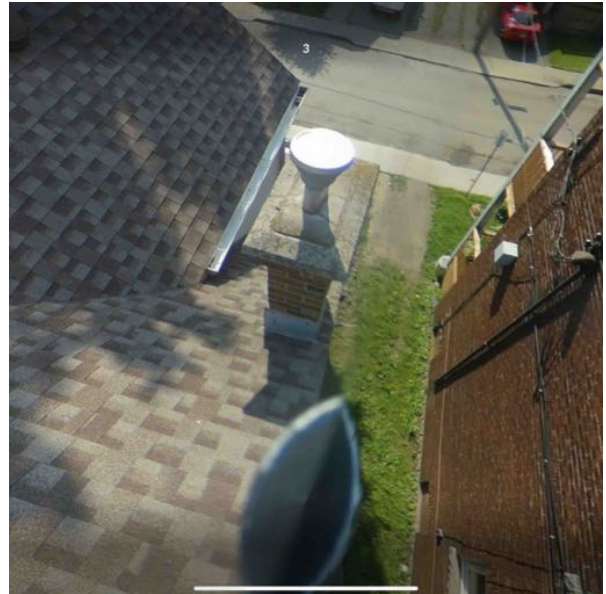
4.6.1 Venting for water heater

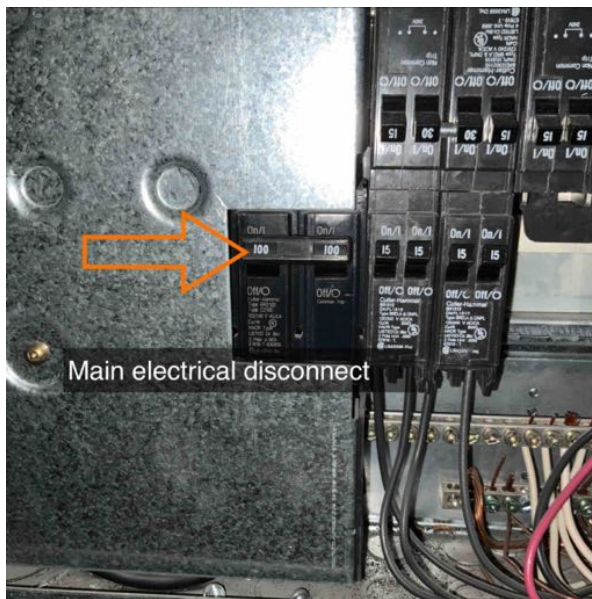
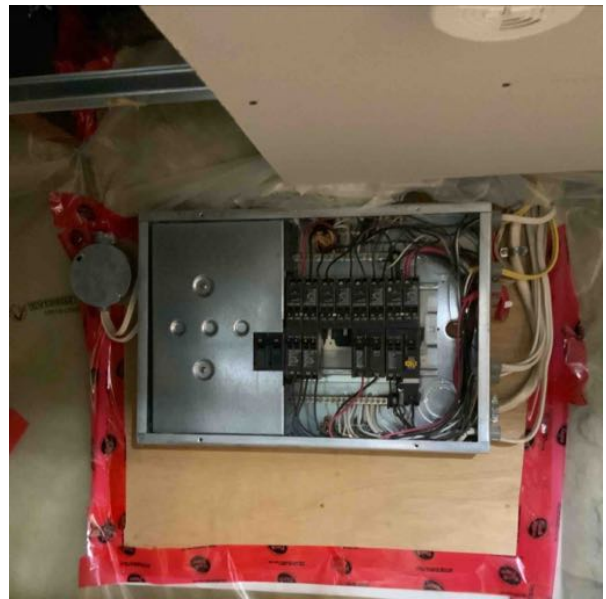
7.4.2 Main disconnect noted in picture

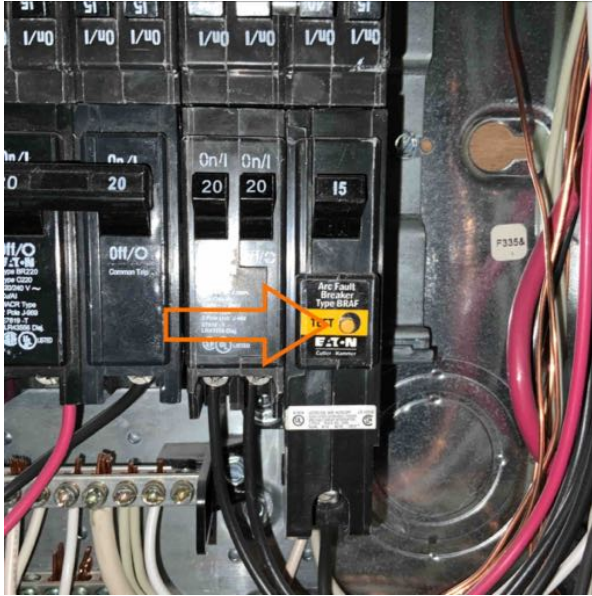
The breaker is defective and should be replaced for improved electrical safety

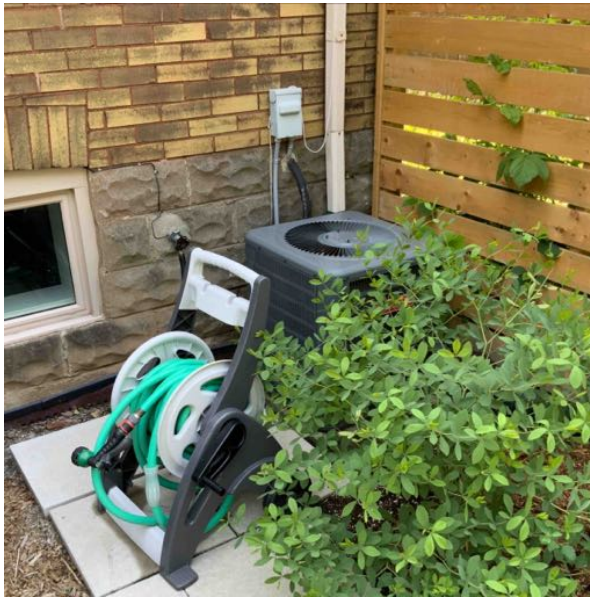
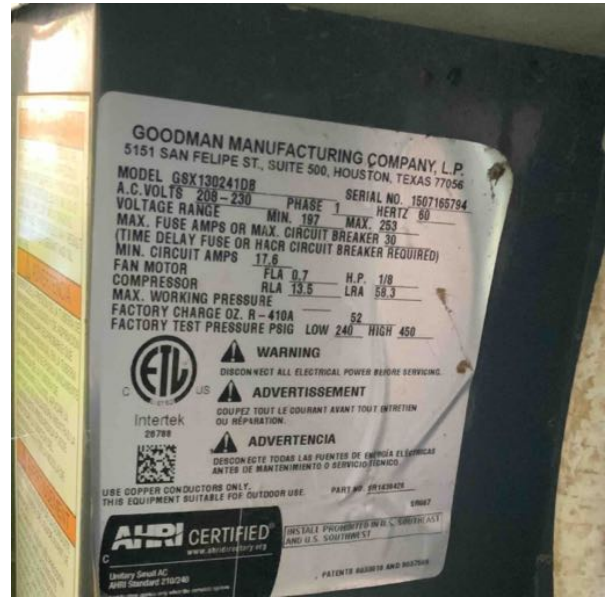
8.5.2 Air conditioner is dated 2015 and is functional (Exterior Back)

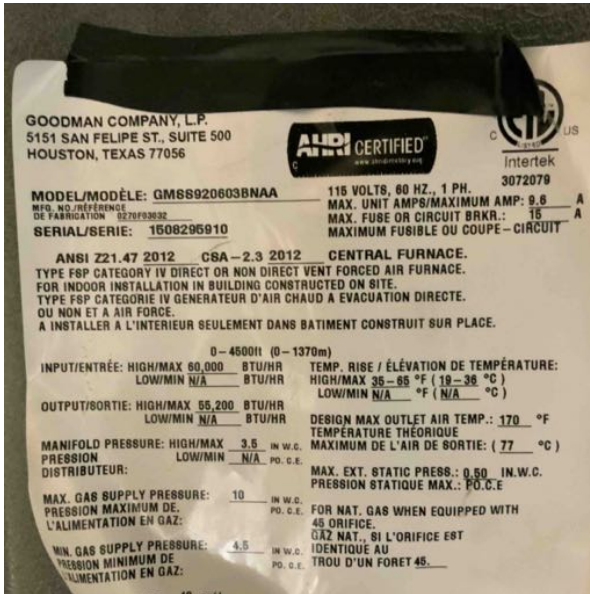
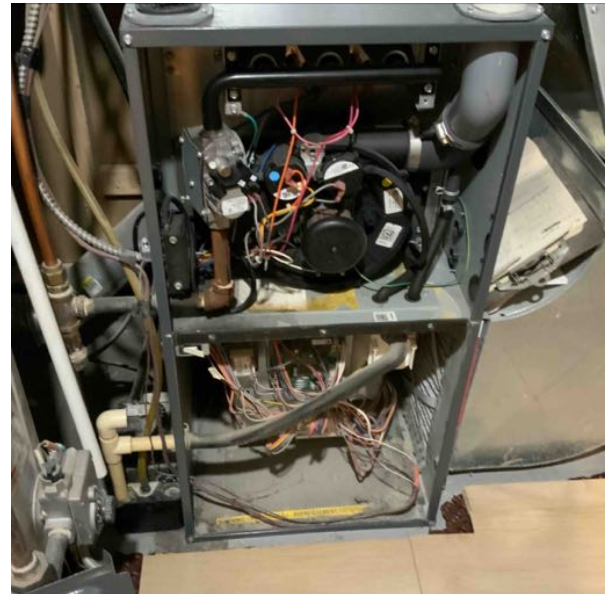
8.6.2 High efficiency furnace is dated 2015 and is functional

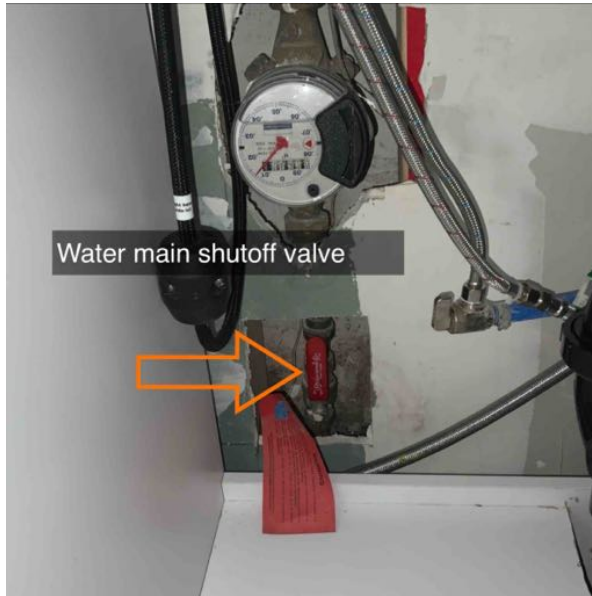
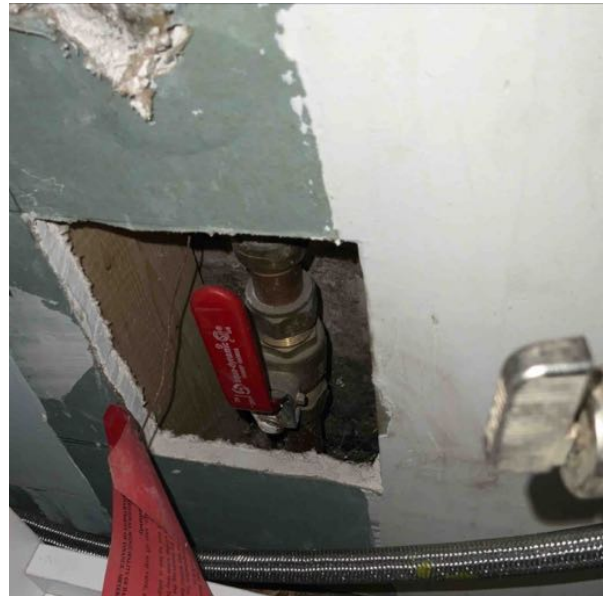
9.2.2 **Copper water main. Upgraded in 2020.**

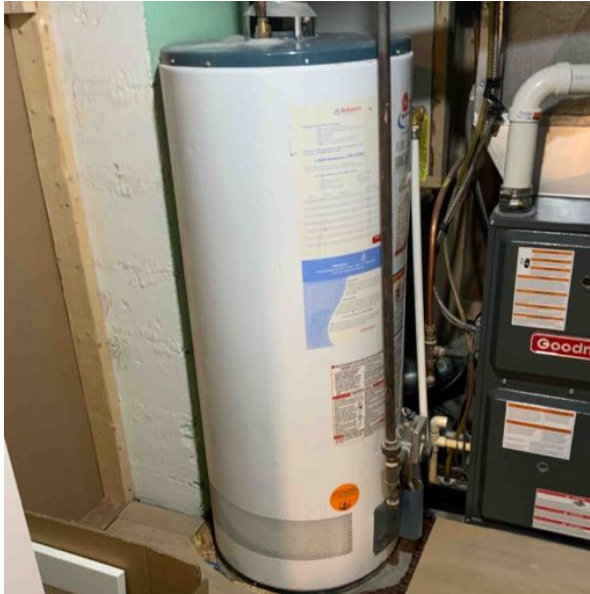
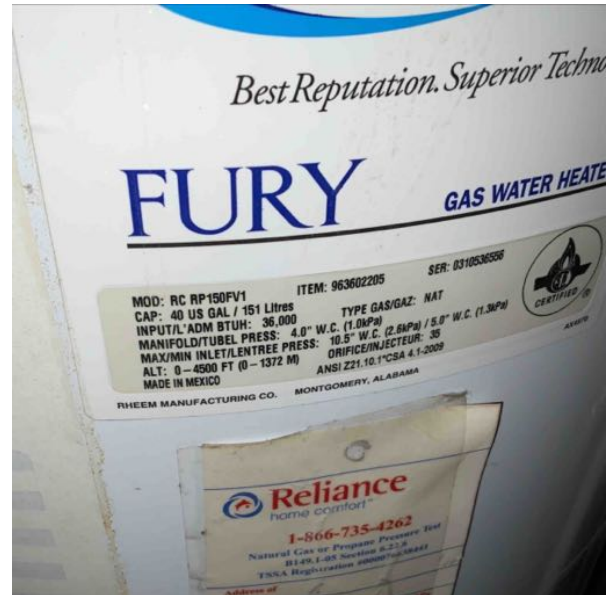
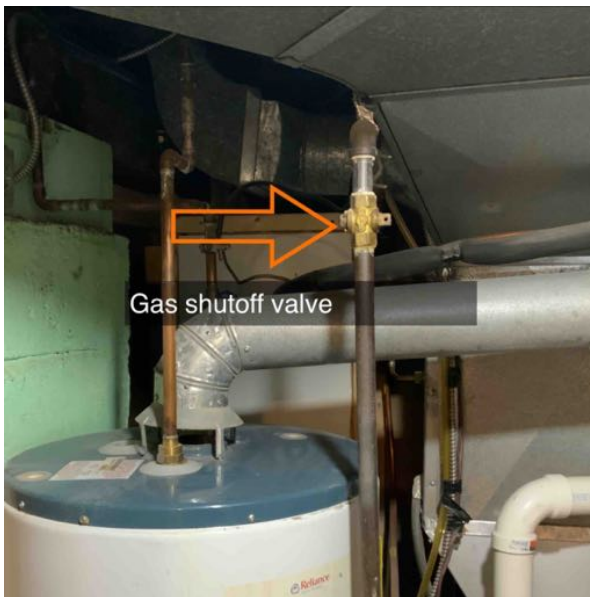
9.5.1 Water heater is dated 2010 and is functional

The water heater is nearing the end of its service life. The remaining life is unpredictable replace the units when it fails, when repairs are no longer cost effective, or proactively to prevent a loss of functionality.

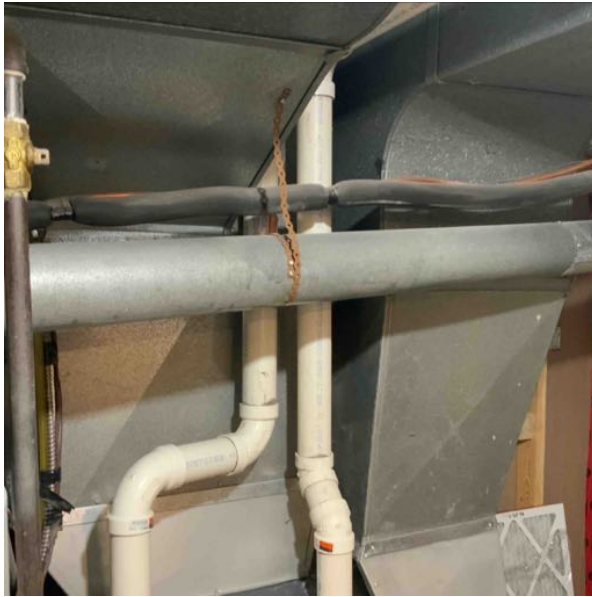
9.6.2 Vented to chimney.

Pipe is secured and in good condition

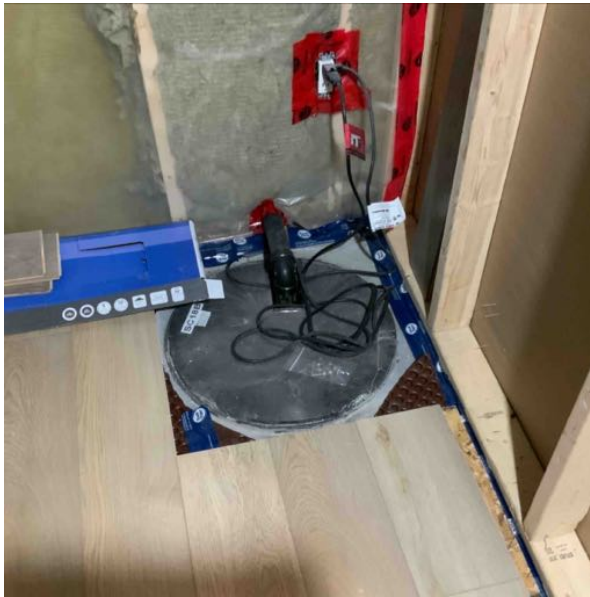
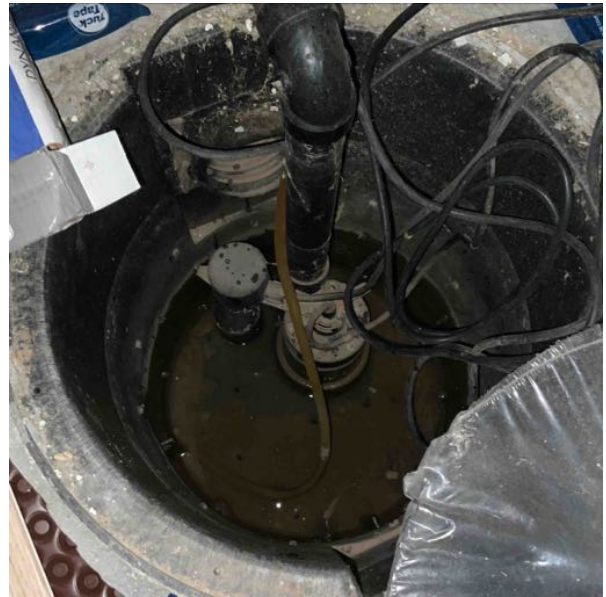
9.13.2 Functional sump pump
