Home Inspection Report

PROPERTY INSPECTED:
235 Browning Avenue
Toronto, ON M4K 1X1

Date of Inspection: 08/01/2023

Inspection No. 141126-2187

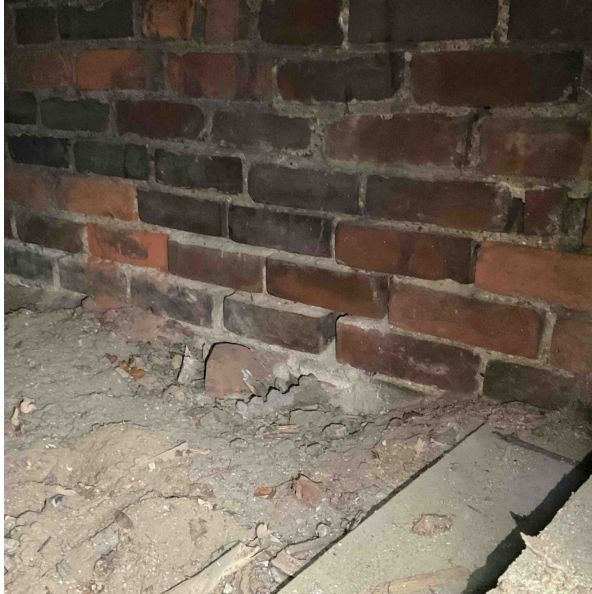
3.3.2 Surface deterioration of brick/mortar noted is common at this age. Repair worn areas, repoint open joints to repel water, reduce further deterioration. Anticipate occasional repairs as part of owning an old property.

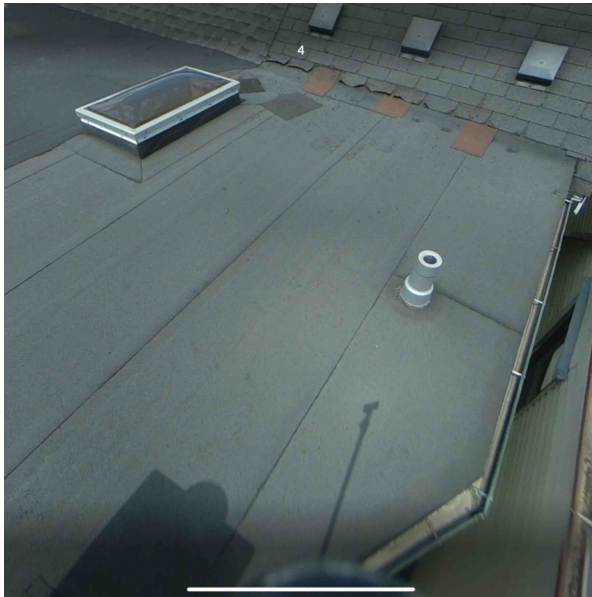
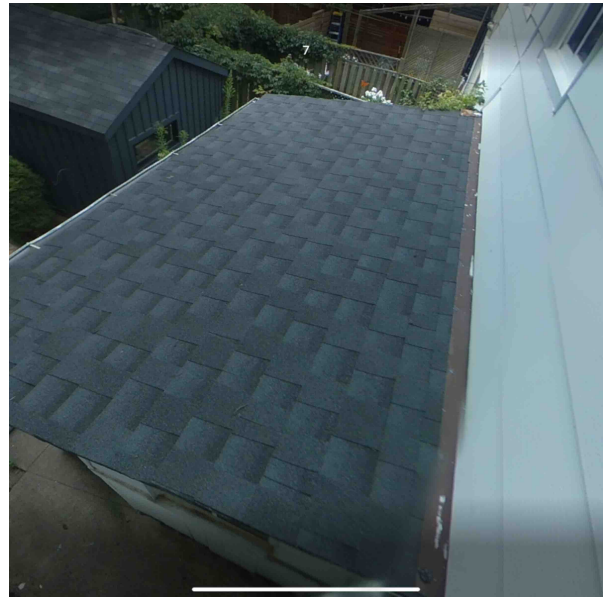
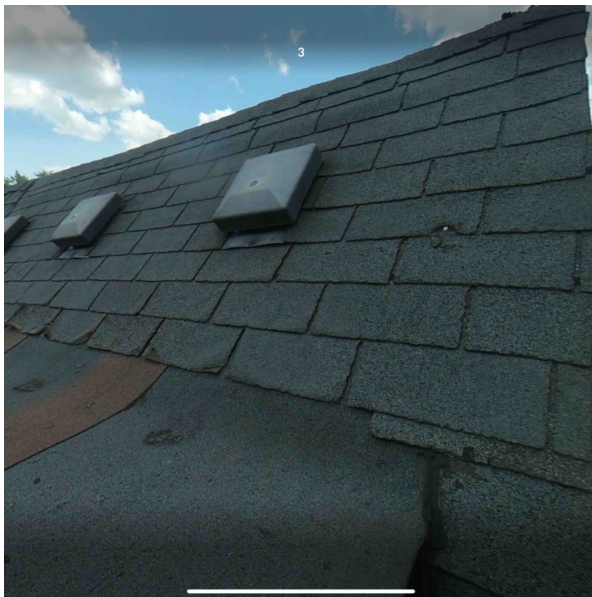
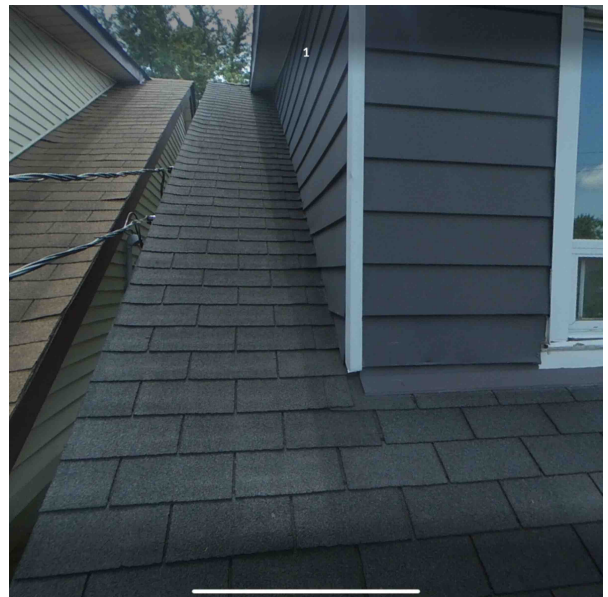
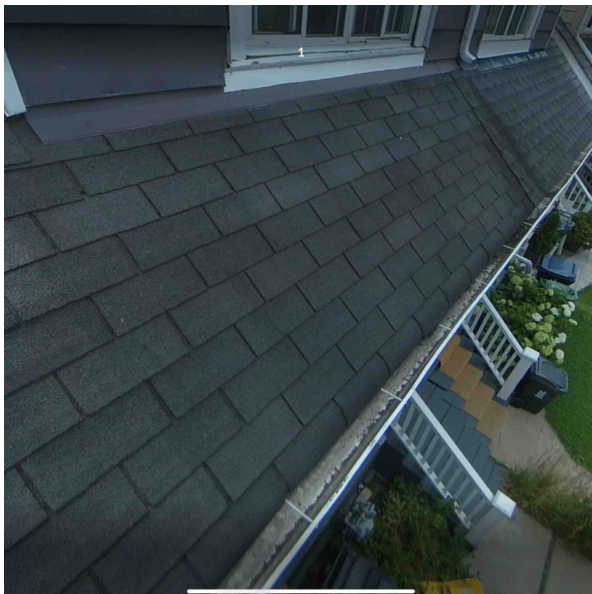
4.3.1 **The roof covering has reached the end of its service life. Replace the roofing to prevent water intrusion**

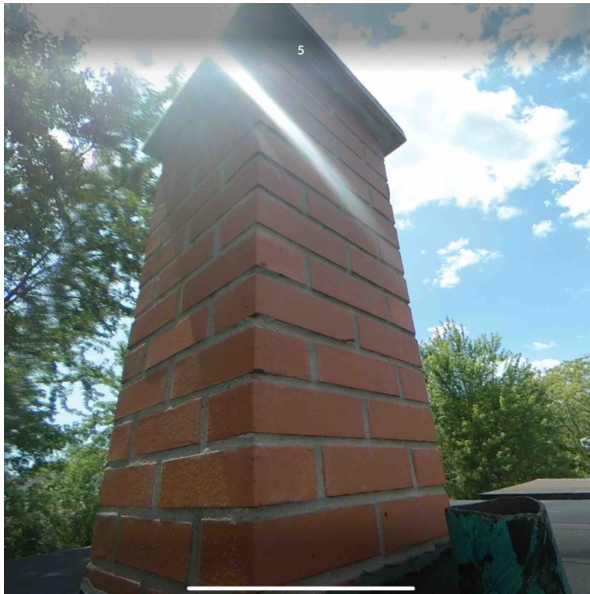
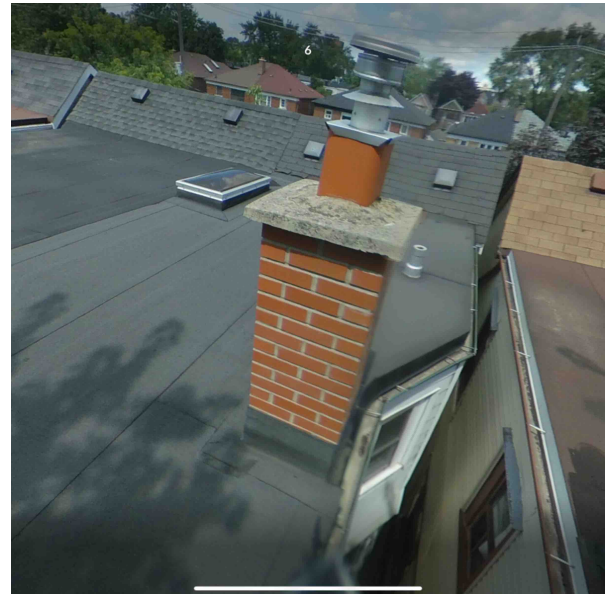
4.7.1 The chimney does not appear to be in use.

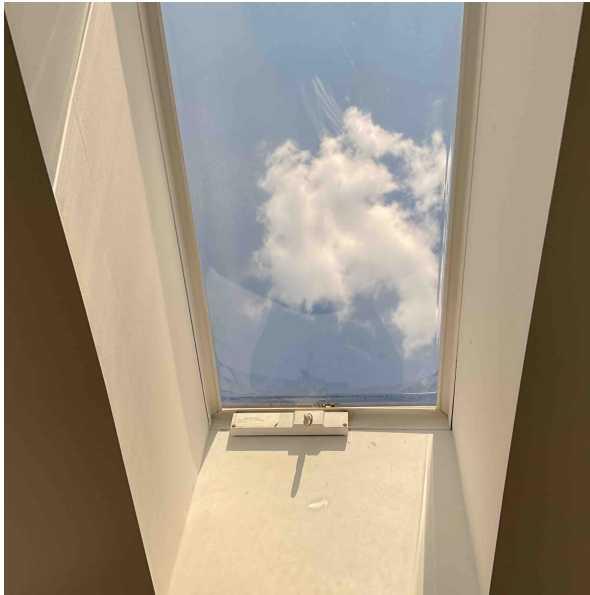
4.8.1 No visible moisture at interior of skylights

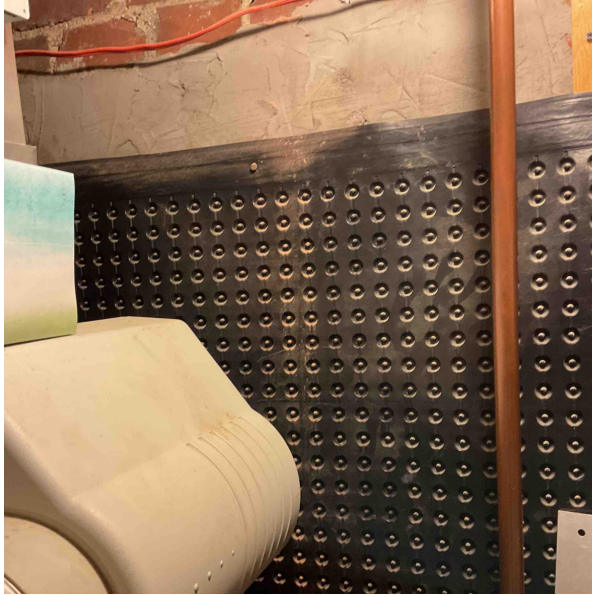
6.3.1 Interior wall has been waterproofed

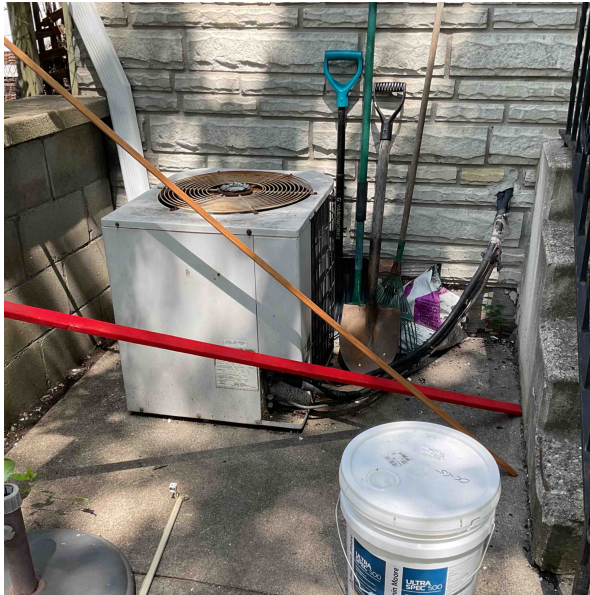
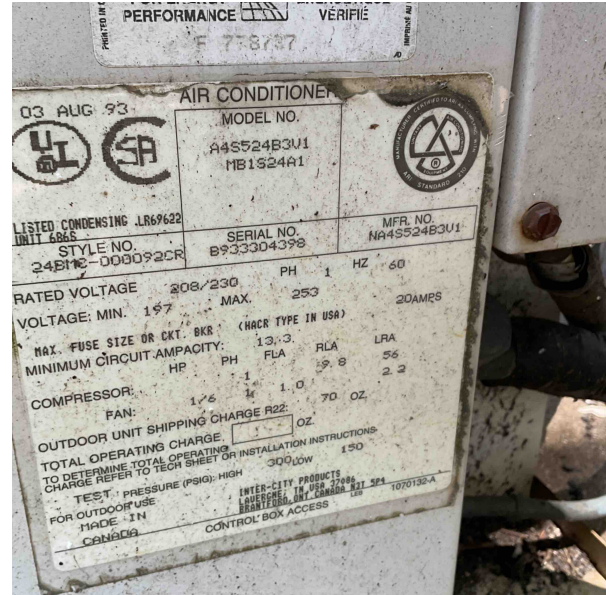
8.5.2 Air conditioner is dated 1993 and has exceeded its typical service life. Functional at time of inspection (Exterior Back)

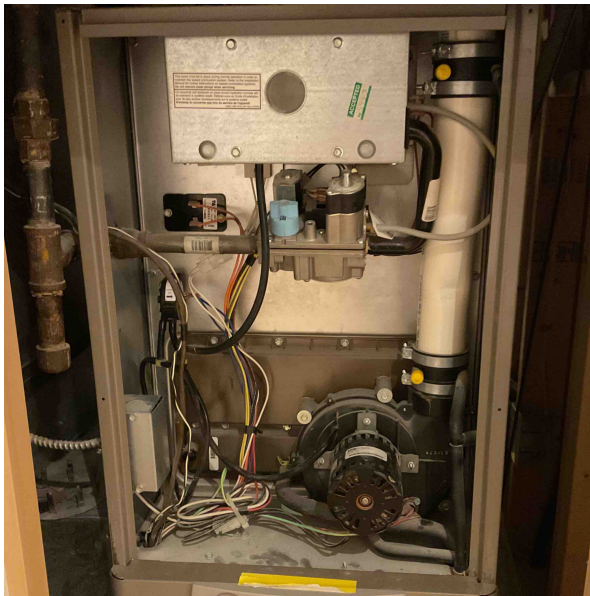
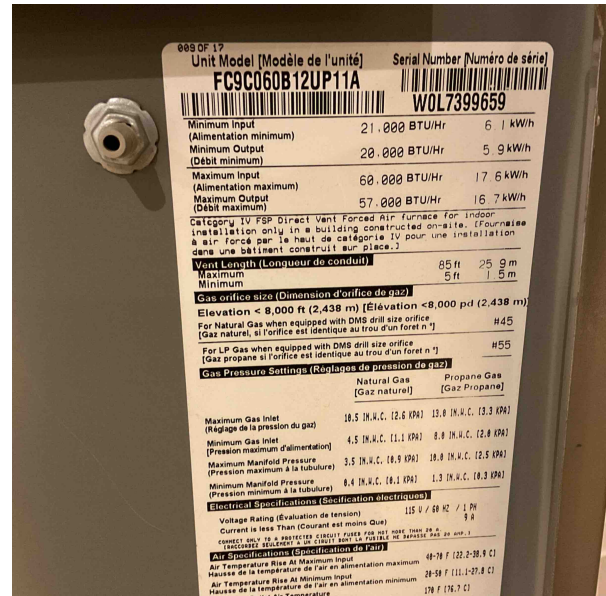
8.6.2 High efficiency furnace is dated 2007 and is functional

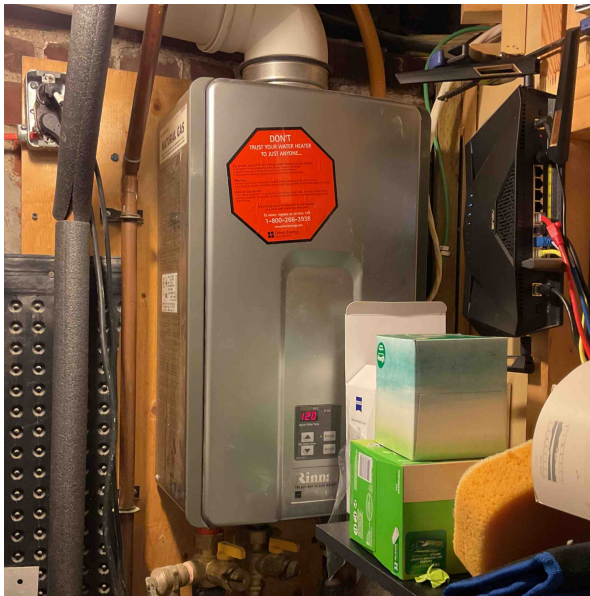
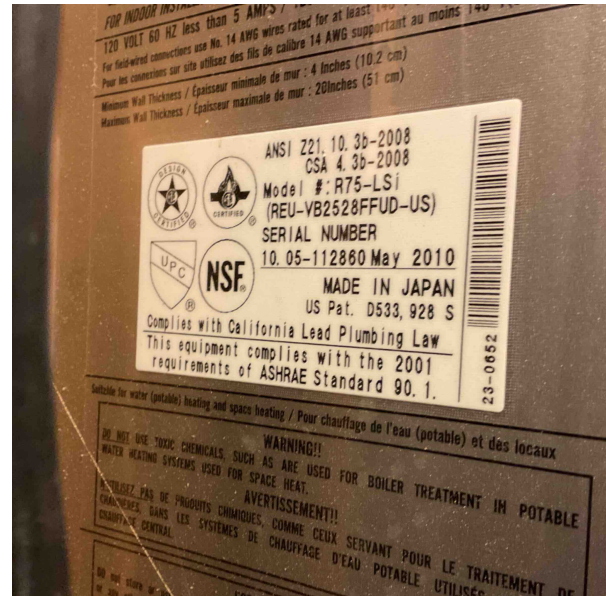
9.5.2 **Tankless water heater is dated 2010 and is functional**

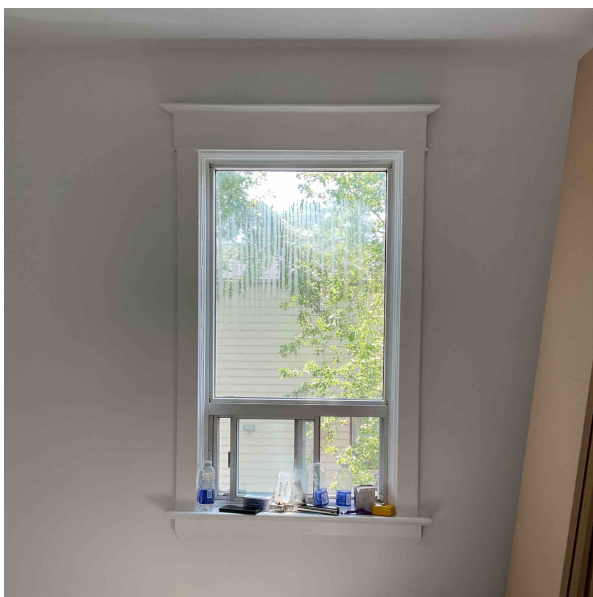
10.4.1 The windows are an insulated type that are typically constructed with 2 panes of glass with a vacuum or an inert gas sealed between the glass panes. Over time, this seal can become compromised and allow outside air to enter the space between the glass. The built-in drying agent in the window eventually becomes saturated and can not handle the moist air. This will cause the window to haze and/or develop condensation between the glass panes. The thermal ability of the windows will be affected slightly. If a window is noted as "Broken Seal", then the compromised seal is obvious. Dirty windows and varying weather conditions can obscure compromised seals. Mild temperatures and low humidity will minimize the visible fogging. High humidity and greater temperature difference between inside and outside will maximize the visible fogging. Compromised seals can also be expected in other windows of the same age at some point in time. The appearance of a compromised seal can vary from slight deposits between the glass to complete hazing of the glass. •Recommend evaluation by a qualified window contractor to determine the exact number of compromised windows, cost and alternatives for correction, and correct where needed. **(South Bedroom)**
