Home Inspection Report

PROPERTY INSPECTED:
83 Coalport Drive
Toronto, ON M1N 4B5

Date of Inspection: 10/04/2023

Inspection No. 141126-2266

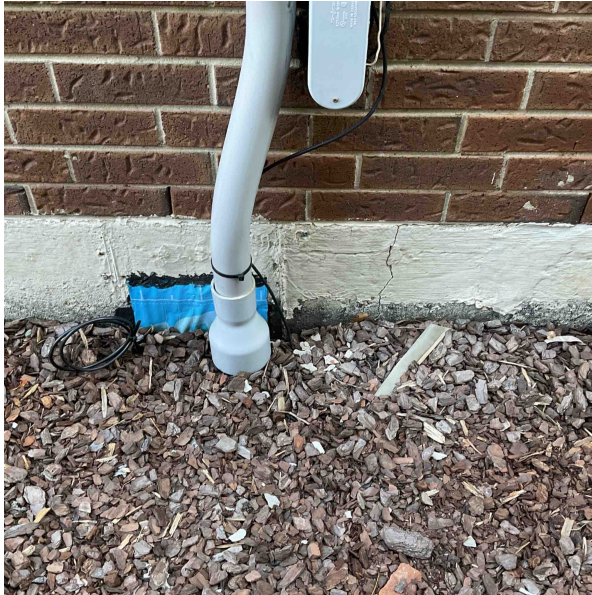
3.2.1 Past foundation repair noted. Ask vendor for details of past leaks, repairs completed and possible warranty information.

Foundation cracks exist on most homes, they develop as the concrete dries and settles. Any crack has the potential to leak and may require future repairs .

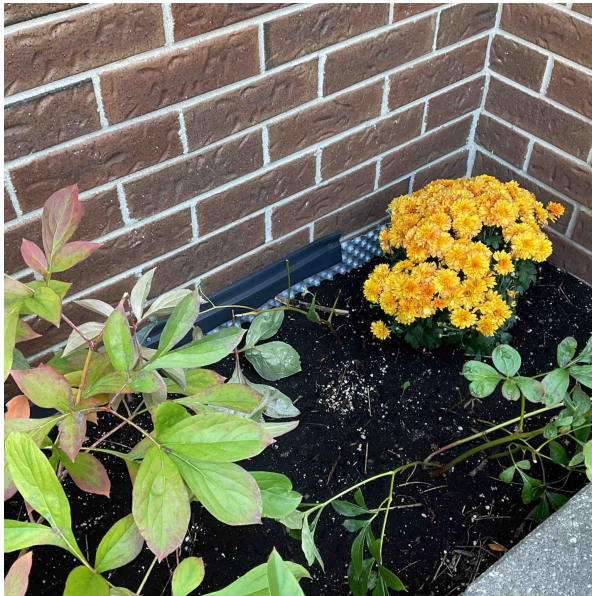
3.2.2 Partial waterproofing visible at right side of home

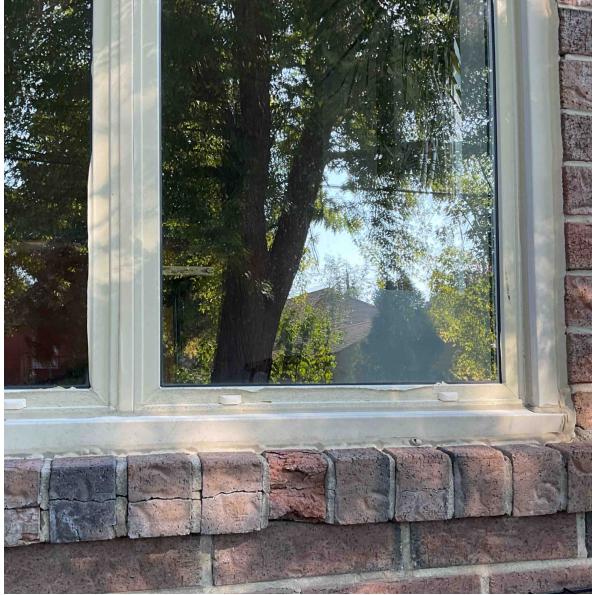
3.3.1 Surface deterioration of brick/mortar noted is common at this age. Repair worn areas, repoint open joints to repel water, reduce further deterioration. Anticipate occasional repairs as part of owning an older property.

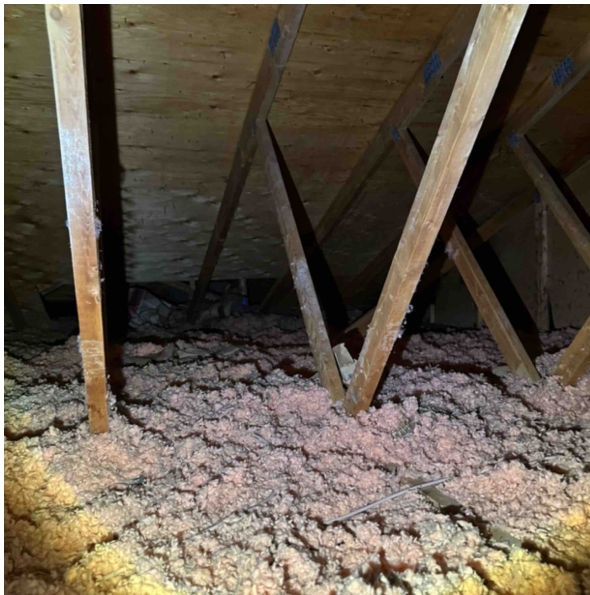
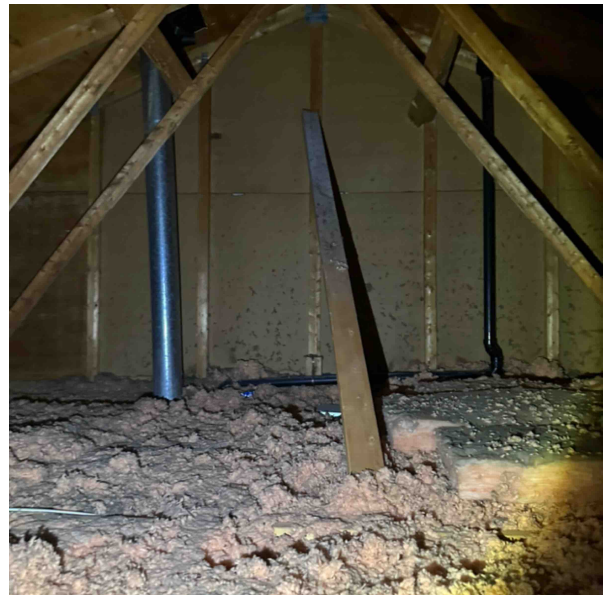
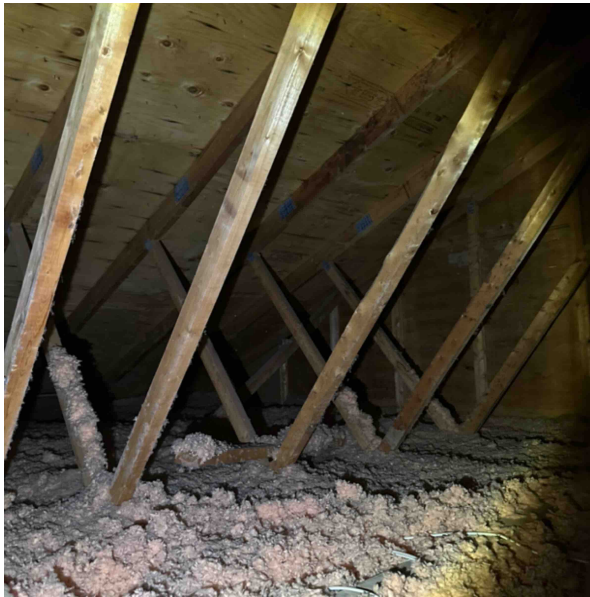
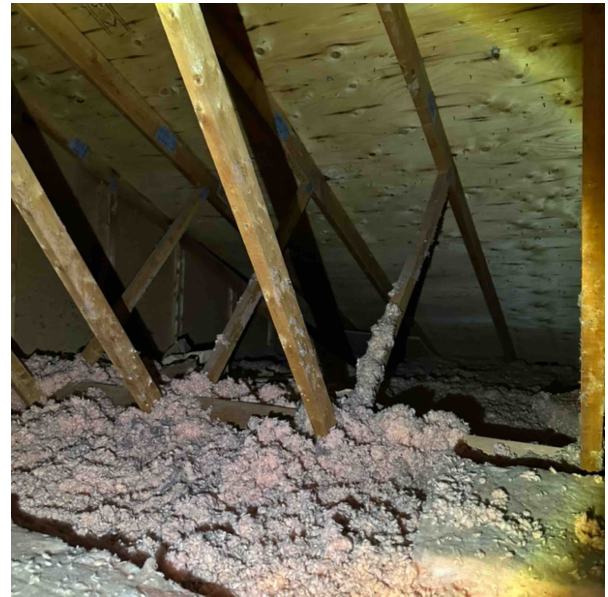
5.3.1 Approximately 6 inches of fiberglass insulation

Typical for a home this age but less than current standard of R-60. Add as needed for improved comfort and energy costs.

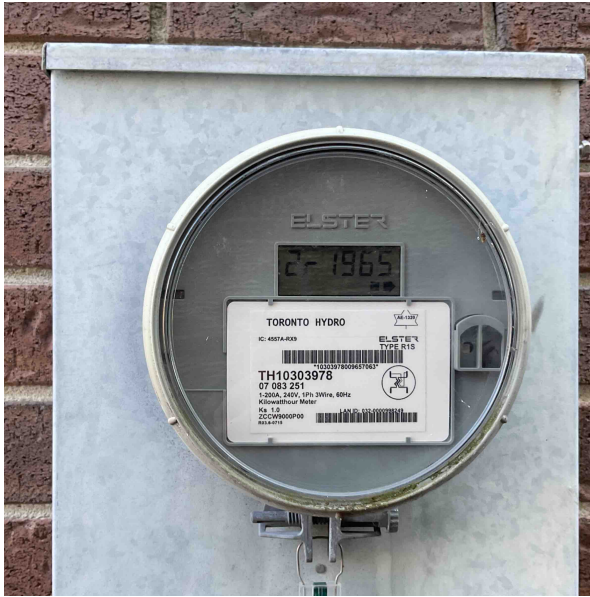
8.2.1 Electrical service to the home is by underground cables.

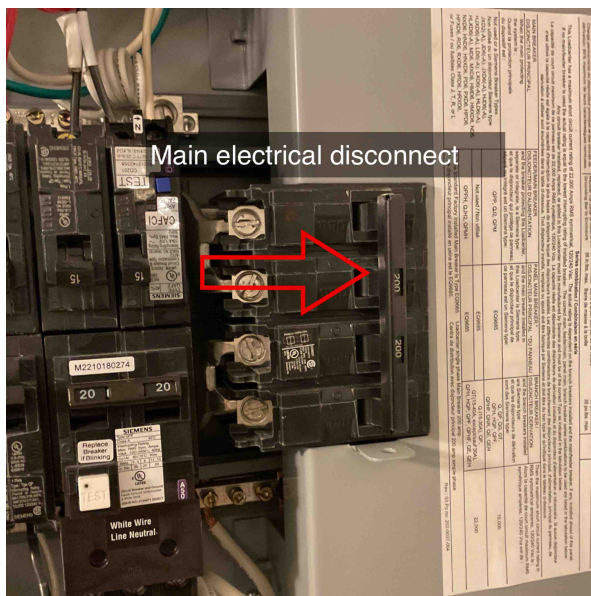
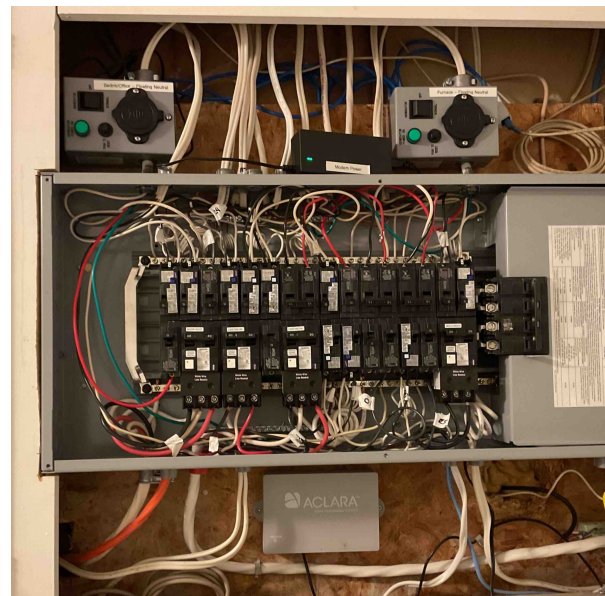
8.4.2 Main disconnect noted in picture

8.5.2 Recently upgraded panel. 200 amp service. breaker panel is full. No significant visible defects inside the panel.

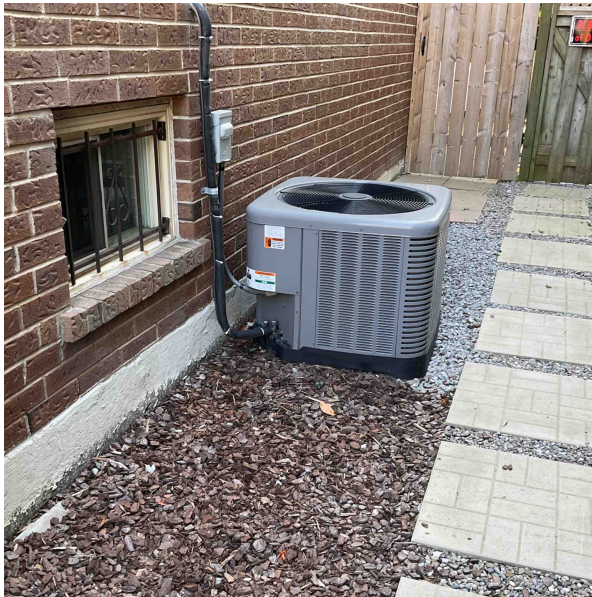
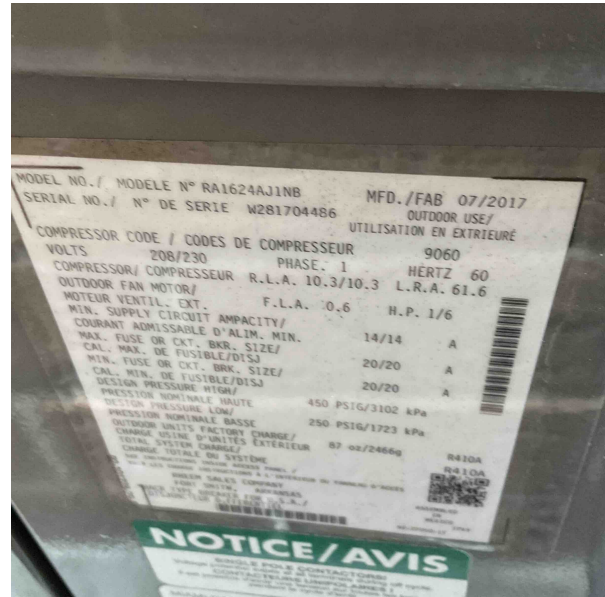
9.5.2 Air conditioner is dated 2017 and is functional (**Exterior Right**)

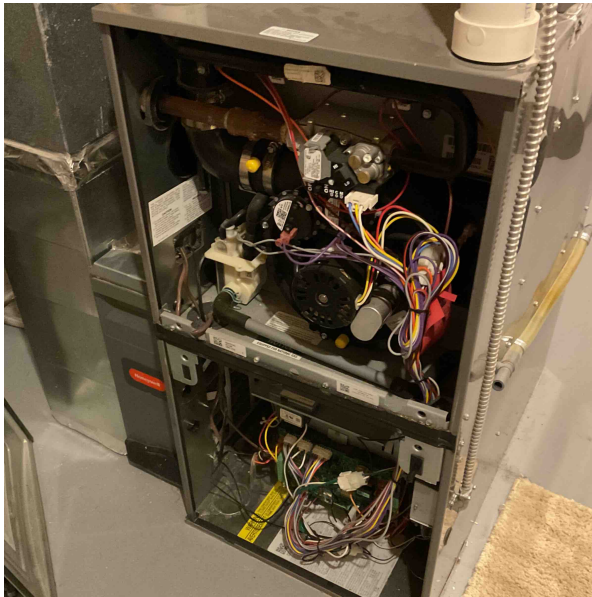
9.6.2 High efficiency furnace is dated 2017 and is functional

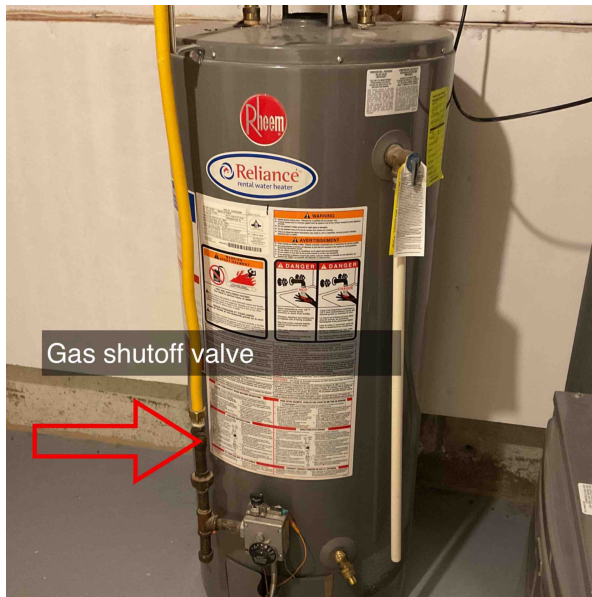
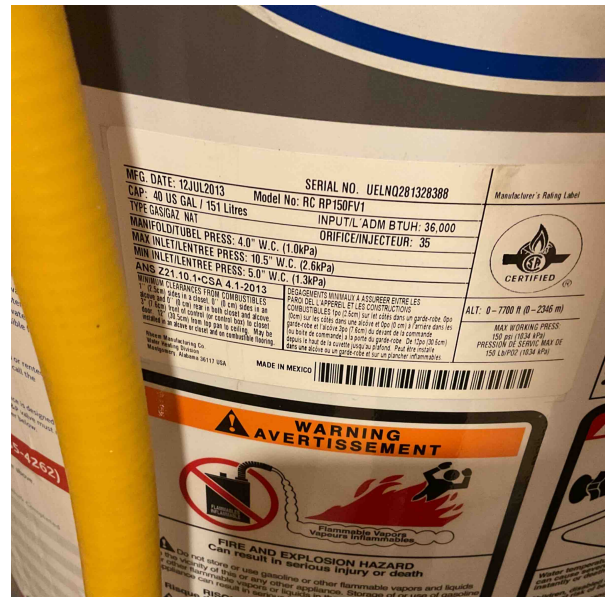
10.5.2 Water heater is dated 2013 and is functional

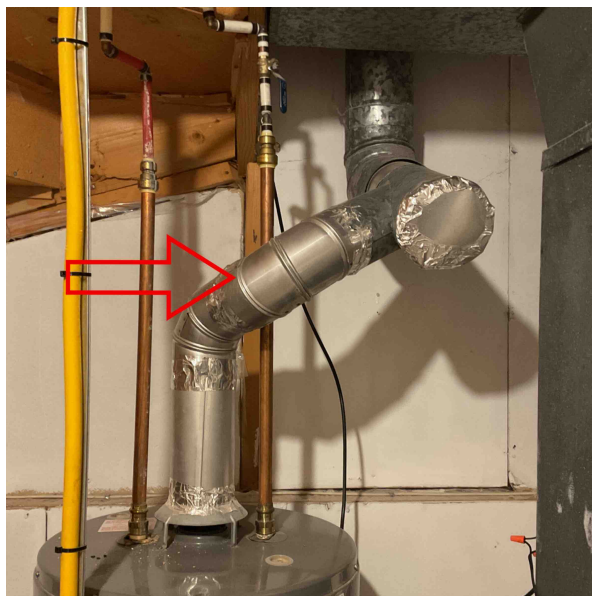
10.6.2 Pipe is secured and in good condition
