Home Inspection Report

PROPERTY INSPECTED: 445 Crawford Street Toronto, ON M6G 3J7

Date of Inspection: 11/16/2023 Inspection No. 141126-2318

# **INSPECTION REPORT**

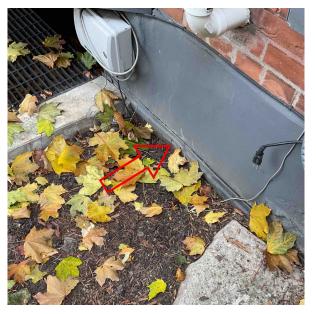
- $\odot$   $\;$  Foundation surface is parged (coated with cementitious material).
- ⊘ The visible portions of the exterior foundation walls were inspected.
- 3.2.1 Exterior wall has been waterproofed

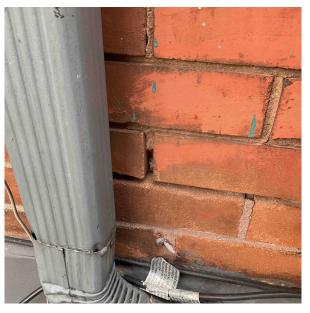
3.3.2 Surface deterioration of brick/mortar noted is common at this age. Repair worn areas, repoint open joints to repel water, reduce further deterioration. Anticipate occasional repairs as part of owning an old property.

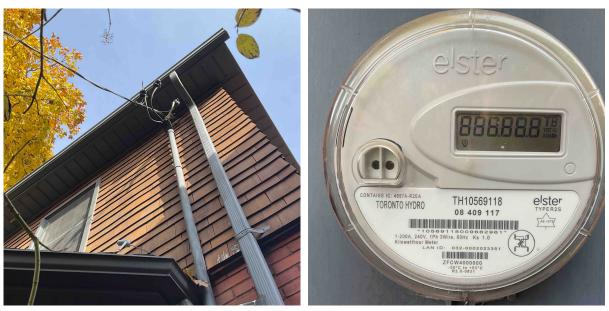
7.2.1 Electrical service to home is by overhead cables.

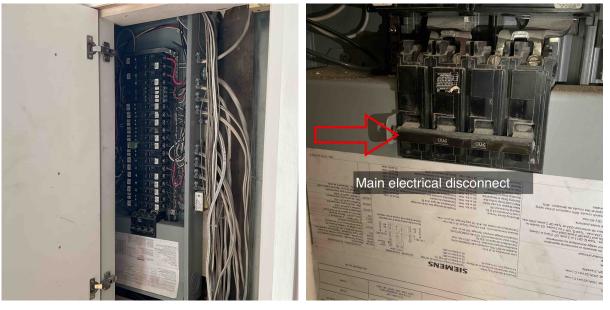
7.4.2 Main disconnect noted in picture

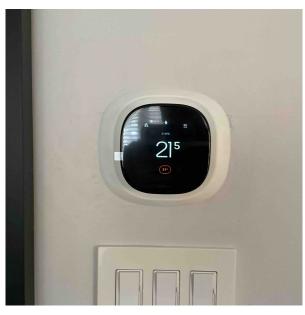
8.3.1 Ecobee thermostat located on main floor

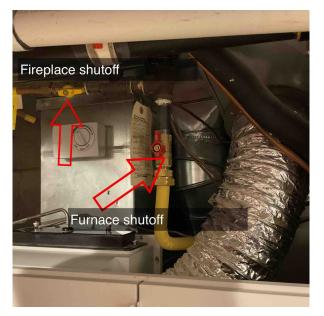
8.4.1 Gas shutoff valve is located at the unit.

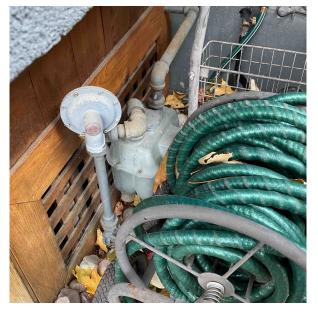
- Natural Gas
- 8.5.1 Located at right side of home

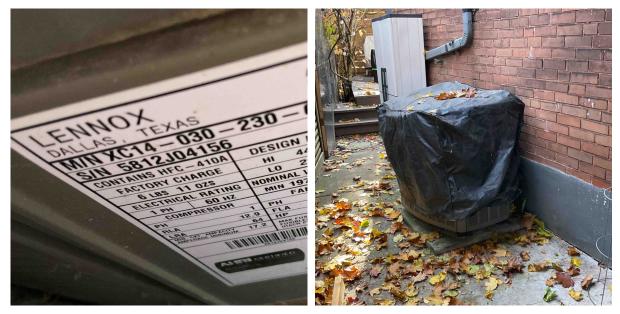
8.6.1 Air conditioner is dated 2012

System not tested due to low outdoor temperature. Determine function in cooling season

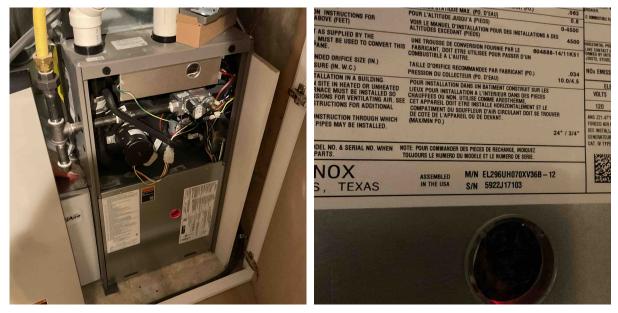
8.7.2 High efficiency furnace is dated 2022 and is functional

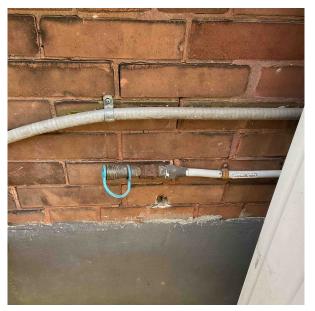
8.9.1 External gas connection

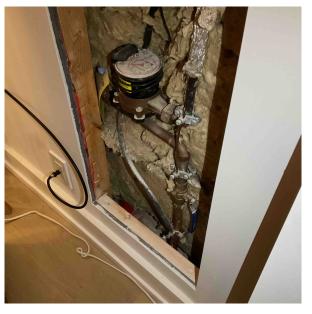
- O Main water shut-off valve is in the basement.
- Metered
- 9.3.1 Inspected the visible portion of the house water main.
- 9.3.2 Copper water main.

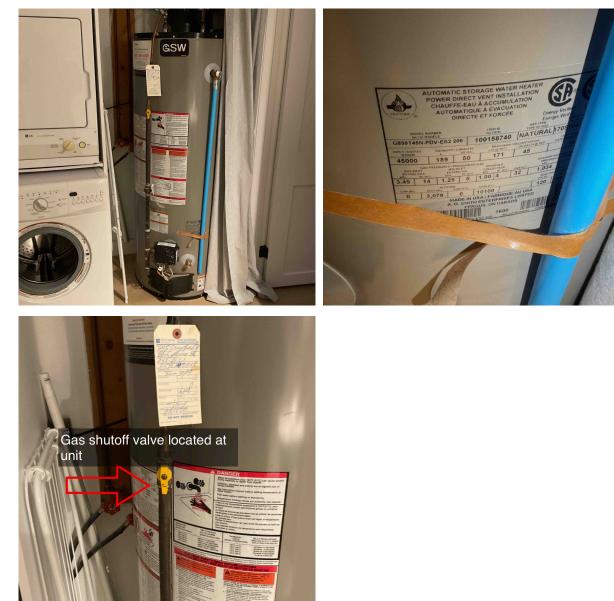
9.6.2 Water heater is dated 2017 and is functional

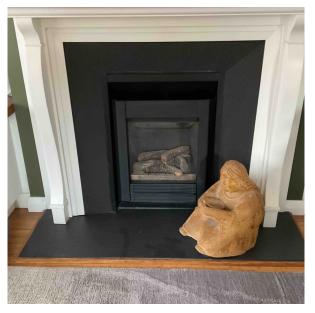
11.1.1 Functional gas fireplace

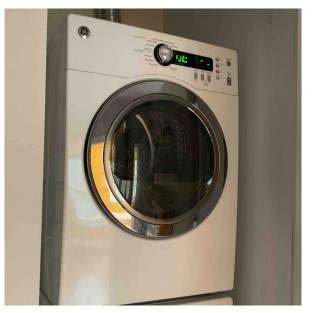
Interior of dryer vent condition concealed-not inspected (Second floor)

Dryer vent cleaning is recommended to increase efficiency and for fire safety. Inspect/clean on a regular basis.
