Home Inspection Report

PROPERTY INSPECTED:
3353 Liptay Avenue
31
Oakville, ON L6M 0M6

Date of Inspection: 04/18/2024

Inspection No. 141126-2492

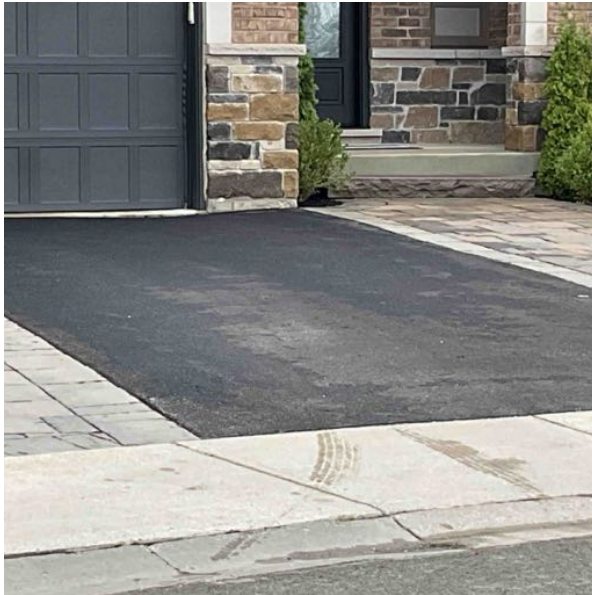
2.4.1 Asphalt driveway appears to be recently sealed.

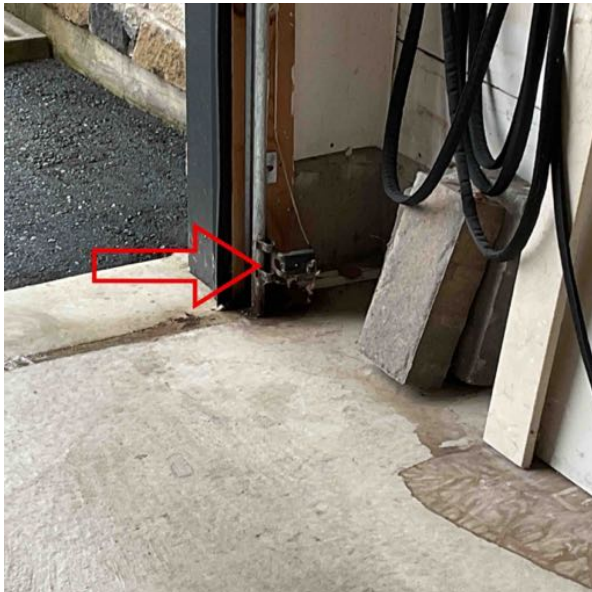
6.5.1 The door was inspected and operated with controls available

6.5.2 Auto reverse sensors installed

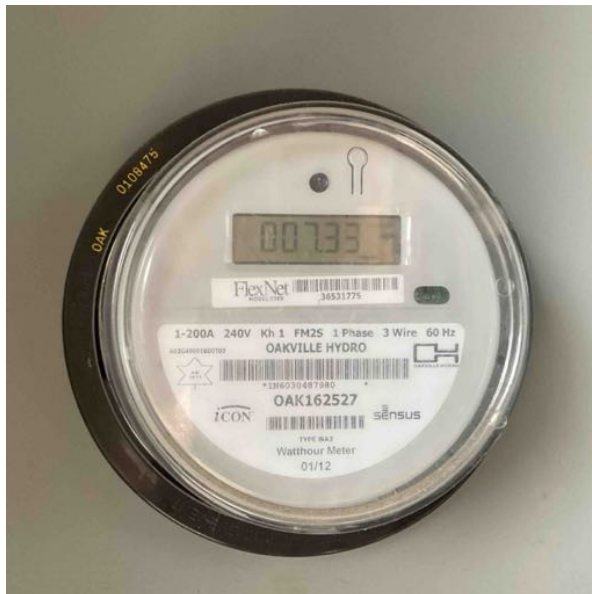
8.2.1 Electrical service to the home is by underground cables.

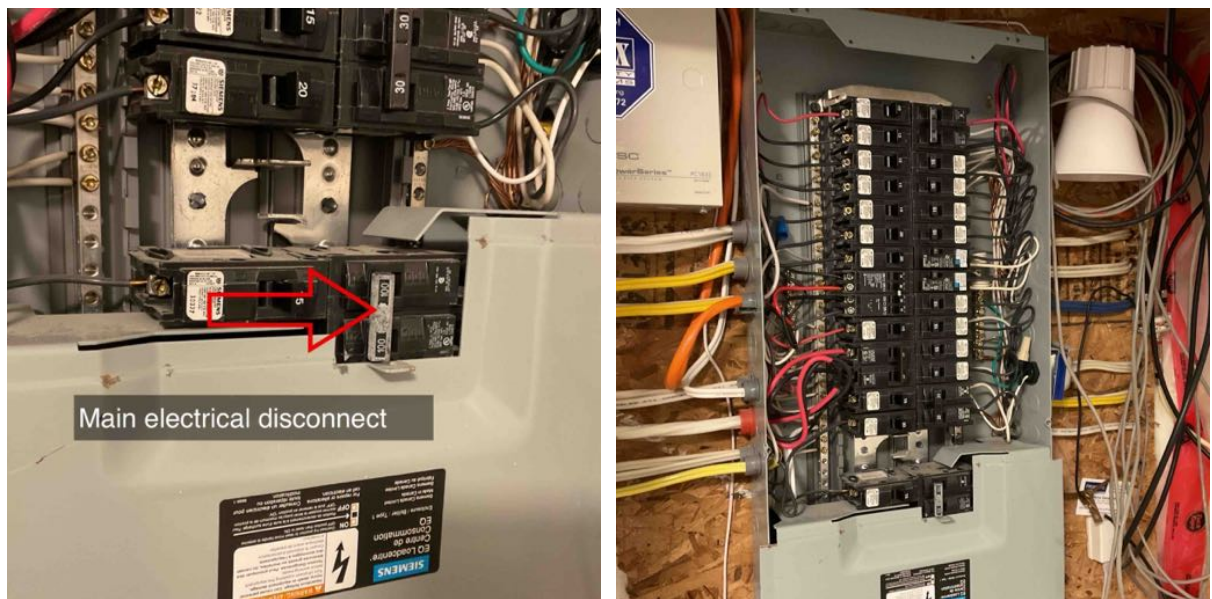
8.4.2 Main disconnect noted in picture

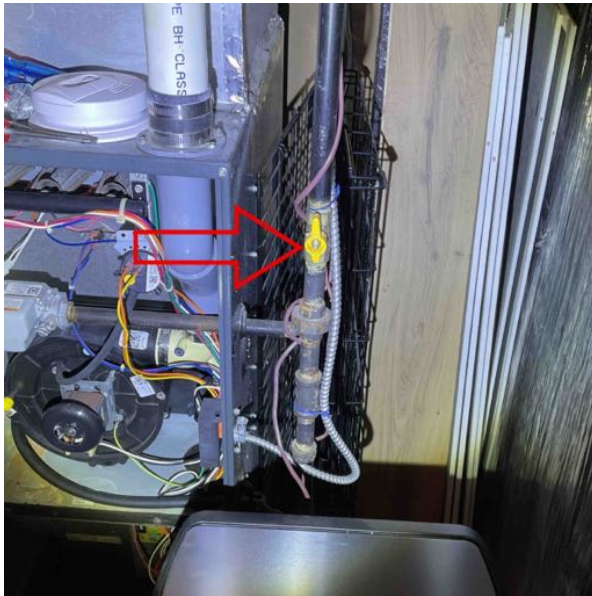
9.3.1 Gas shutoff valve is located at the unit.

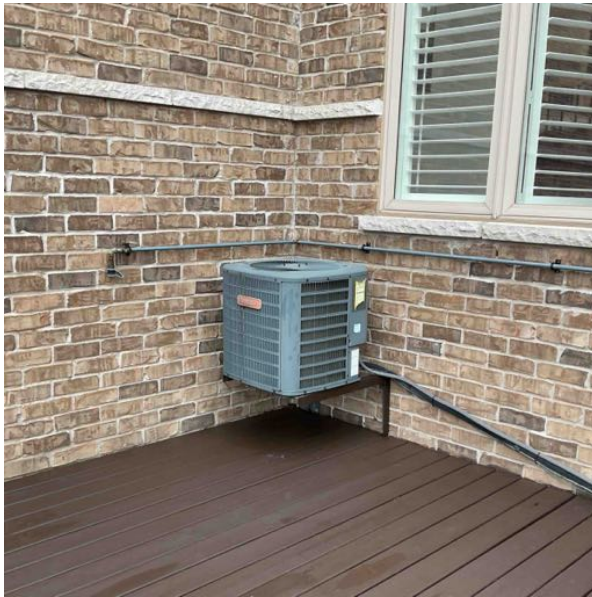
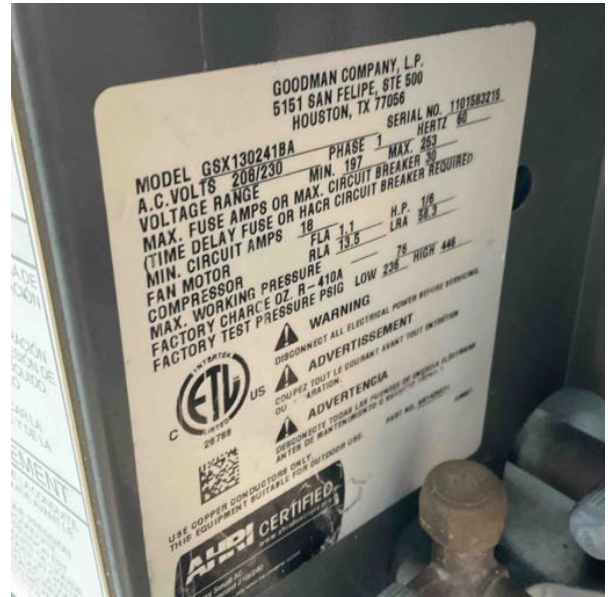
9.5.1 Air conditioner is dated 2011

System not tested due to low outdoor temperature. Determine function in cooling season (**Exterior Back**)

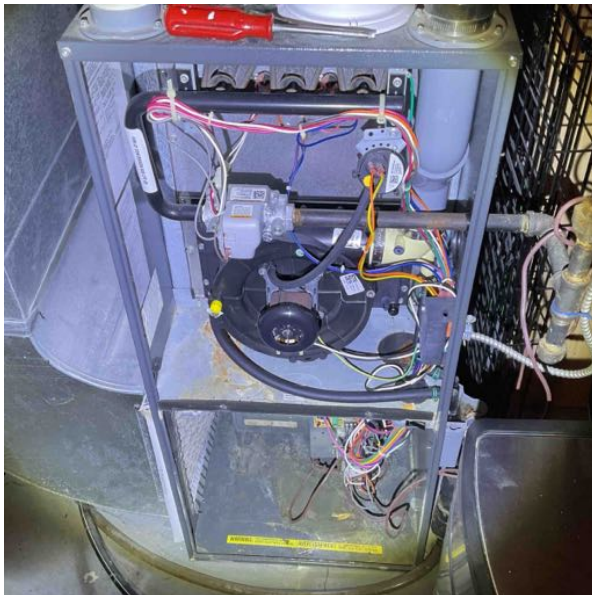
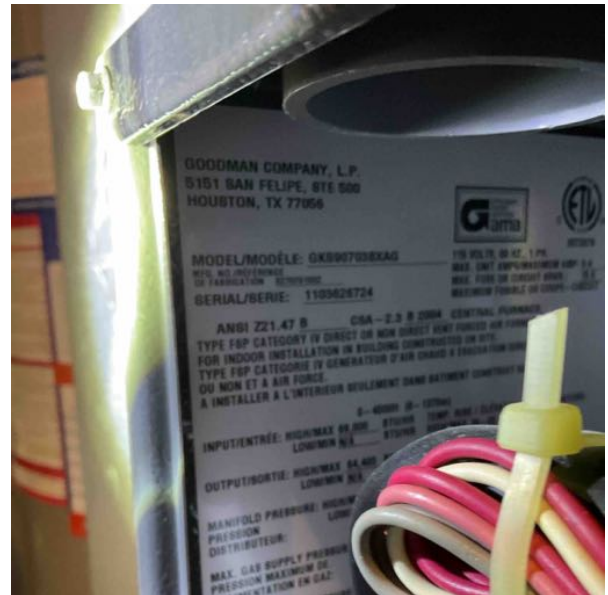
9.6.2 High efficiency furnace is dated 2011 and is functional

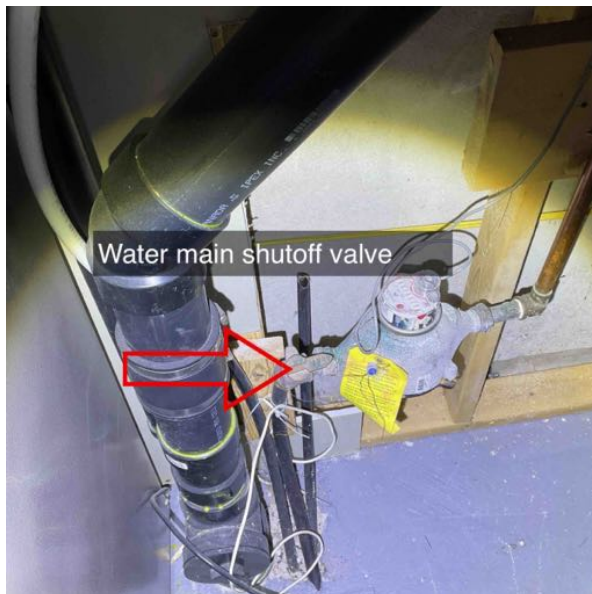
10.3.2 Plastic water main

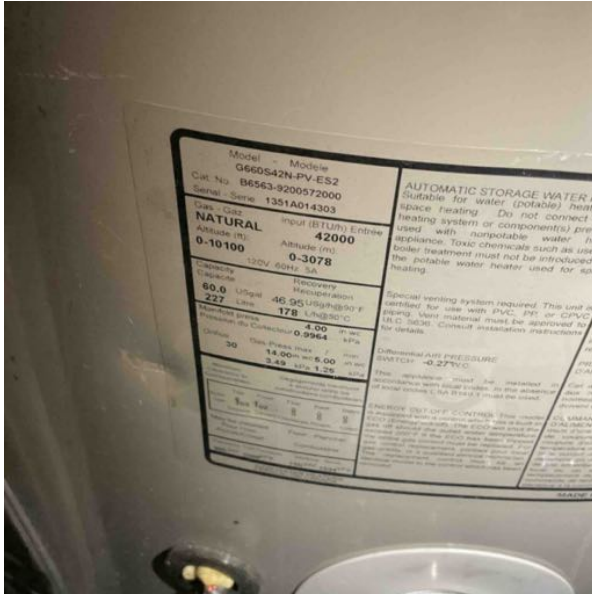
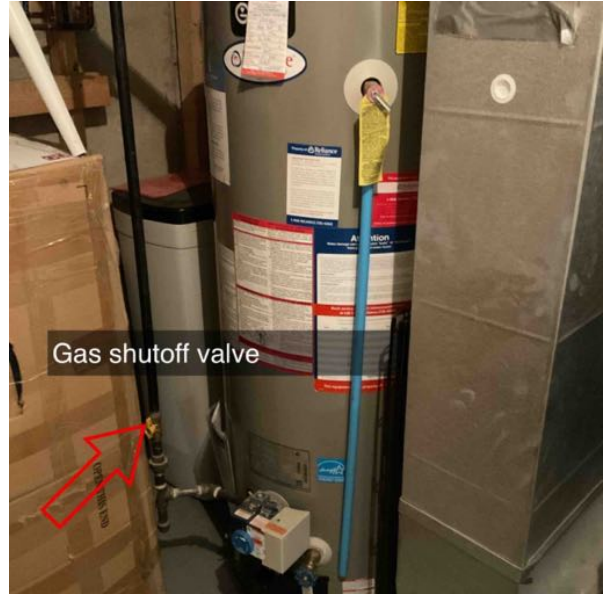
10.6.2 Water heater is dated 2013 and is functional

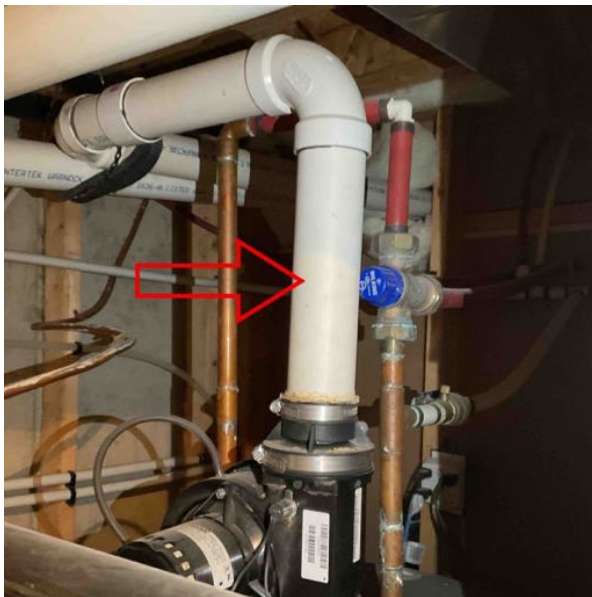
10.7.1 Power vented to exterior. Pipe is secured and in good condition.

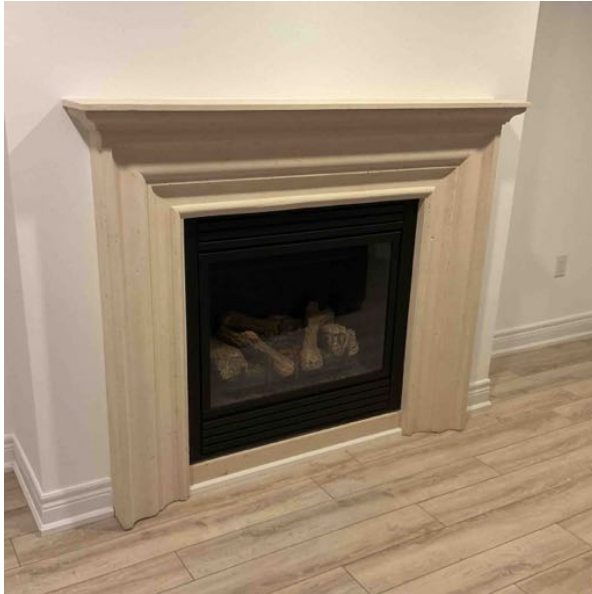
12.1 Gas Insert(s)**12.1.1 Pilot light out. System not tested (Basement)**

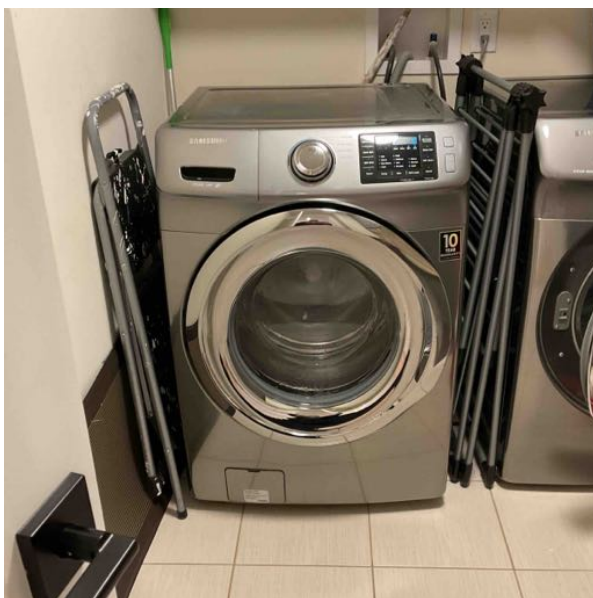
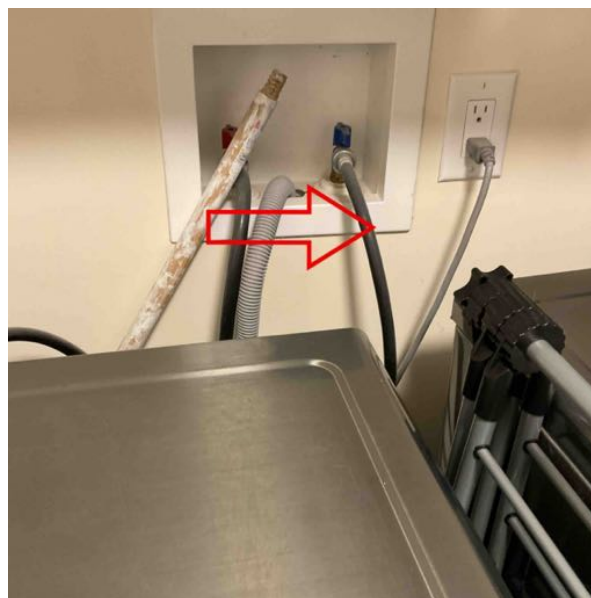
Supply lines are due for replacement. Install braided steel pressure lines for improved leak protection. **(Second floor)**

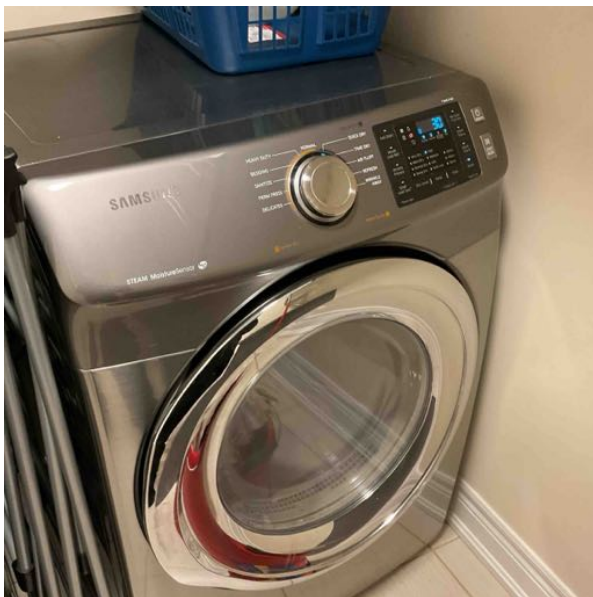
Interior of dryer vent condition concealed-not inspected **(Second floor)**

Dryer vent cleaning is recommended to increase efficiency and for fire safety. Inspect/clean on a regular basis.
