Home Inspection Report

PROPERTY INSPECTED:
916 Carlaw Avenue
Toronto, ON M4K 3L3

Date of Inspection: 03/22/2024

Inspection No. 141126-2361

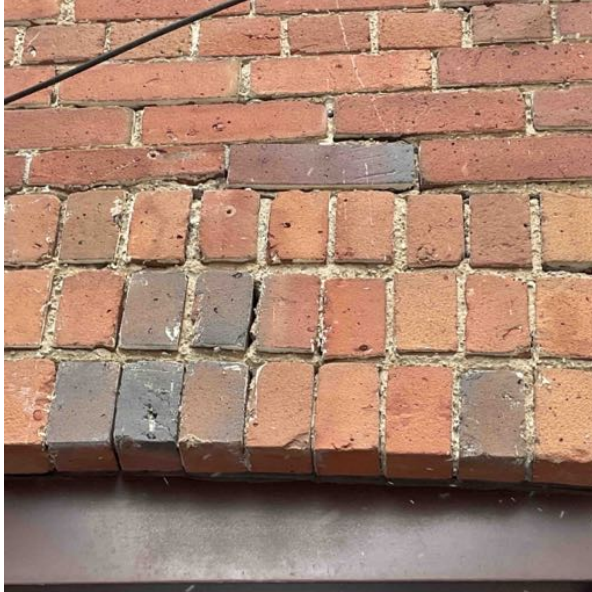
3.3.1 Surface deterioration of brick/mortar noted is common at this age. Repair worn areas, repoint open joints to repel water, reduce further deterioration. Anticipate occasional repairs as part of owning an old property.

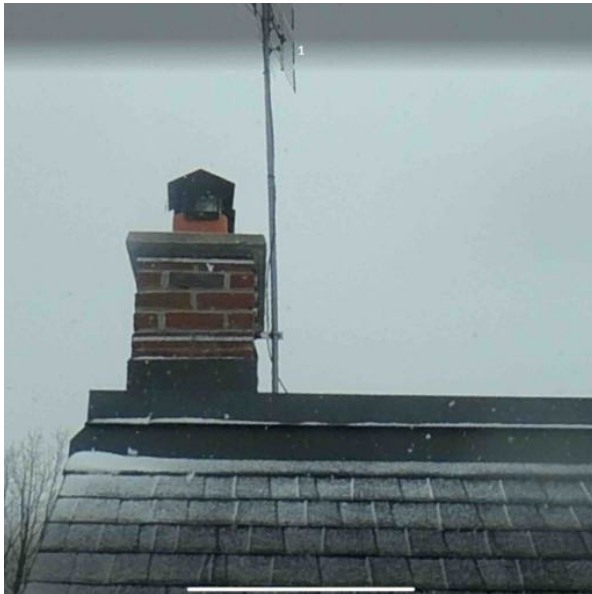
4.7.1 Brick chimney vents fireplace. No visible defects

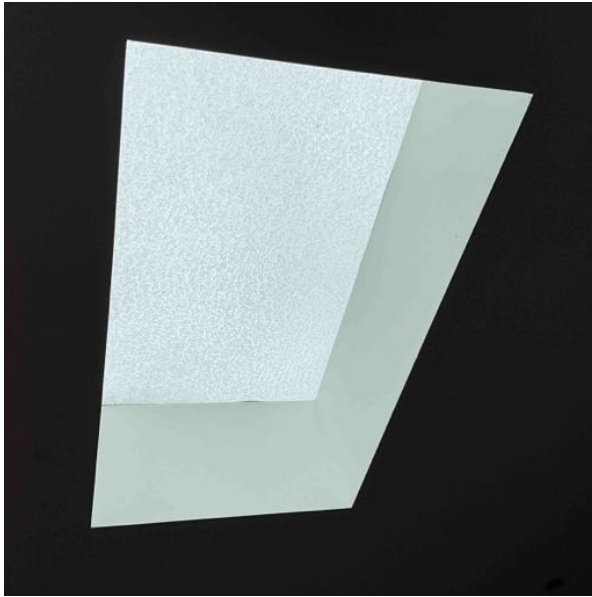
4.8.1 Skylights are approximately 5 years old.

No visible moisture at interior of skylights

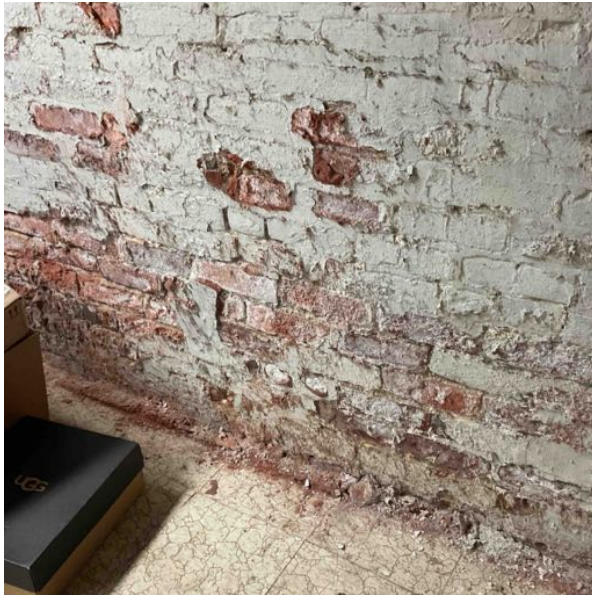
7.3.1 There is no active leakage. Surface deterioration and efflorescence indicates occasional leaks. Old foundations are prone to occasional leakage, they were not constructed with modern damp proofing materials. Be sure water drains well away from the foundation. Be prepared for leak repairs prior to finishing.

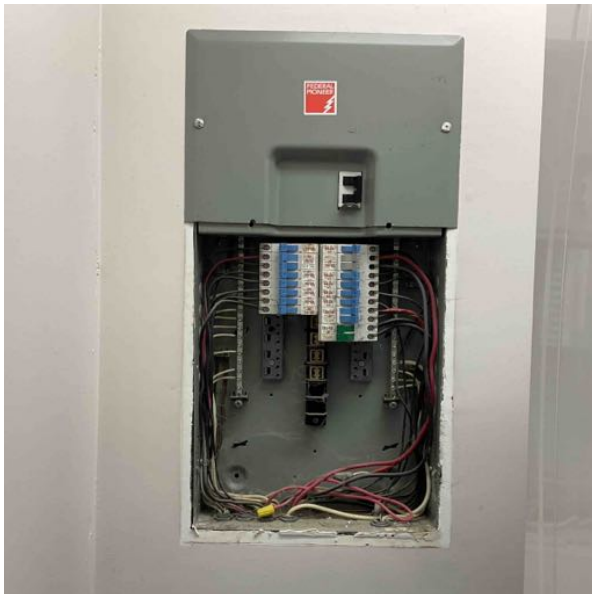
8.6.1 100 Amp Sub panel located on third floor. All copper wire. Room for expansion. No significant visible defects

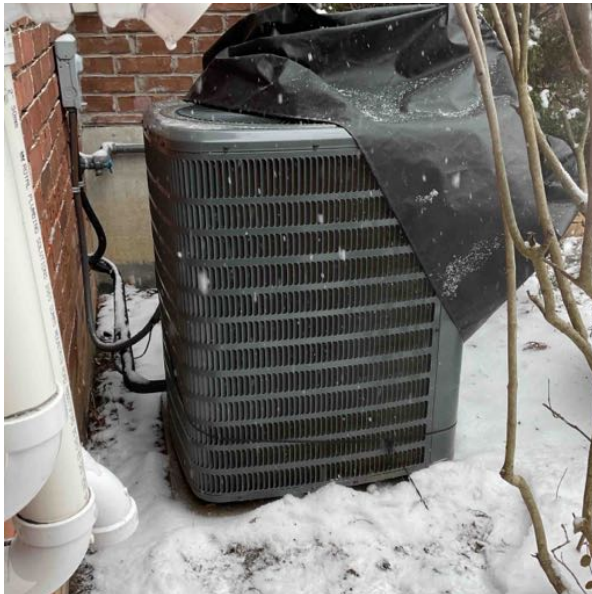
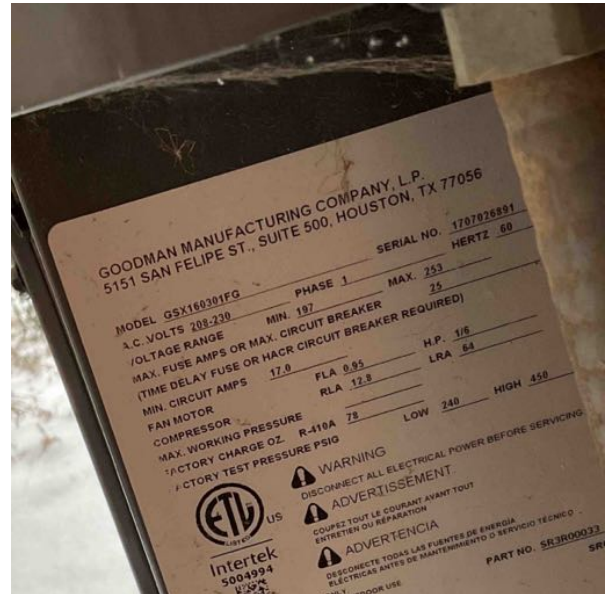
9.5.1 Air conditioner is dated 2017

System not tested due to low outdoor temperature. Determine function in cooling season (**Exterior Front**)

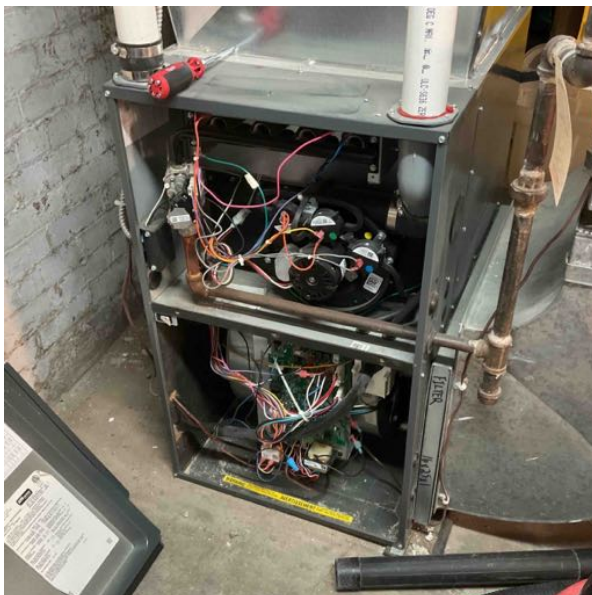
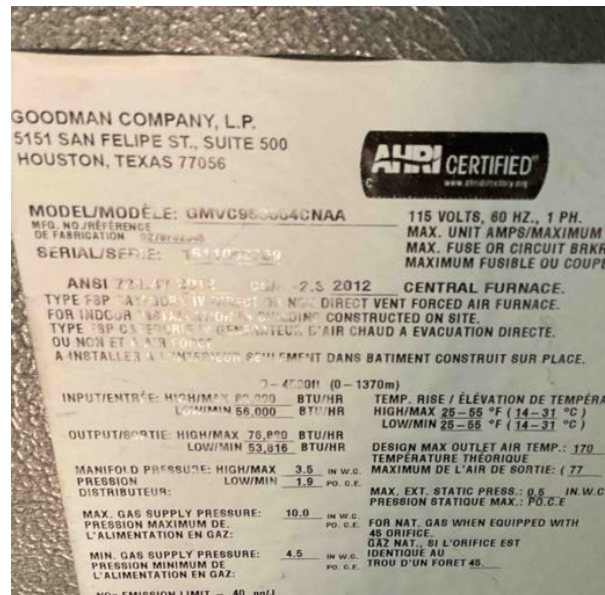
9.6.2 High efficiency furnace is dated 2016 and is functional

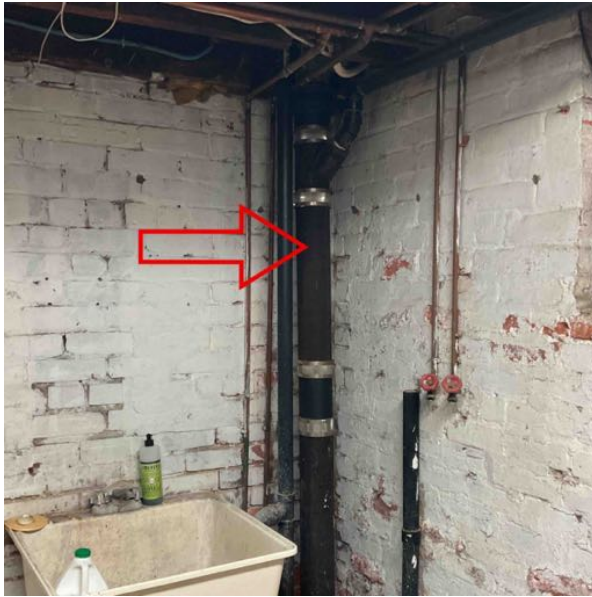
10.5.1 Cast iron drains have limited life. No active leakage detected but a budget is needed to upgrade as needed or when completing renovations.

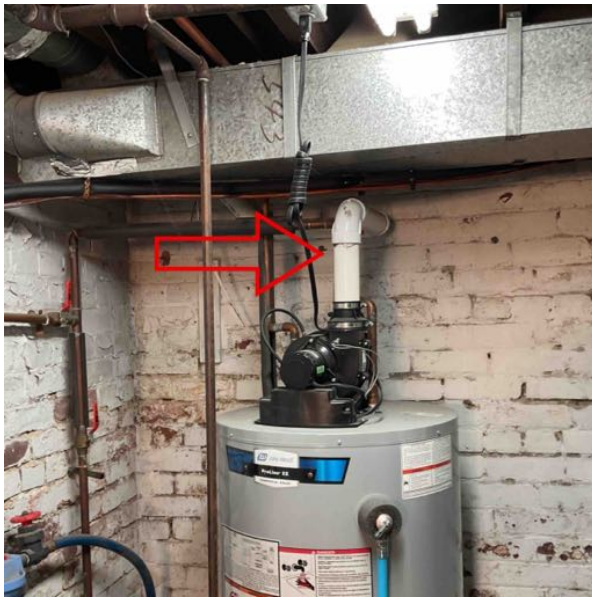
10.7.2 Power vented to exterior. Pipe is secured and in good condition.

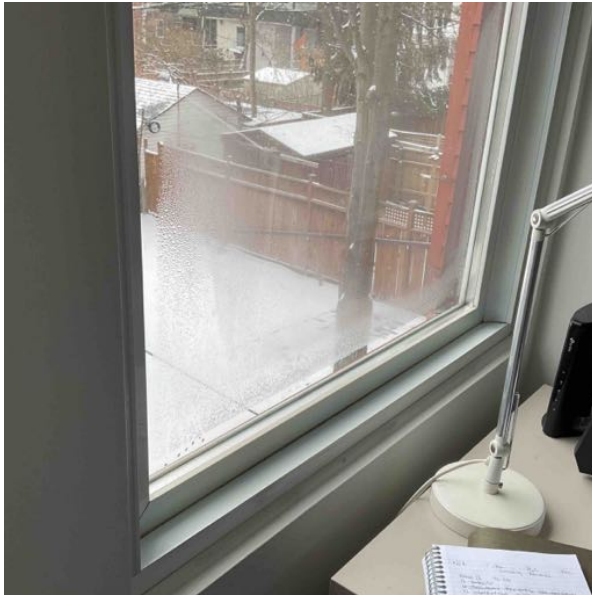
(West bedroom)

11.4.1 The windows are an insulated type that are typically constructed with 2 panes of glass with a vacuum or an inert gas sealed between the glass panes. Over time, this seal can become compromised and allow outside air to enter the space between the glass. The built-in drying agent in the window eventually becomes saturated and can not handle the moist air. This will cause the window to haze and/or develop condensation between the glass panes. The thermal ability of the windows will be affected slightly. If a window is noted as "Broken Seal", then the compromised seal is obvious. Dirty windows and varying weather conditions can obscure compromised seals. Mild temperatures and low humidity will minimize the visible fogging. High humidity and greater temperature difference between inside and outside will maximize the visible fogging. Compromised seals can also be expected in other windows of the same age at some point in time. The appearance of a compromised seal can vary from slight deposits between the glass to complete hazing of the glass. •Recommend evaluation by a qualified window contractor to determine the exact number of compromised windows, cost and alternatives for correction, and correct where needed.

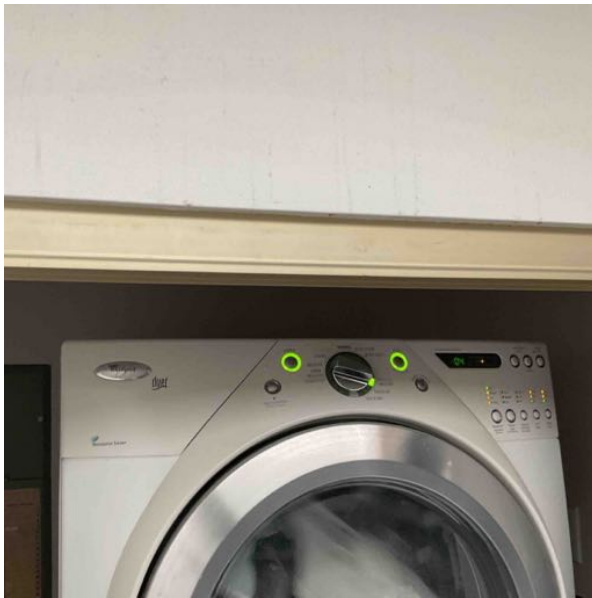
Interior of dryer vent condition concealed-not inspected (**Third floor**)

Dryer vent cleaning is recommended to increase efficiency and for fire safety. Inspect/clean on a regular basis.
