PRELIMINARY BUILDING INSPECTION REPORT

134 Colin Avenue

January 24, 2025

Tim Stechishin, RHI

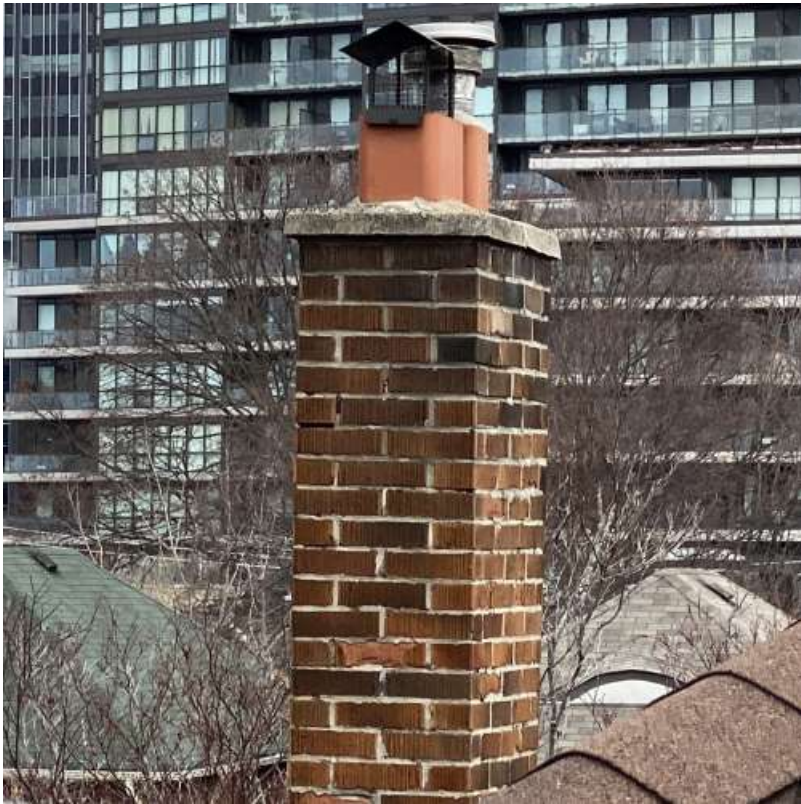
A view of the masonry chimney requiring repair.

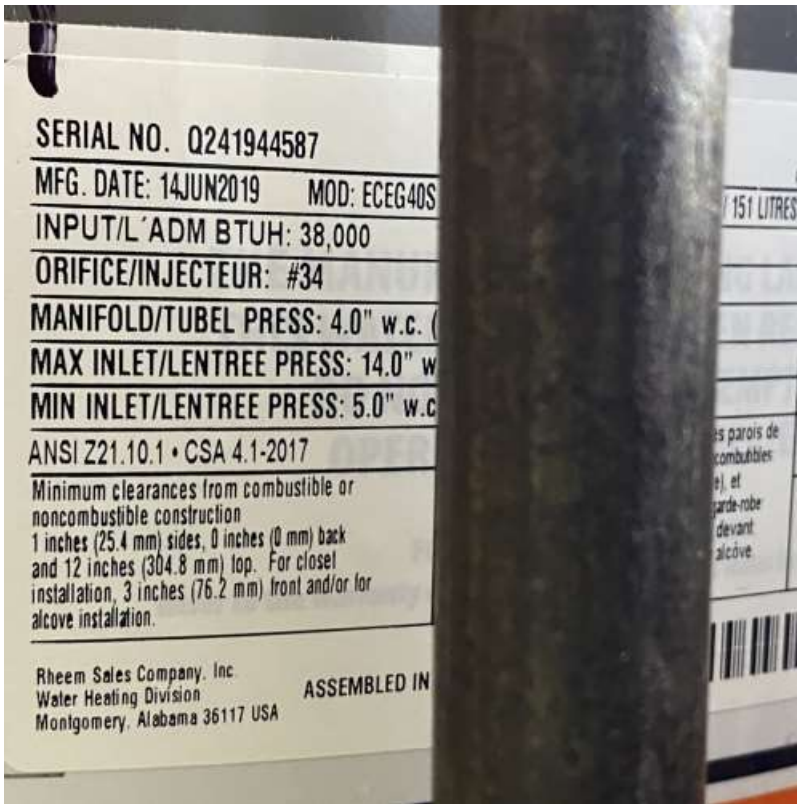
A view of the data plate for the domestic hot water tank.

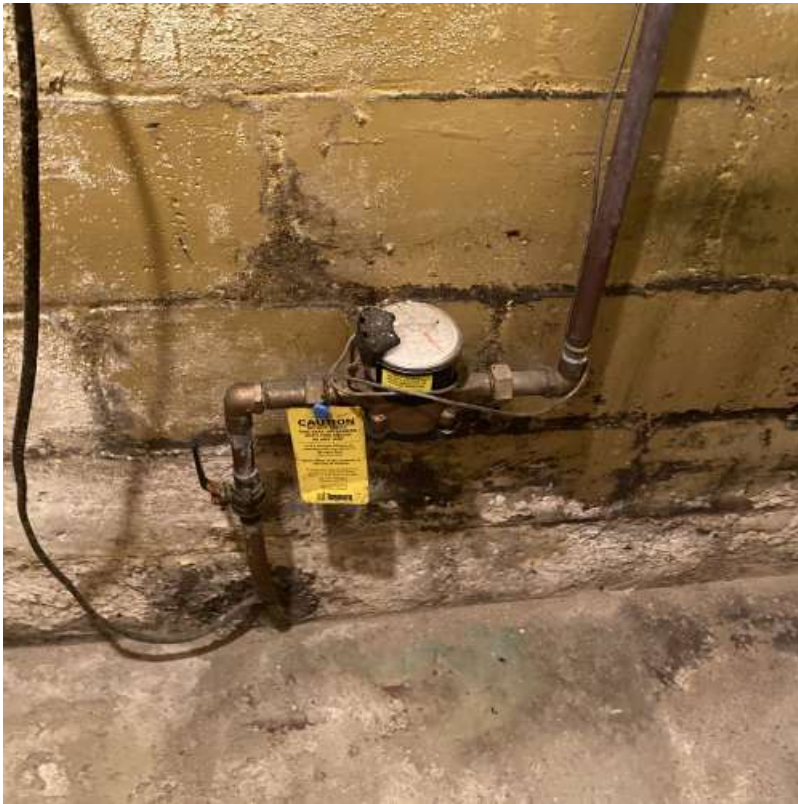
A view of the main water shutoff valve requiring possible heating repair.

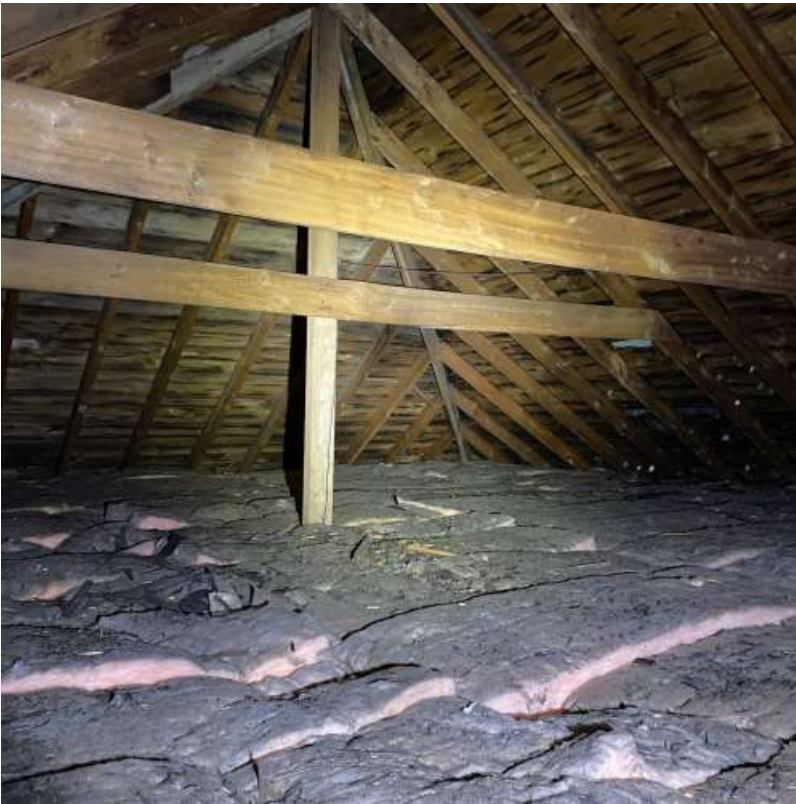
Additional insulation is recommended to be installed in the attic floor.

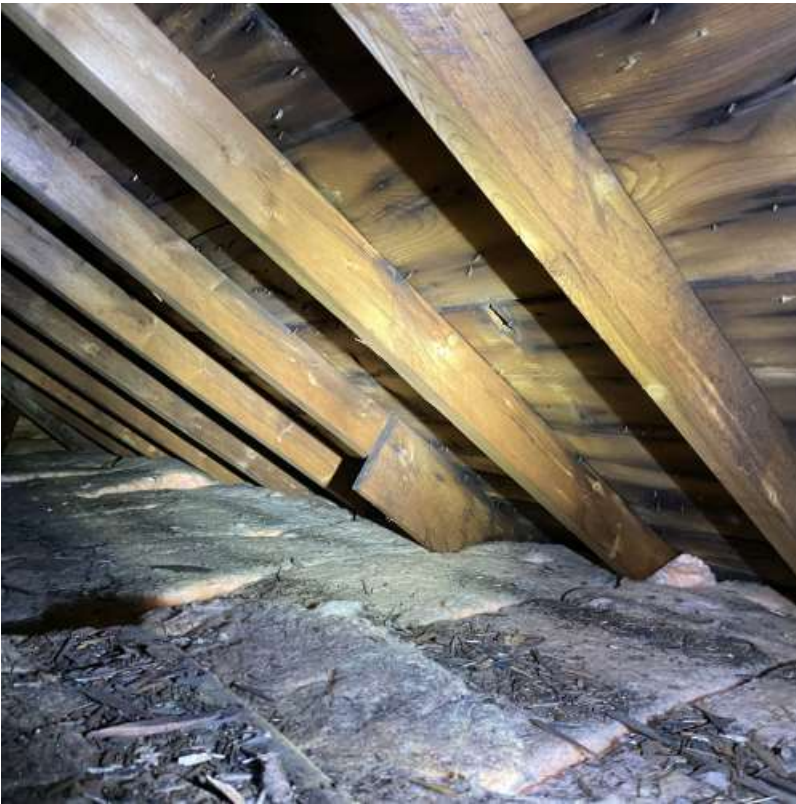
Attic structure is in good overall condition.
