## PRELIMINARY BUILDING INSPECTION REPORT

# Property Address: 73 Foxley Street Date of inspection: June 24, 2025

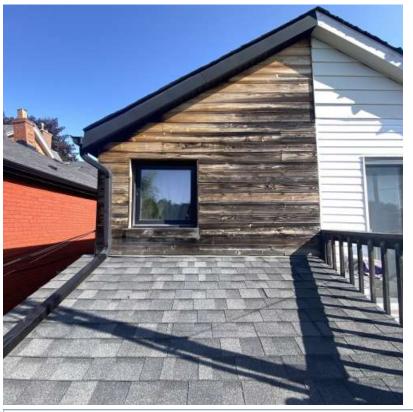
Rear Elevation, wood sidings need coat of paint/ stain to extend lifespan.

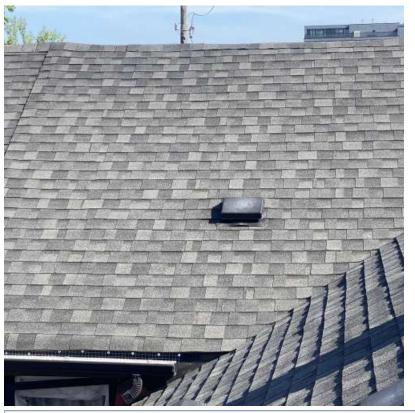
Roof coverings are in good overall condition.

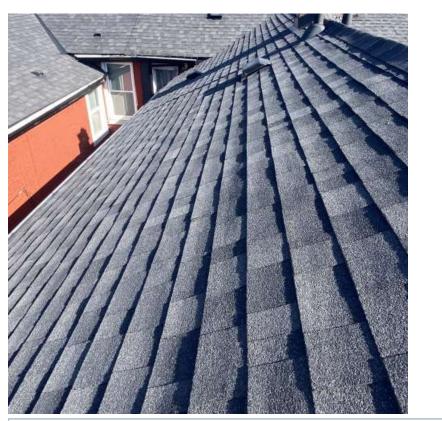
Roof coverings are in good overall condition. Professional maintenance is required to prolong lifespan.

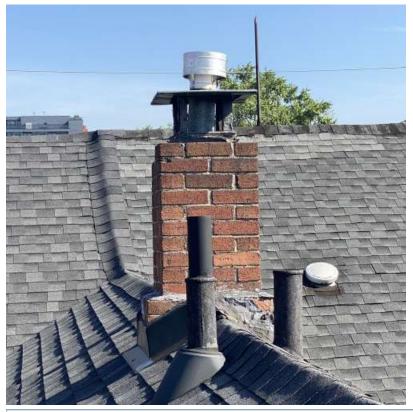
A view of the masonry chimney. Tuck pointing/repair/new chimney cap is required
