Your Inspection Report

140 Jones Ave
Toronto, ON M4M 3A1

PREPARED BY:
Gordon Mathieu, B.Sc Elec Eng., RHI

RE: Report No. 96443, v.2
140 Jones Ave
Toronto, ON
M4M 3A1

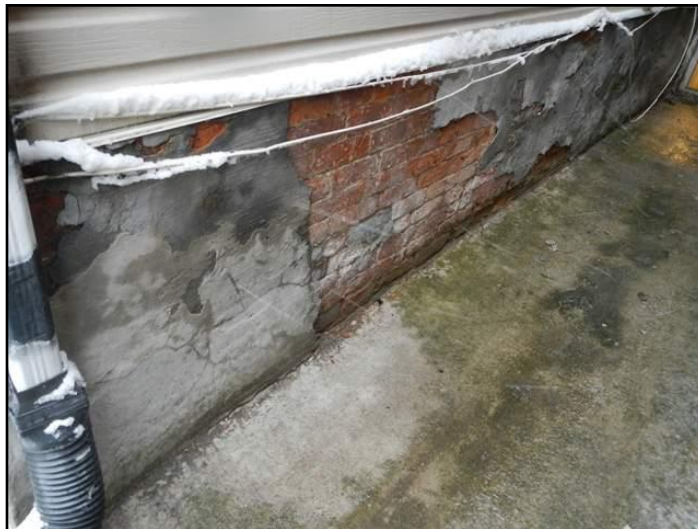
Condition: • The gap at the wall should be well sealed.

Task: Improve

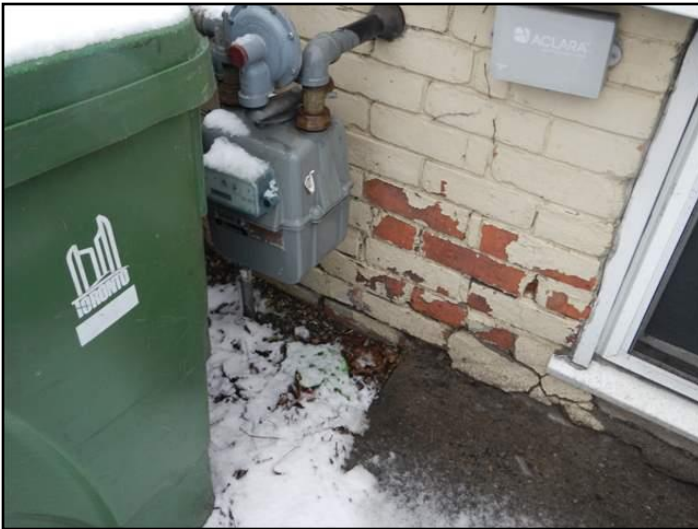
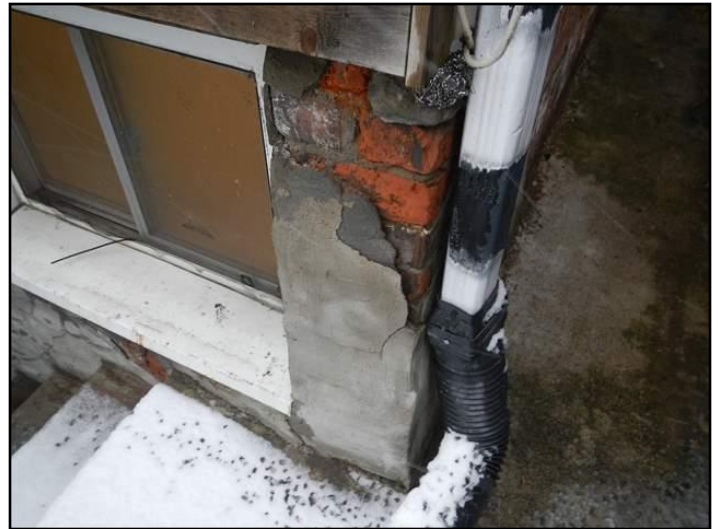
Condition: • Masonry deterioration

Masonry deterioration: front

Rear

Task: Repair

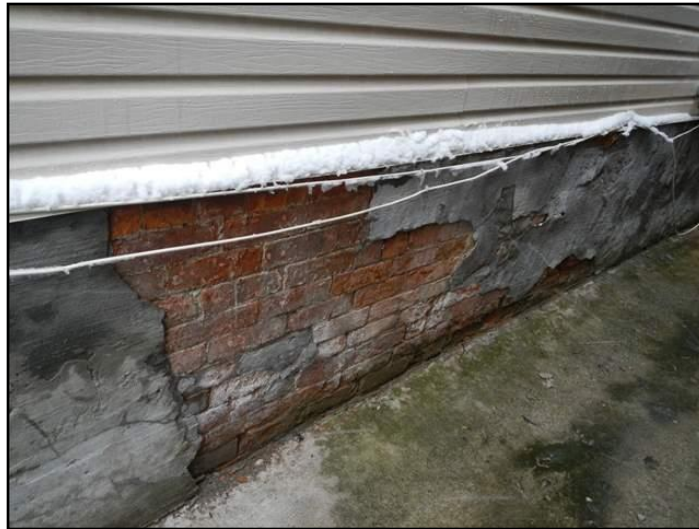
Condition: • Parging damaged or missing

Parging damaged or missing

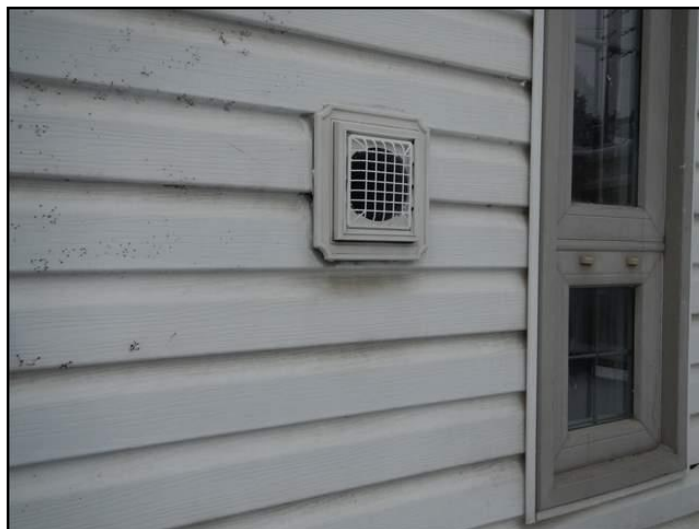
Condition: • Cover missing

Cover/flap missing

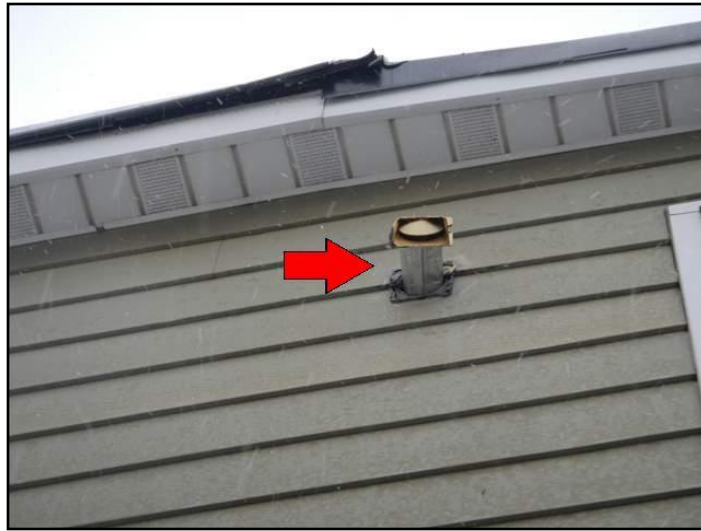
Condition: • Seal - ineffective

Seal - ineffective

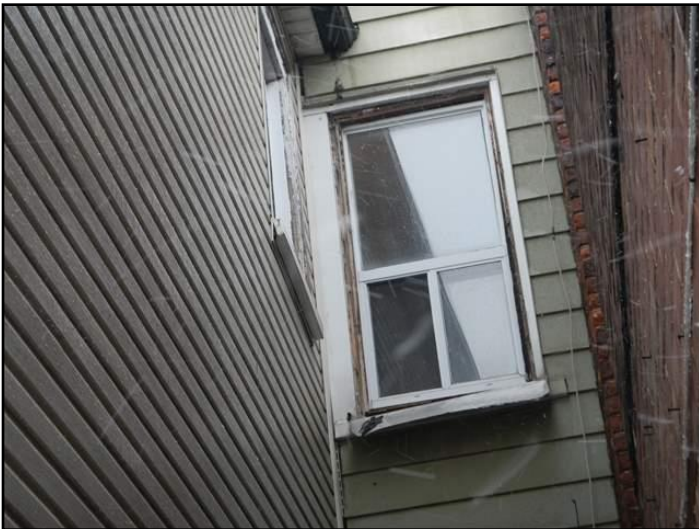
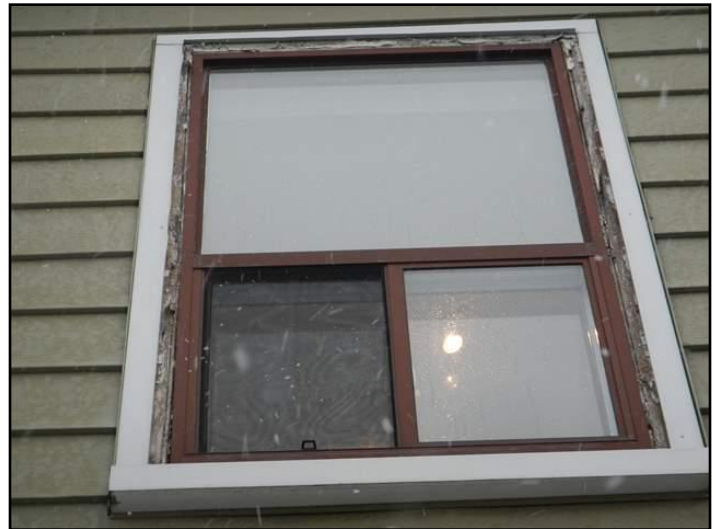
Condition: • Paint and caulking - deteriorated / missing

Paint and caulking - deteriorated / missing

Task: Improve

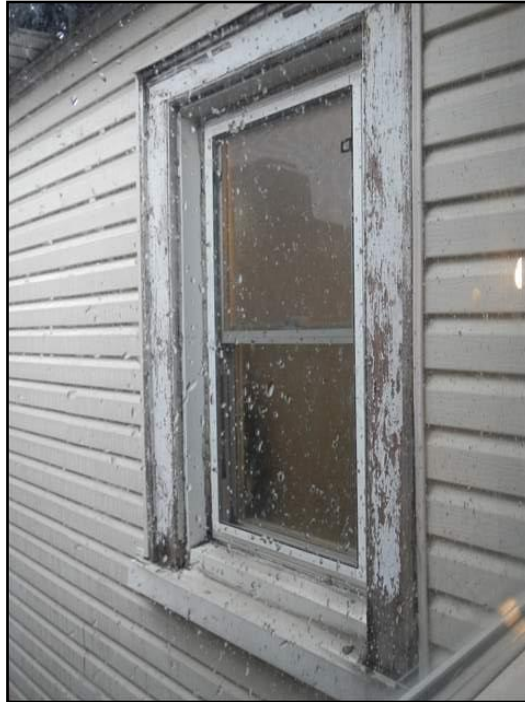
Paint and caulking - deteriorated / missing

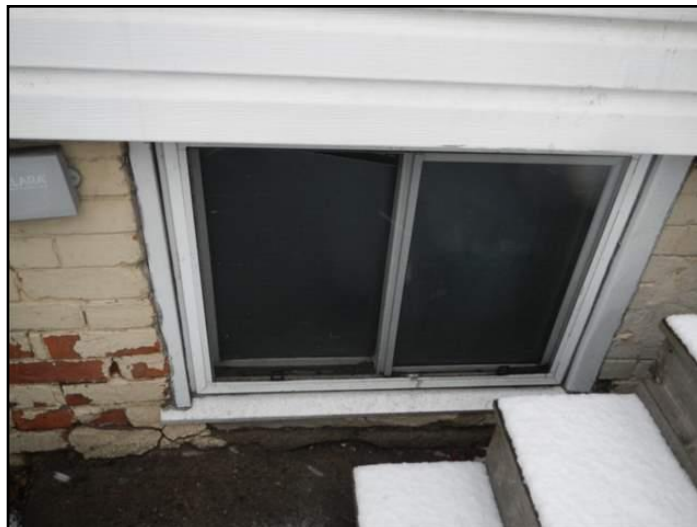
Condition: • Sill close to grade

Task: Inspect and sweep/shovel

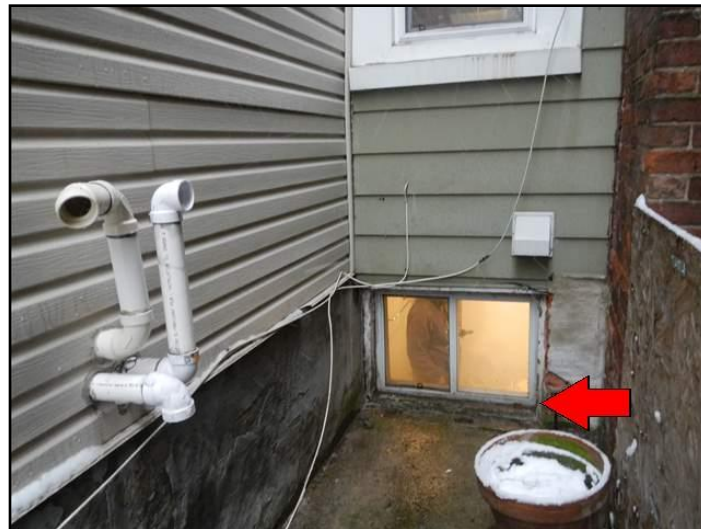
Condition: • Missing

Missing

Task: Provide
Time: As required
Cost: Minor

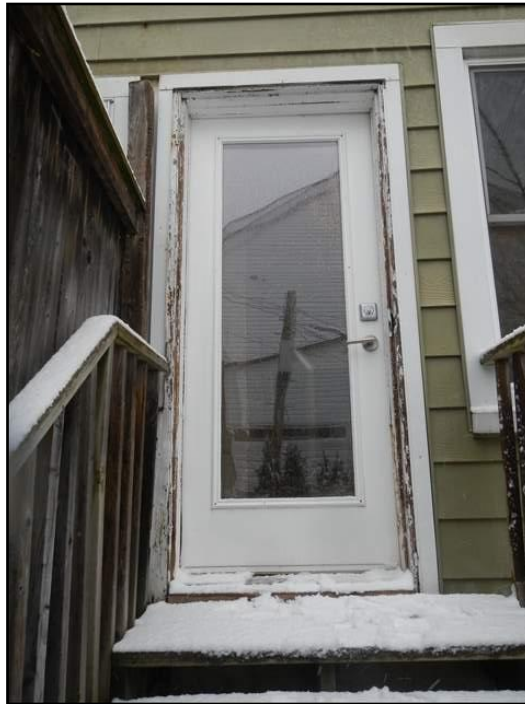
Condition: • Paint or stain - needed
...and caulking.

Paint or stain - needed

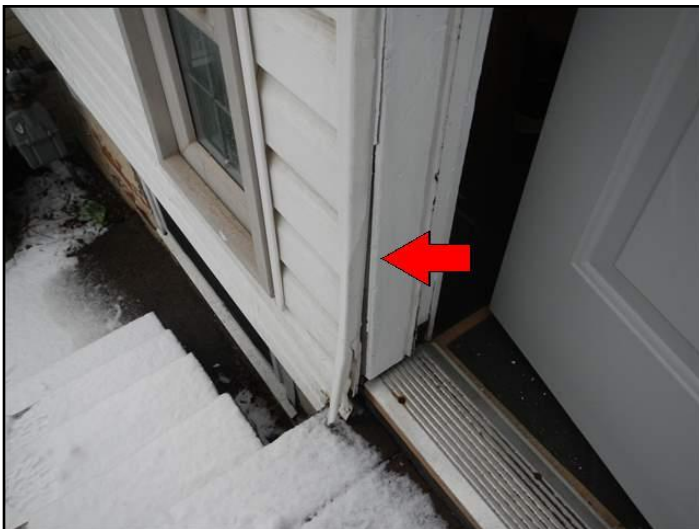
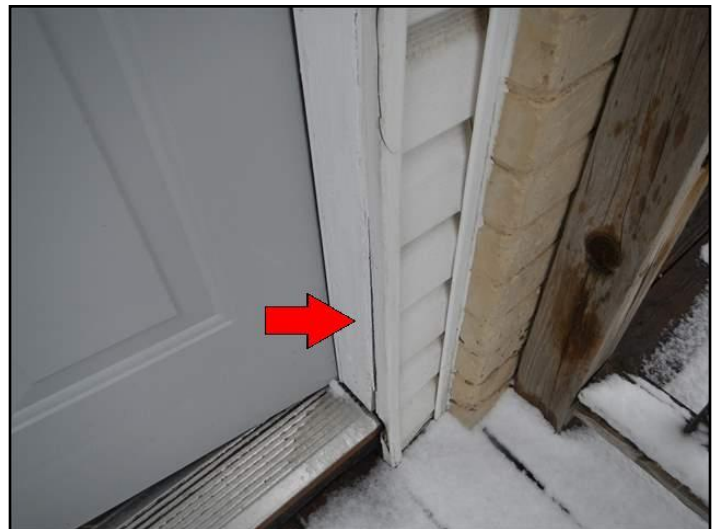
Condition: • Damage

Task: Repair

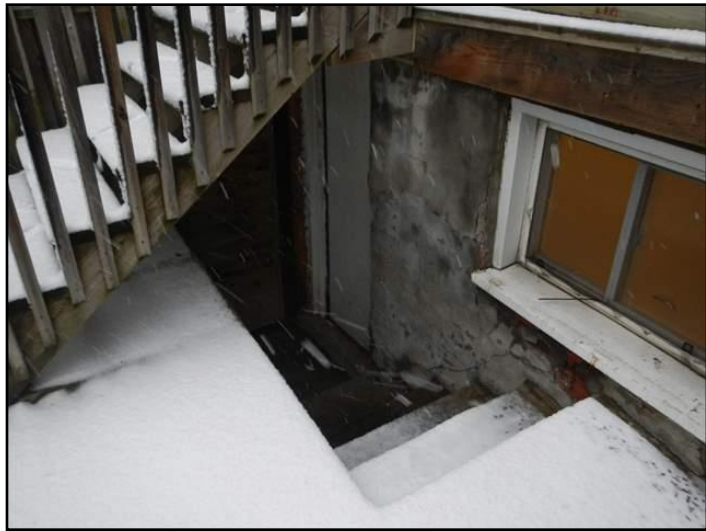
Condition: • Guard / handrail - missing

Guard / handrail - missing

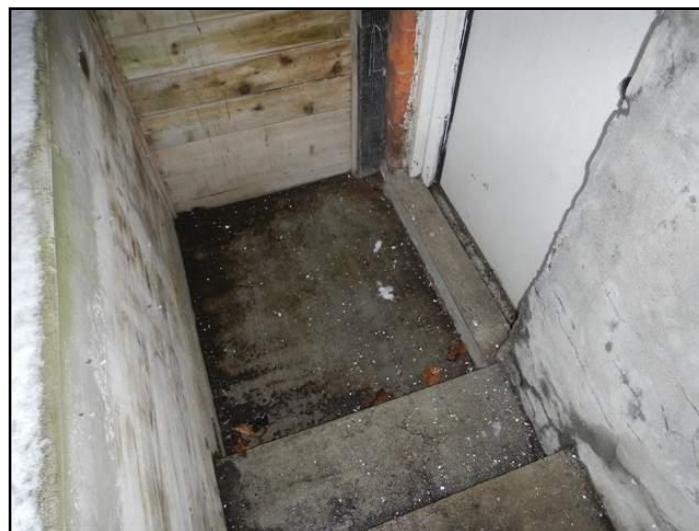
Condition: • Drain - missing
Task: Provide
Time: As required
Cost: Not determined

Drain - missing

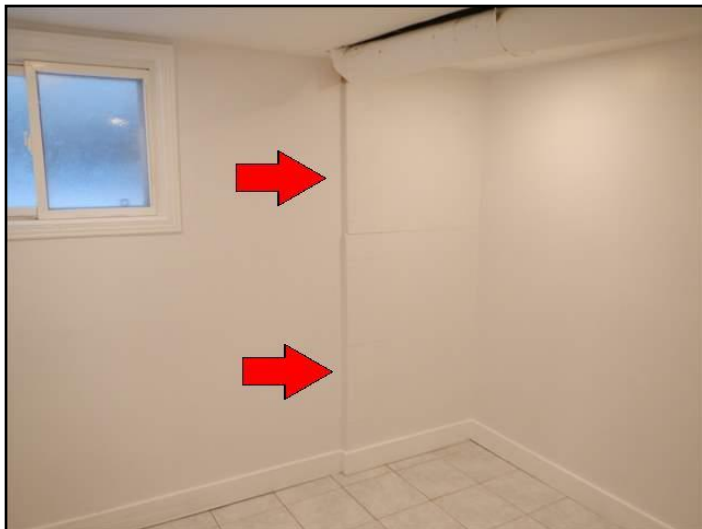
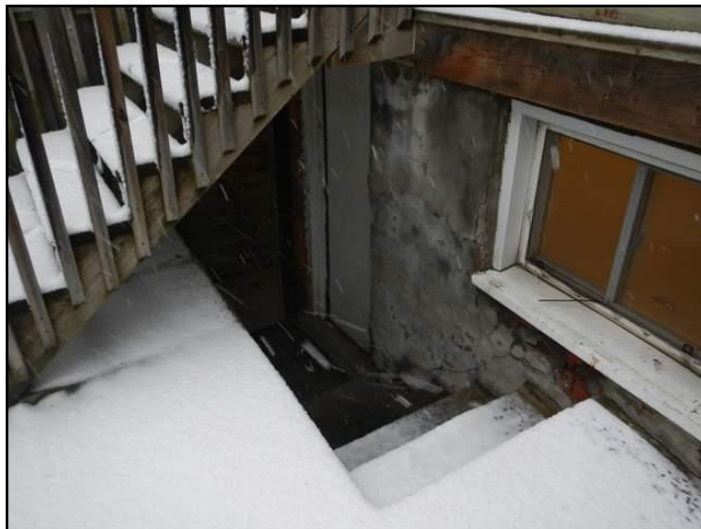
Condition: • The walkout is no longer in use.

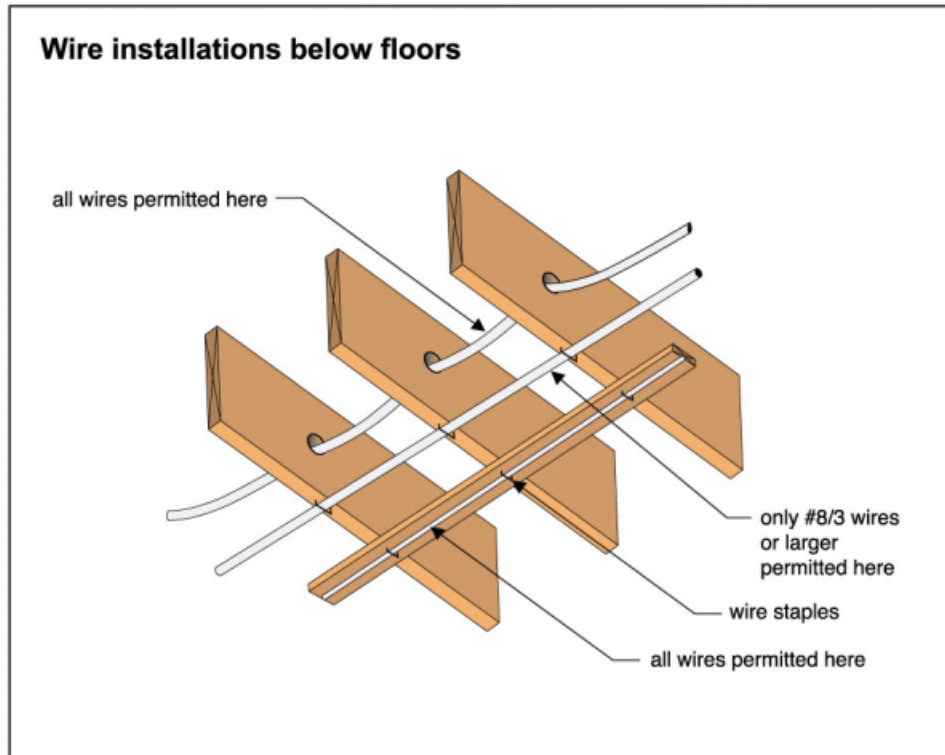
Condition: • Exposed on walls or ceilings

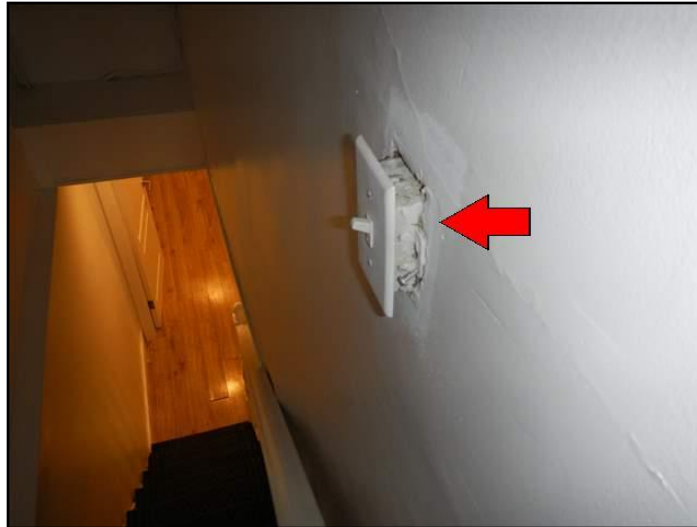
Condition: • Poor installation.

Task: Improve

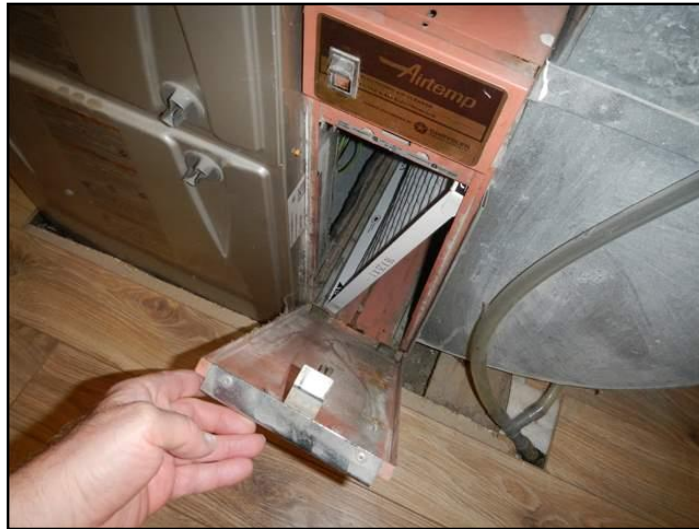
Condition: • [Missing components](#)

Not in use anymore. The original electronic air filter components have been removed. Now in place is a thin passive filter. A much wider one is recommended for better performance.

Missing components

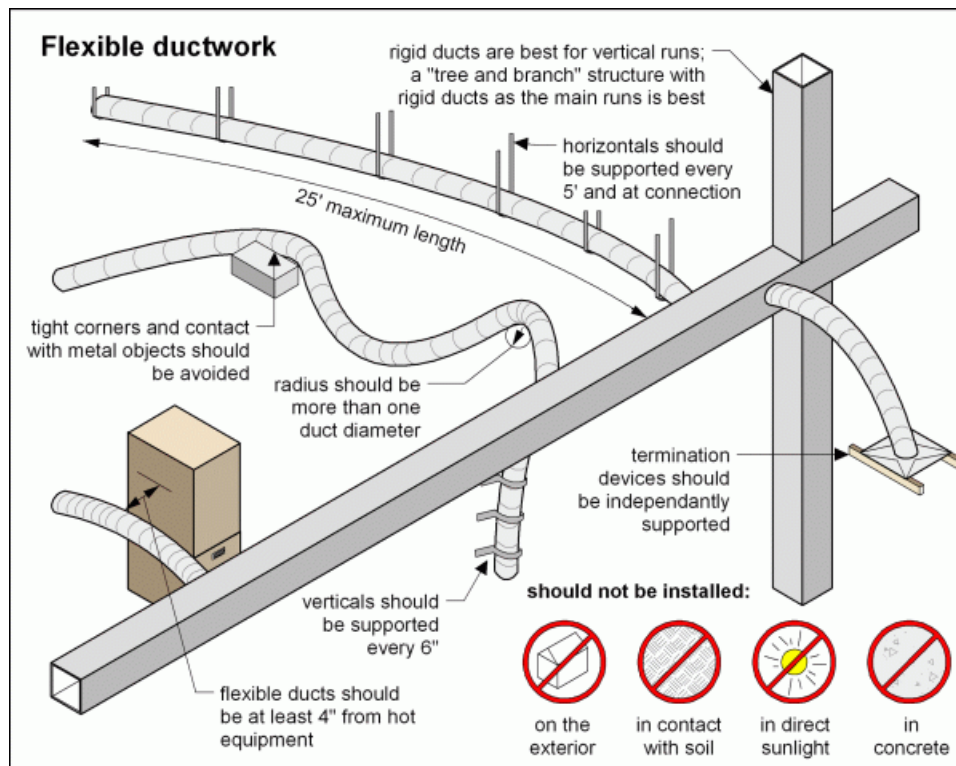
Condition: • [Excessively long runs, excessive elbows](#)

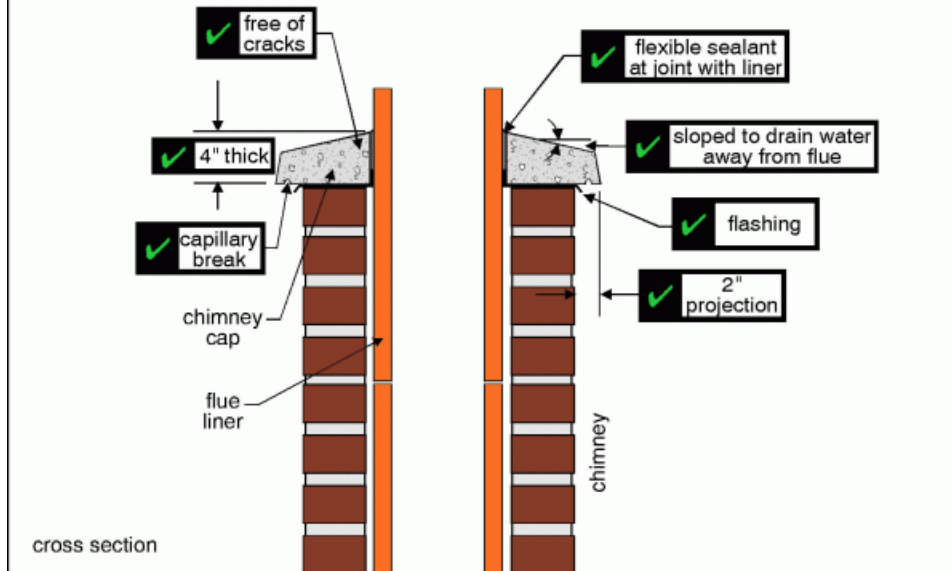
Condition: • Missing

Cost: \$1,000 to \$2,500 (depending on several variables)

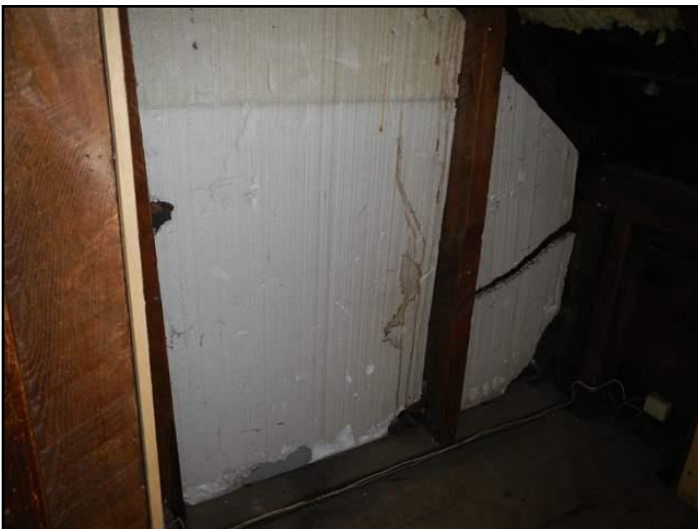
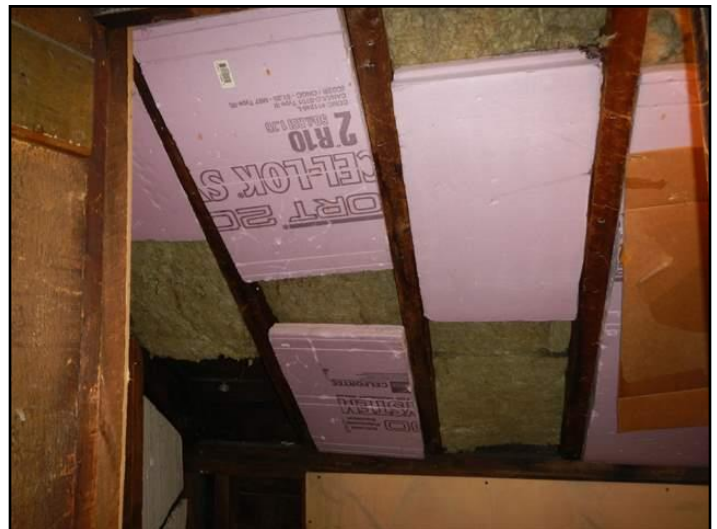
Condition: • [Exposed combustible insulation](#)

Exposed combustible insulation

Task: Improve

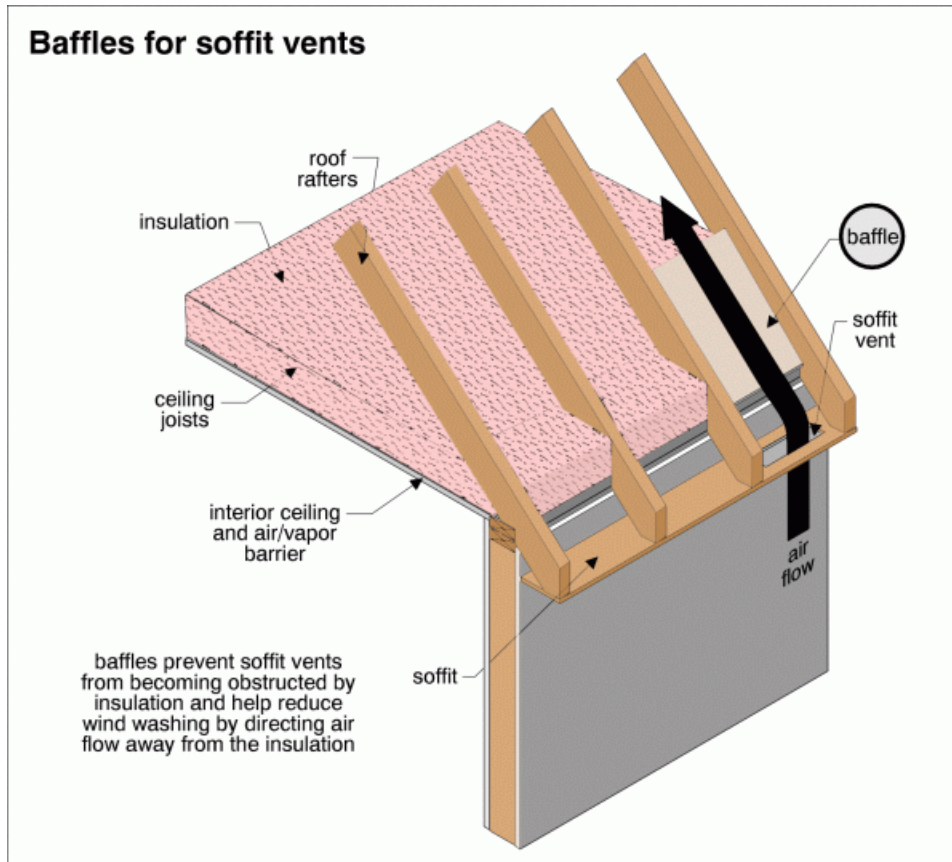
Condition: • Ventilation suspect

A good time to check for excessive humidity in the attic is in the winter; it will appear as frost on the roof sheathing.

Task: Engage roofing specialist to inspect and advise.

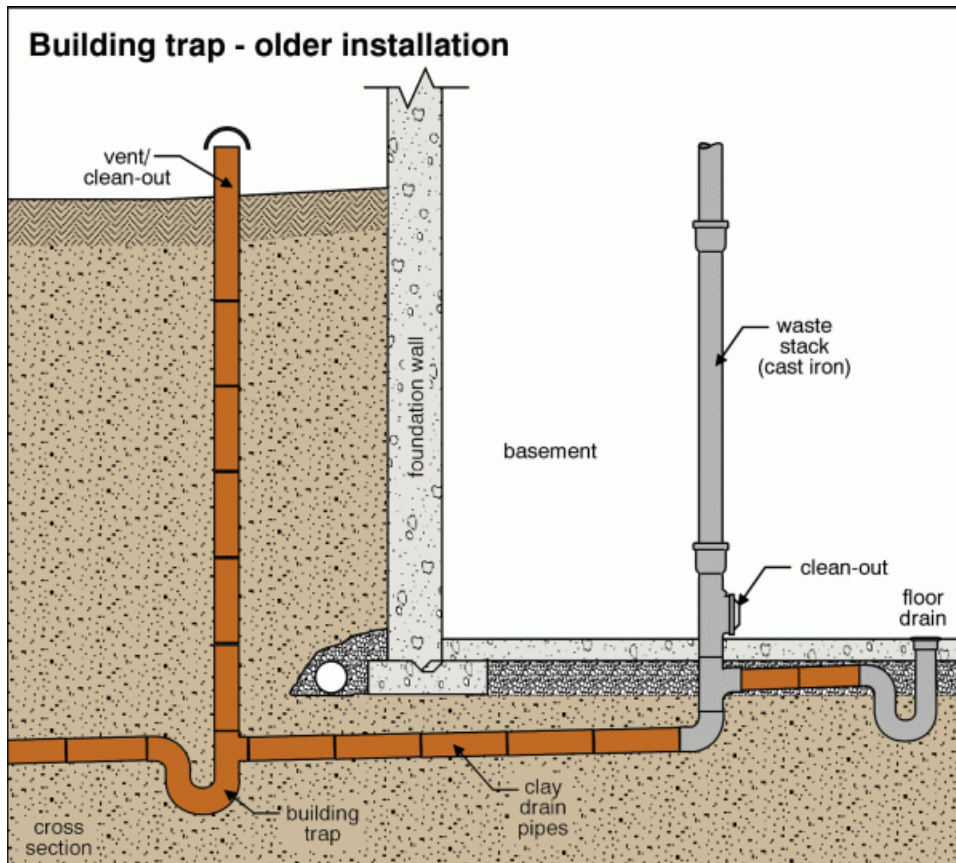
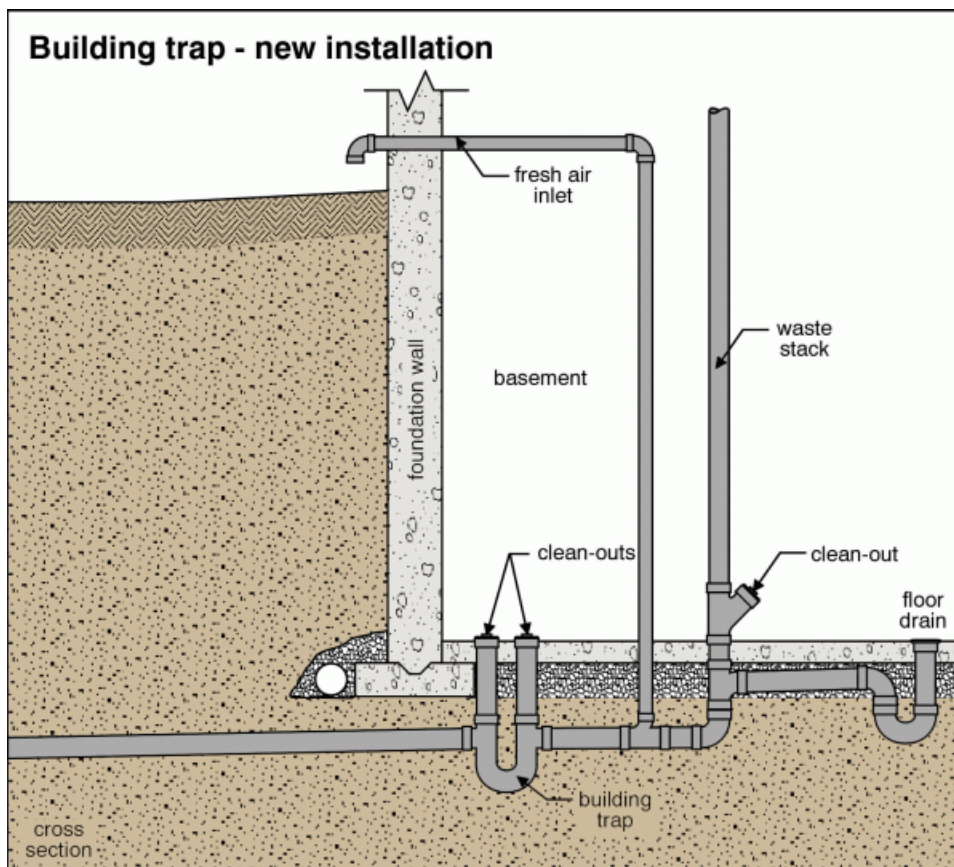
Condition: • Clean-outs missing or inaccessible

Task: Locate, or provide if missing

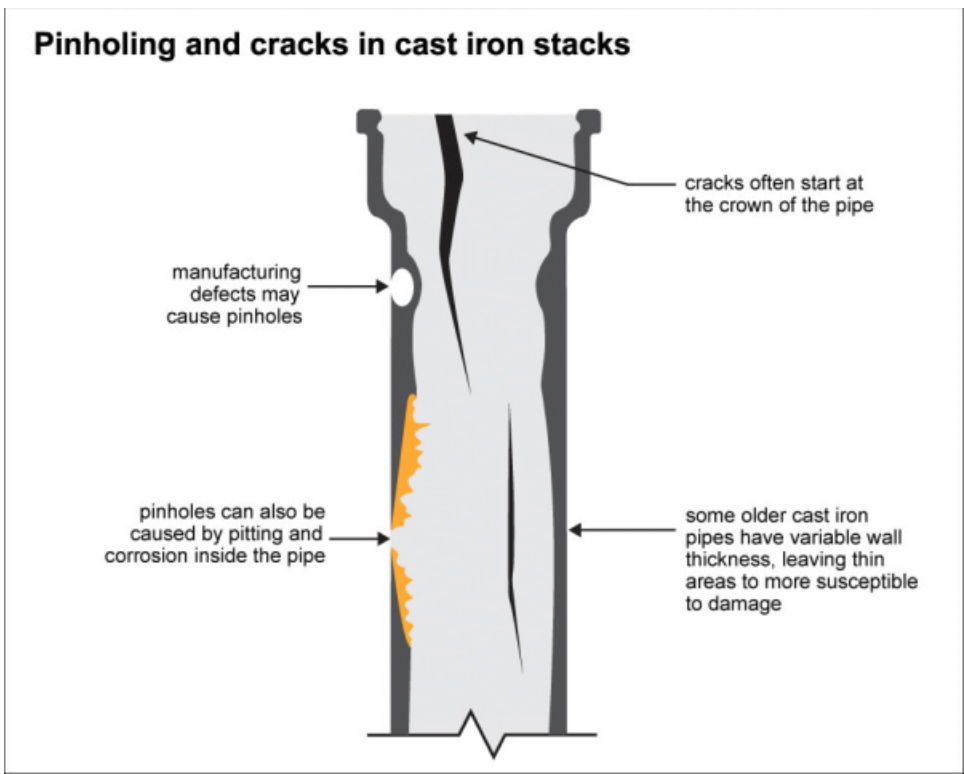
Condition: • The cast iron waste piping is near the end of its normal life expectancy and is prone to rusting through or splitting. Replacement may be required in the near future.

Task: Further evaluation Replace

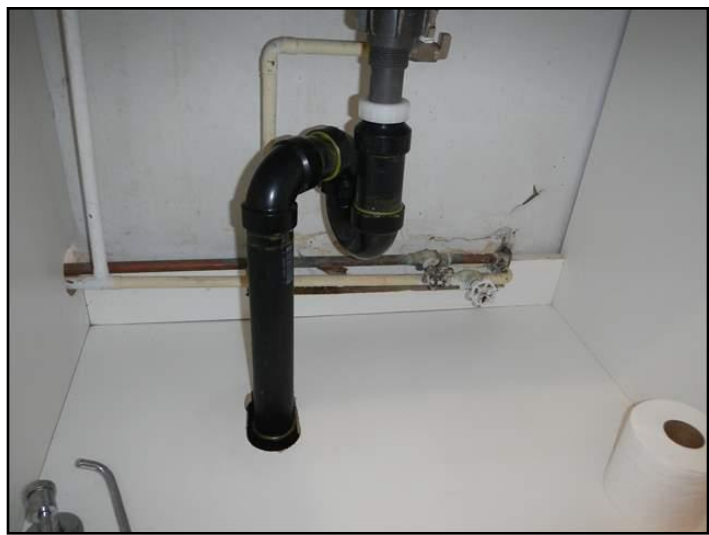
Condition: • S-trap noted.

Task: Improve

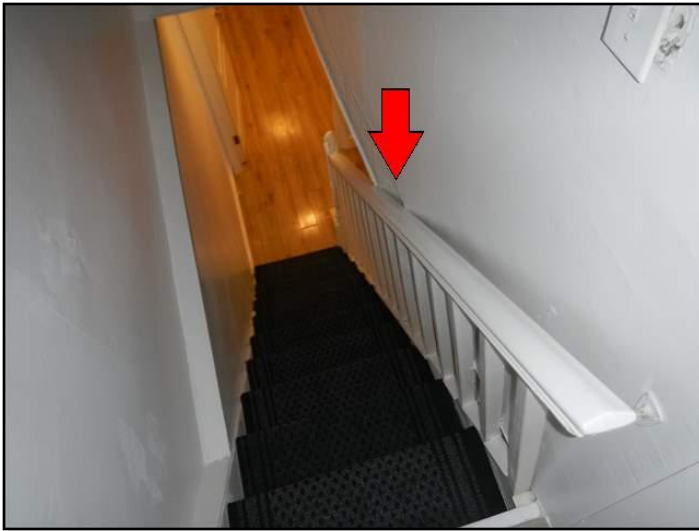
Condition: • [Hard to hold](#)

Hard to hold

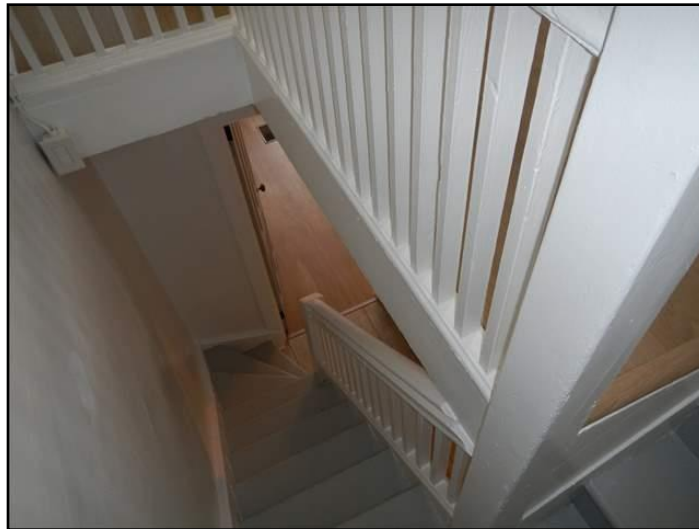
Condition: • Incomplete or not continuous railing

Incomplete or not continuous railing

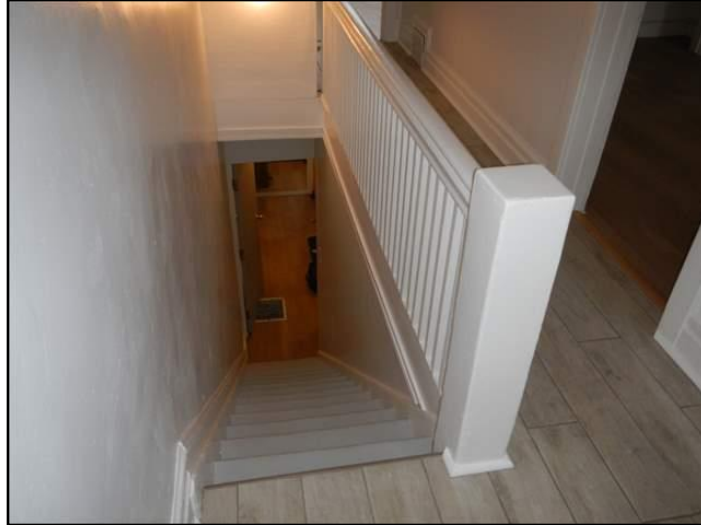
Condition: • [Missing](#)

Missing

Task: Provide
Time: Immediate
Cost: Minor

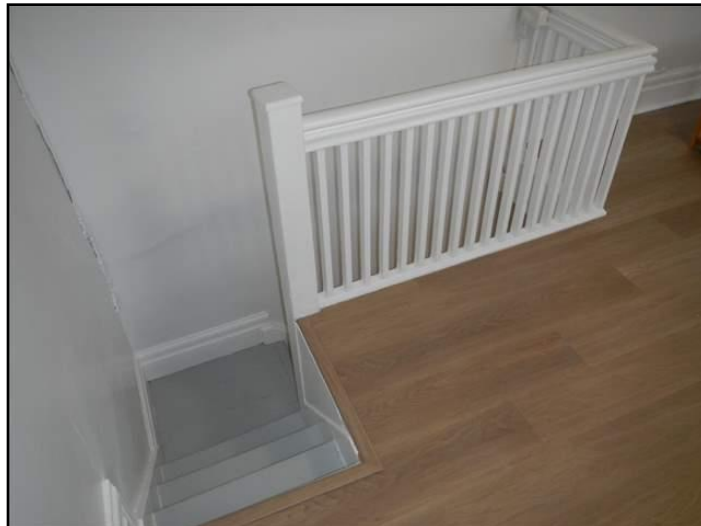
Condition: • [Missing](#)

Missing

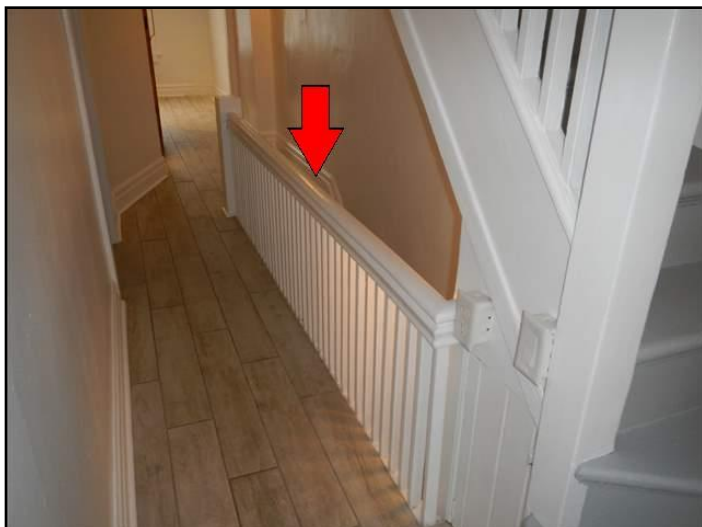
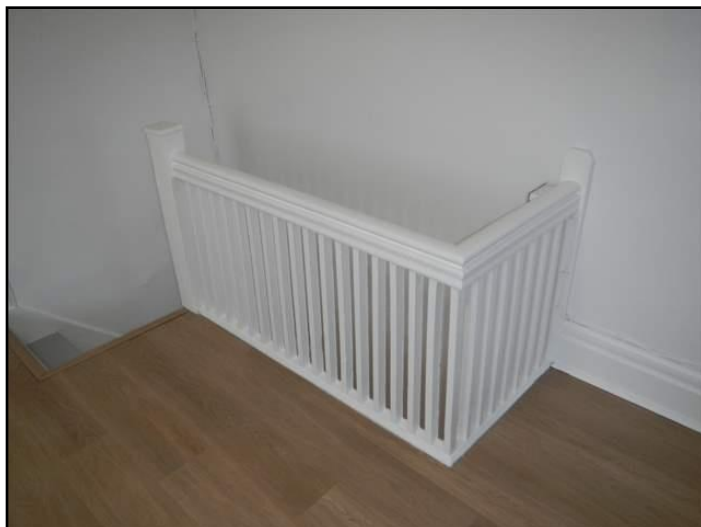
Condition: • [Too low](#)

Too low

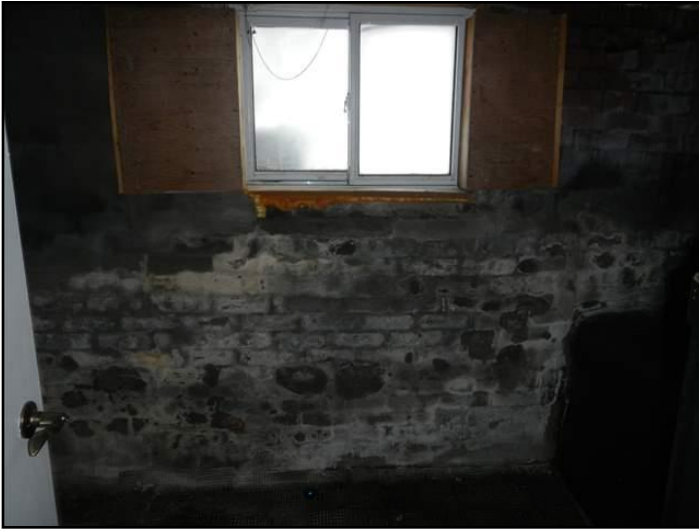
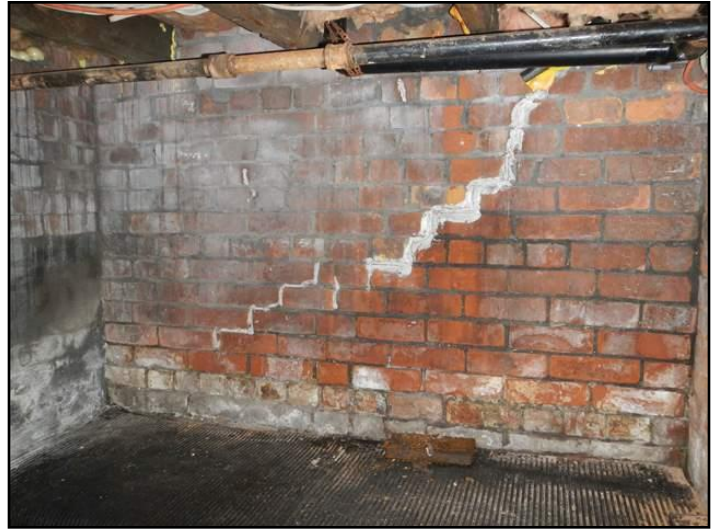
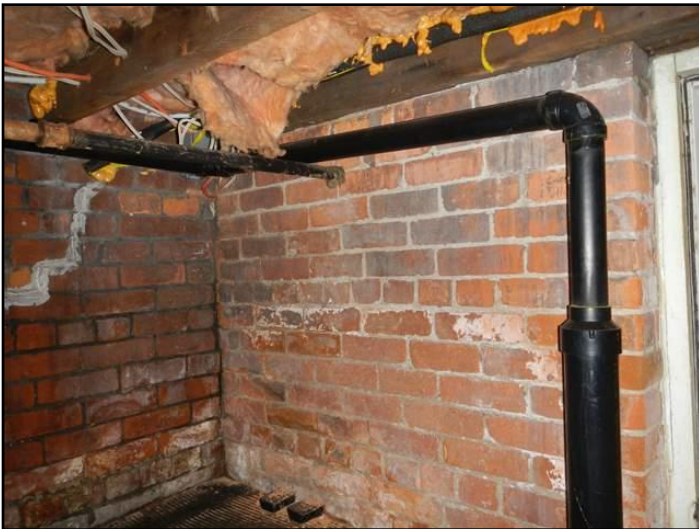
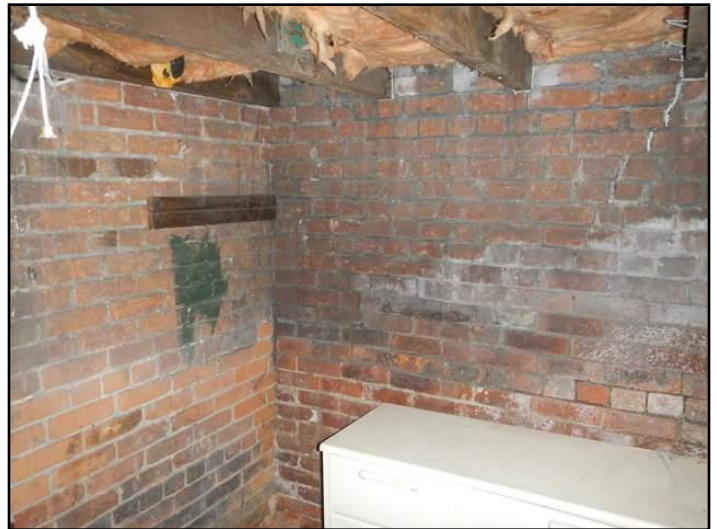
Condition: • The cold room is in 'as is' condition.
