# INSPECTION REPORT

For the Property at:  
**112 WOLSELEY STREET**  
TORONTO, ON M6J 1K2

RE: Report No. 4043, v.0  
112 Wolseley Street  
Toronto, ON  
M6J 1K2

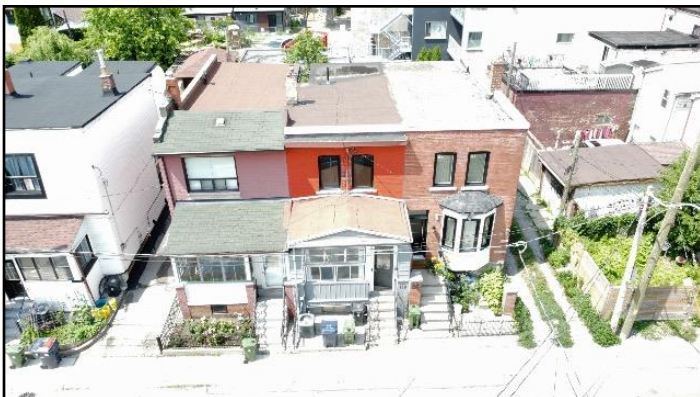
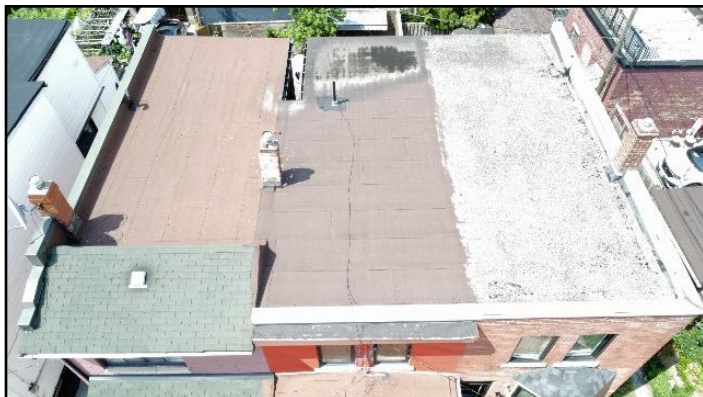
- Modified bitumen membrane

In good condition.

Approximate age 12 years old.

Noticed signs ponding in the rear roof.

Contact a professional roofing company for further evaluation.

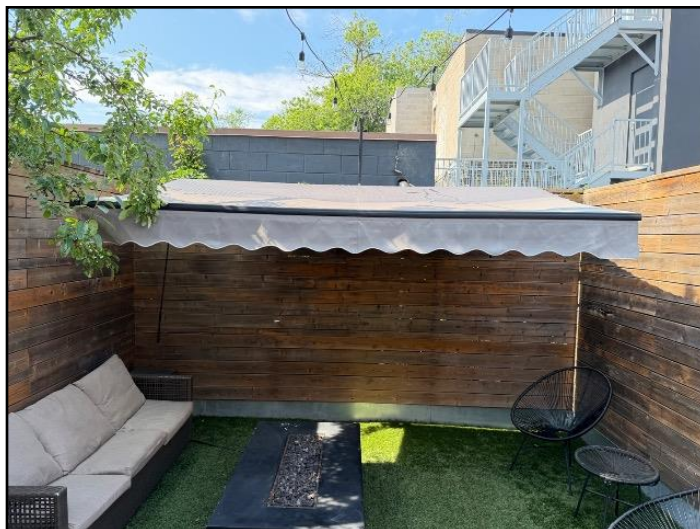
3.

**General:** • Installed outdoor awning

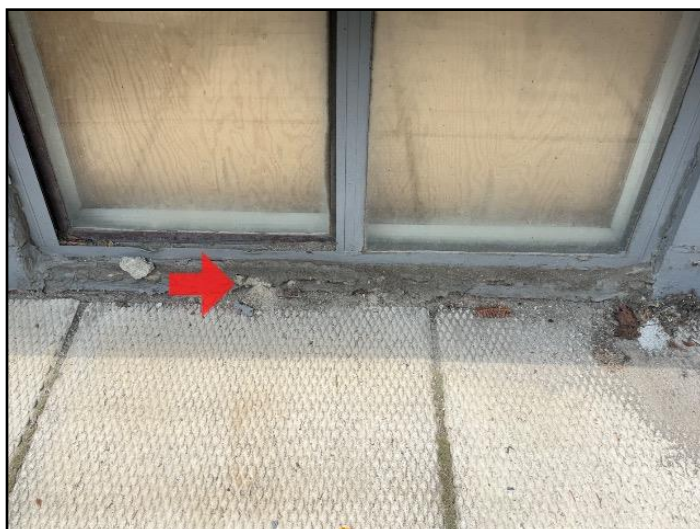
4.

**1. Condition:** • Deteriorated outdoor caulking

**Location:** Front Basement Exterior Wall

**Task:** Repair

**Time:** ASAP

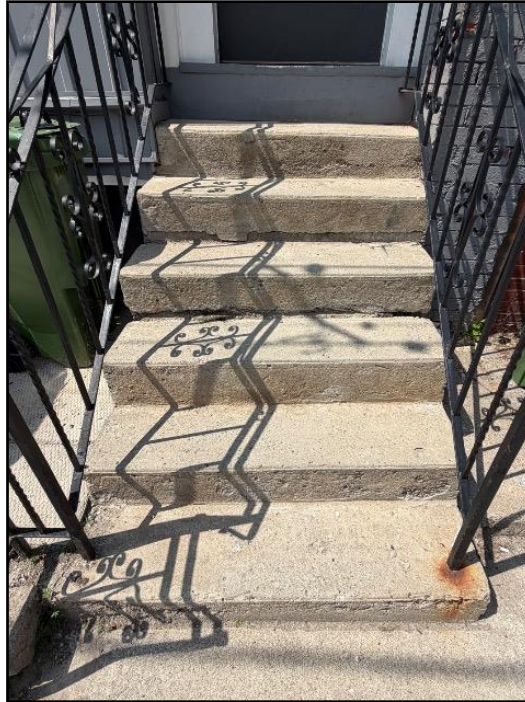
5.

**2. Condition:** • Cracked concrete steps

**Task:** Repair

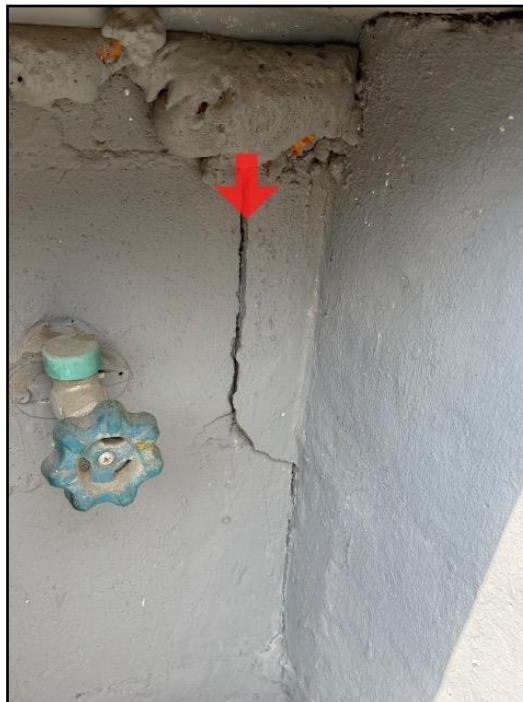
6.

**3. Condition:** • Cracked parging

**Location:** Front Exterior Wall

**Task:** Repair

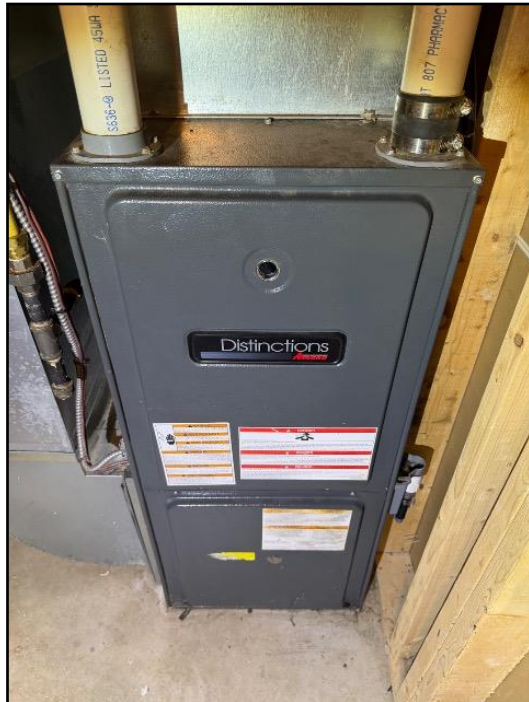
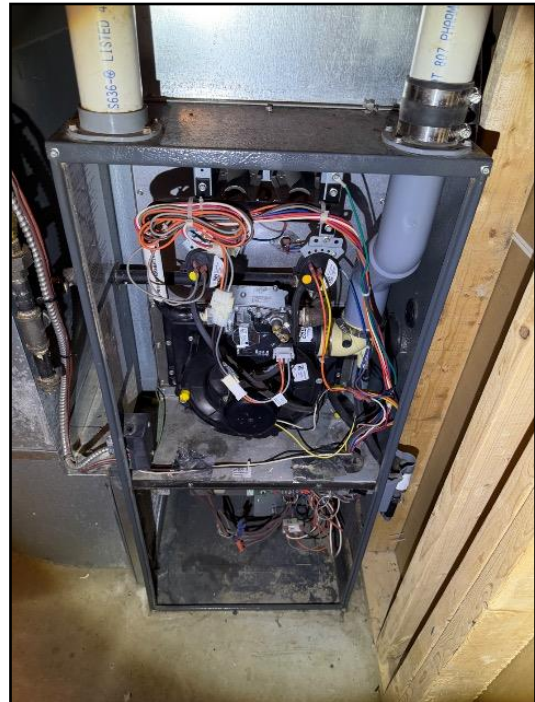
- Furnace
- Model Year 2011  
46,000 BTU's  
High Efficiency  
In good working condition  
Replace filter every 3 months  
Service annually

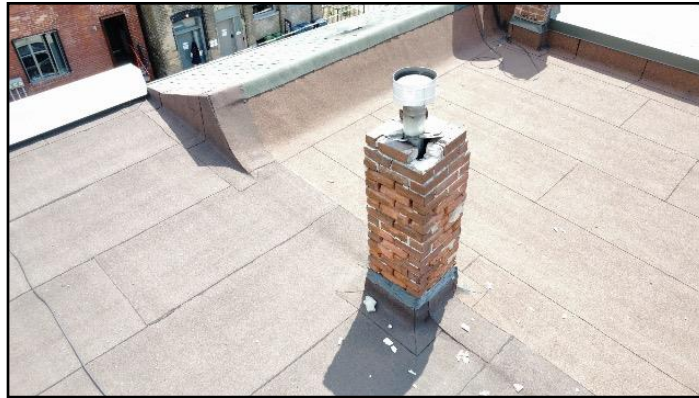
14.

**4. Condition:** • Mortar deterioration

Non-functioning chimney has been sealed

**Task:** Repair

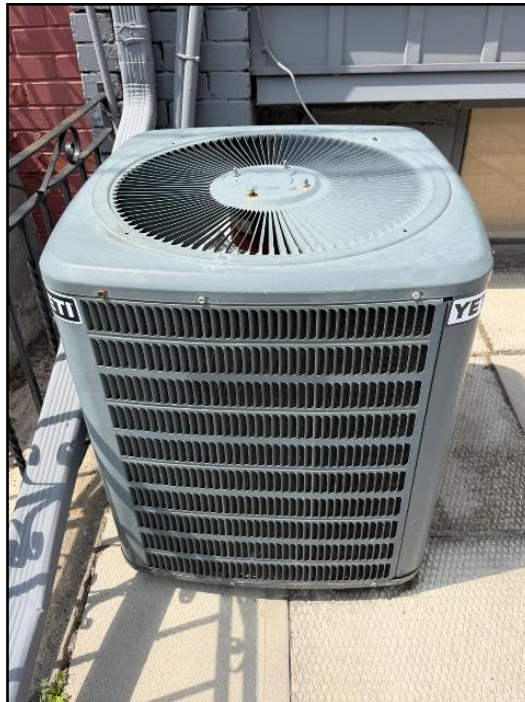
15.

- Central

Model Year 2007

Near end of life expectancy

2.5 Tons Unit

In good working condition

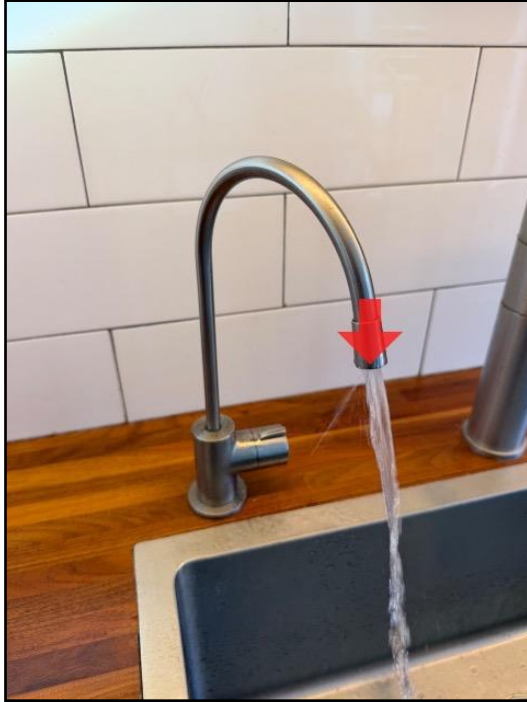
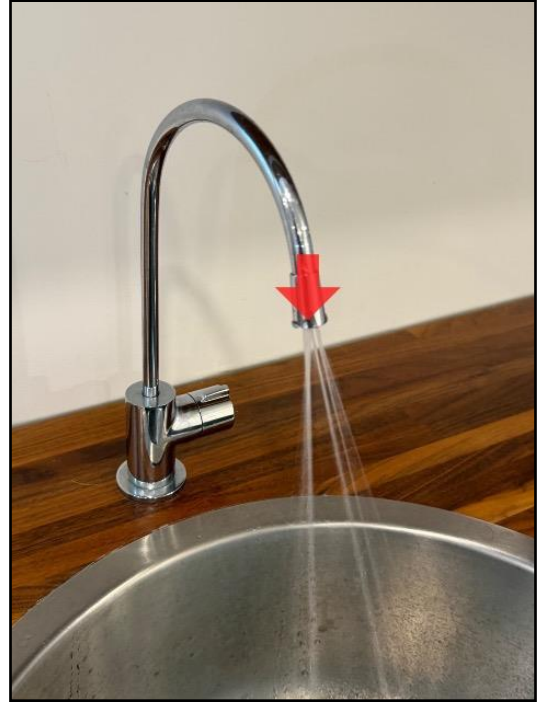
**5. Condition:** • Clogged faucet filter cap

**Location:** Kitchen Sink & Bar Sink

**Task:** Clean

**Time:** ASAP

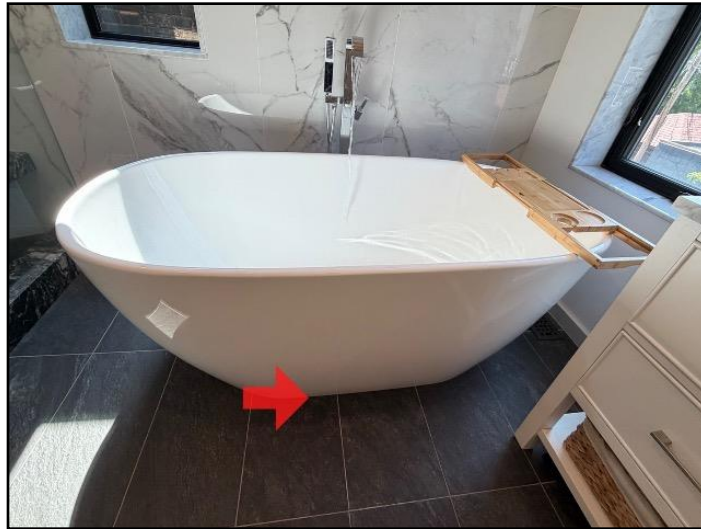
24.

**6. Condition:** • Missing silicone caulking at the bottom of the tub

**Location:** Second Floor Bathroom

**Task:** Repair

**Time:** ASAP
