INSPECTION REPORT

279 CEDARVALE AVENUE

TORONTO, ON M4C 4K3

RE: Report No. 1292 279 Cedarvale Avenue Toronto, ON M4C 4K3

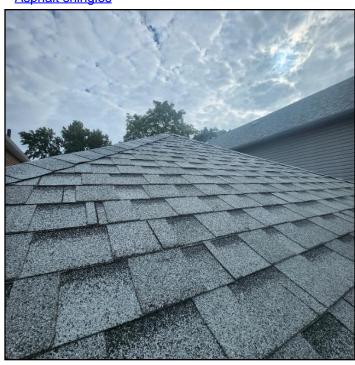
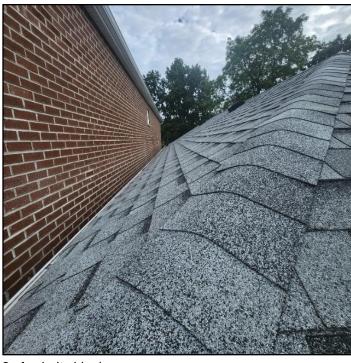
1. Asphalt shingles

2. Asphalt shingles

1. Condition: • The roof shingles are in good overall condition.

Annual inspections are recommended (on any roof) to take care of any roof damage and/or regular maintenance items (flashings/caulking).

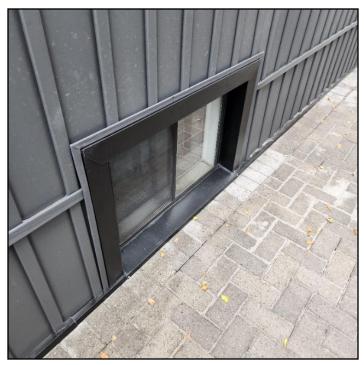
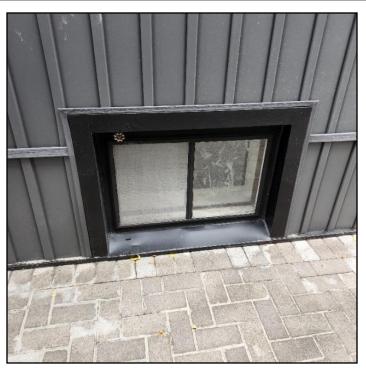
4. Condition: • No window wells are installed at basement windows. Keep windows clear from snow and monitor for any leakage. If necessary, install window wells.

Implication(s): Moisture intrusion, damage to finishes

3. No window well installed

4. No window well installed

Location: Exterior Task: Upgrade Time: If necessary 279 Cedarvale Avenue, Toronto, ON November 1, 2024

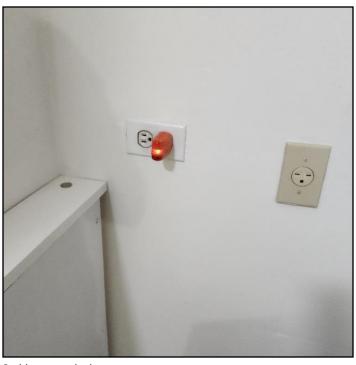
7. Condition: • <u>Ungrounded</u> Implication(s): Electric shock

8. Ungrounded

Task: Repair

Time: As soon as possible

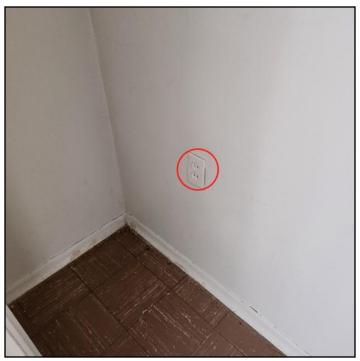
9. Condition: • According to the National Electrical Code (NEC),no outlet shall be in a cupboard, cabinet or similar enclosure without being de-energized when the door is closed. Consult a licensed electrician for further evaluation and/or repair

Location: Bedroom closet

9. Plug located in closet should be removed

Task: Remove

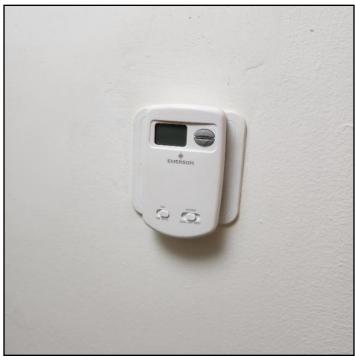
12. Condition: • Poor location

13. Poor location

Time: As soon as possible

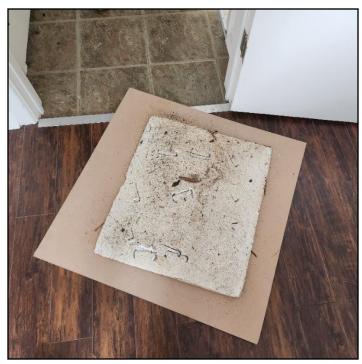
15. Condition: • Inadequate weather-stripping

17. Inadequate weather-stripping

Task: Repair

Time: As soon as possible

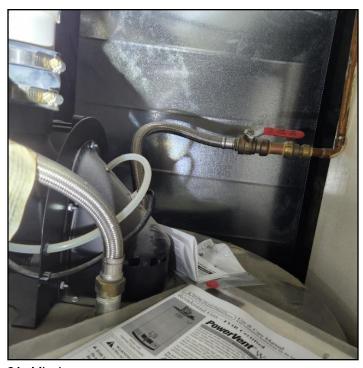
18. Condition: • Missing

Mixing valve should installed for child safety. This device can prevent scalding. Upgrade is recommended

21. Missing

Task: Upgrade

Time: As soon as practical **Cost**: Less than - \$400

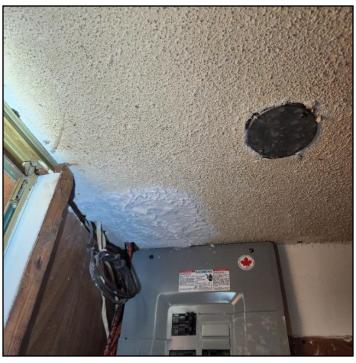
21. Condition: • Patched

No signs of active moisture at patched ceiling near electrical panel. Monitor area ongoing for any changes.

Implication(s): Chance of damage to contents, finishes and/or structure

Location: Basement Cold Room

22. Patched

Task: Monitor

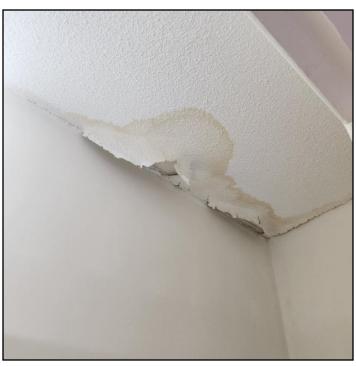
22. Condition: • Water stains

Implication(s): Chance of water damage to structure, finishes and contents

23. Water stains

Task: Repair Monitor **Time**: As soon as practical

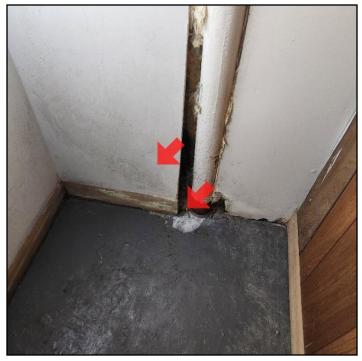
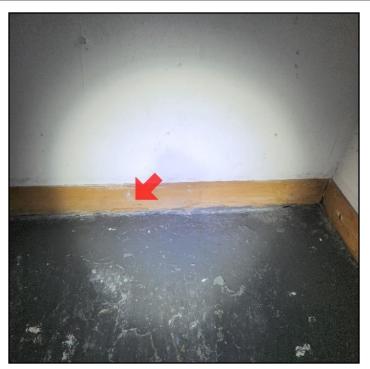
23. Condition: • Water stains

Water stains and efflorescence visible in cold room (electrical panel area) appeared to be the result of past moisture intrusion. There were no signs of active moisture at time of inspection. This area should be monitored on a on-going basis and repaired if needed.

Implication(s): Chance of water damage to structure, finishes and contents

24. Water stains

25. Water stains

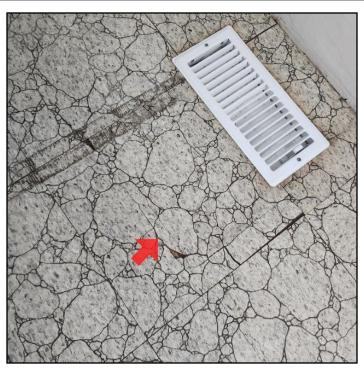
24. Condition: • <u>Tiles cracked</u> **Implication(s)**: Trip or fall hazard

26. Tiles cracked

Location: Front **Task**: Replace

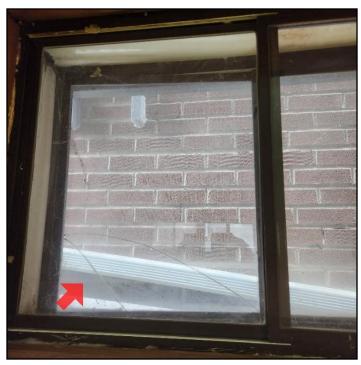
25. Condition: • <u>Cracked</u> **Implication(s)**: Physical injury

27. Cracked

Location: Basement **Task**: Replace

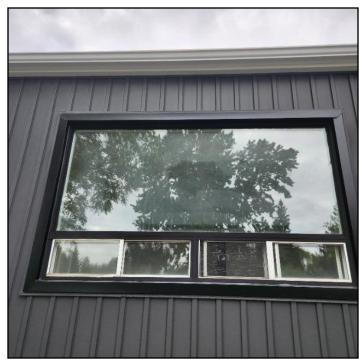
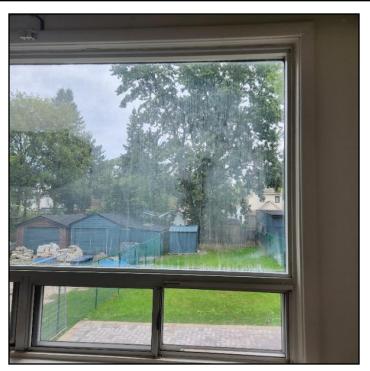
26. Condition: • Lost seal on double or triple glazing

While arguably an aesthetic issue, in most cases, eventual replacement is likely.

28. Lost seal (Exterior View)

29. Lost seal (Interior View)

Most of the time, the glass alone can be replaced; other times the whole window is replaced.

Location: Bedroom
Task: Repair or replace
Time: As soon as practical
Cost: \$500 - \$1,000

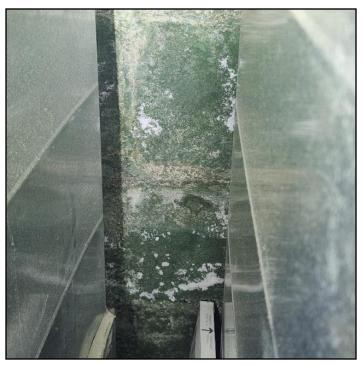
30. Condition: • Efflorescence

efflorescence visible at foundation wall behind furnace. This appears to be the result of past moisture intrusion. The moisture meter showed no levels of moisture in the foundation wall at the time of inspection. You should monitor this area for future signs of moisture intrusion in an effort to identify and correct any source of moisture.

Implication(s): Chance of water damage to structure, finishes and contents

Location: Basement Furnace Room

33. Efflorescence

Task: Monitor
Time: Ongoing

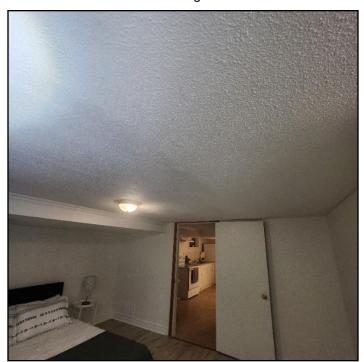
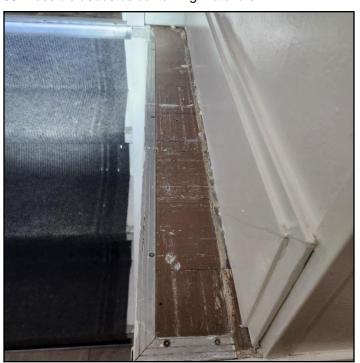
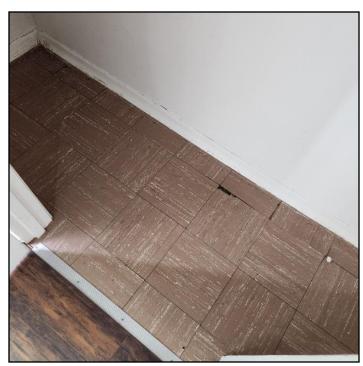
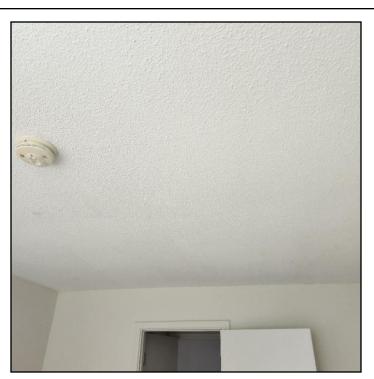
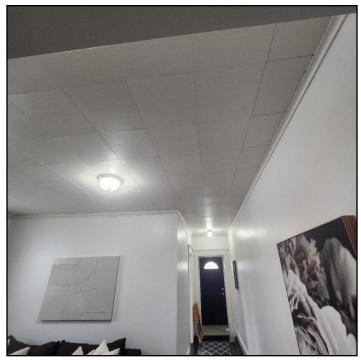
31. Condition: • Possible asbestos containing materials

Due to the age of the house, the popcorn texture, ceiling and floor tiles visible throughout the home may contain asbestos and should be tested prior to any renovation. Consult an environmental specialist for further evaluation and/or repair.

Implication(s): Health hazard

34. Possible asbestos containing materials

36. Possible asbestos containing materials

35. Possible asbestos containing materials

37. Possible asbestos containing materials

38. Possible asbestos containing materials

39. Possible asbestos containing materials

40. Possible asbestos containing materials

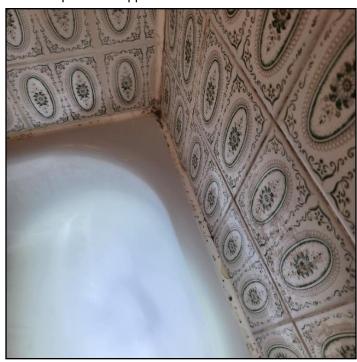
32. Condition: • Mold

Apparent mold noted in basement bathroom and furnace room. Inspector recommends removing caulking and repalce with new caulking.

Implication(s): Health hazard

41. Mold at tub caulking

42. Mold at furnace room wall

Furnace room walls can be cleaned with a mold solution and/or painted with a mold resistant paint or you may want to remove drywall and replace. Consult a licensed contractor for repair

Task: Repair

Time: As soon as possible **Cost**: Depends on approach
