Toronto, Ontario M9B 6L1

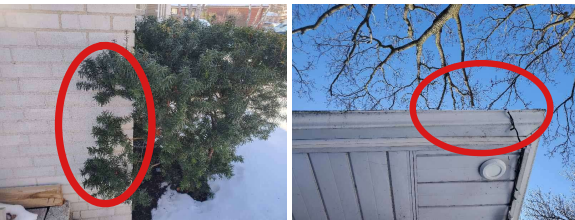
Lots and Grounds

- Allow for good light and air circulation between plantings and the foundation;
- Trees that will reach a height of 10m (30') or more should be minimum of 5m (15') from the foundation;
- Shrubs should be a minimum of 1.8m (6') from the foundation.
- Keep at least 20cm (8") of foundation height below the siding or brick exposed (not covered with soil or stored materials).

Vegetation to close to the external wall. Recommend pruning to prevent moisture transfer. This is considered normal maintenance.

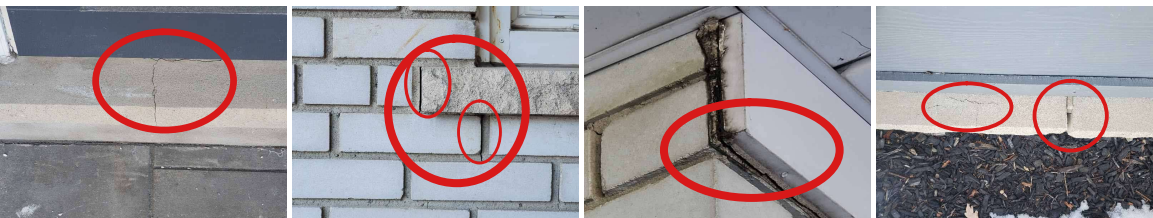
2. Entire Exterior Surface Type: Concrete, Brick.

Recommend filling all cracks/gaps/holes to prevent rainwater from entering and deteriorating the surrounding materials. This is considered normal maintenance.

Recommend replacing the mortar within the concrete sills. Rainwater will enter and can deteriorate the surrounding materials. This is considered normal maintenance.

There are signs of waterproofing. This helps a prevent rain water from leaking through the foundation.

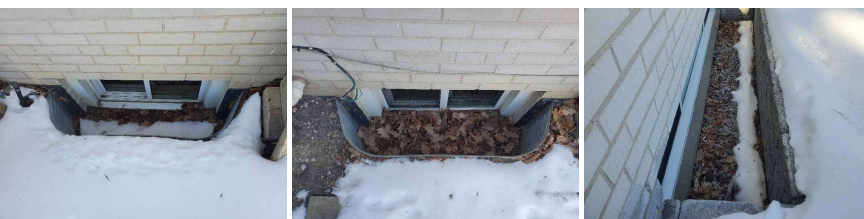
4. Basement Windows: Sliders .

5. Window Wells: Metal, Flagstone.

Recommend using a window well cover. This will help prevent rainwater from entering.

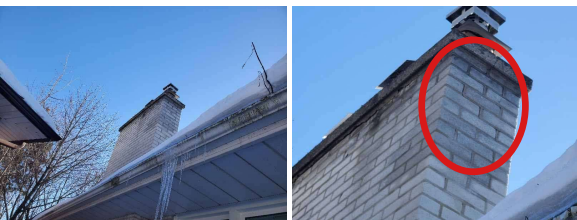
8. East Chimney Chimney: Brick.

Inspect brick chimneys annually for loose or missing mortar. Maintenance of brick and mortar (ie. tuckpointing) is normally required every few years to protect the chimney structure. Consult a qualified masonry specialist, with experience in brick chimney repair.

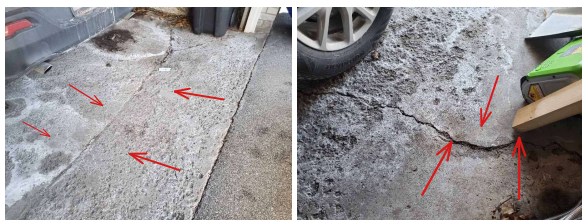
10. Attached Garage Floor/Foundation: Poured concrete.

Unable to inspect due to homeowners belongings being in the way.

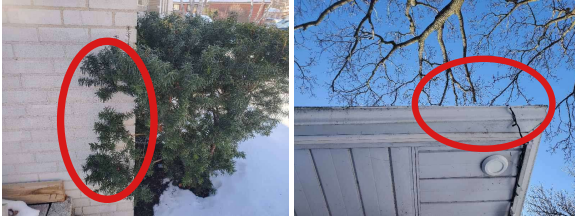
5. Acceptable **Grading:** Minor slope.

- Allow for good light and air circulation between plantings and the foundation;
- Trees that will reach a height of 10m (30') or more should be minimum of 5m (15') from the foundation;
- Shrubs should be a minimum of 1.8m (6') from the foundation.
- Keep at least 20cm (8") of foundation height below the siding or brick exposed (not covered with soil or stored materials).

Vegetation: (continued)

considered normal maintenance.

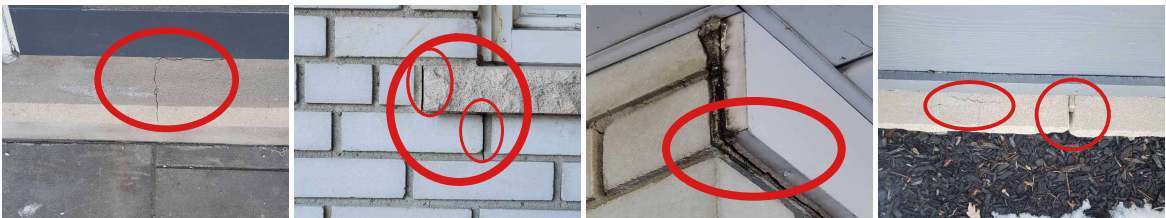
1. Marginal **Type:** Concrete, Brick.

Recommend filling all cracks/gaps/holes to prevent rainwater from entering and deteriorating the surrounding materials. This is considered normal maintenance.

Recommend replacing the mortar within the concrete sills. Rainwater will enter and can deteriorate the surrounding materials. This is considered normal maintenance.

There are signs of waterproofing. This helps a prevent rain water from leaking through the foundation.

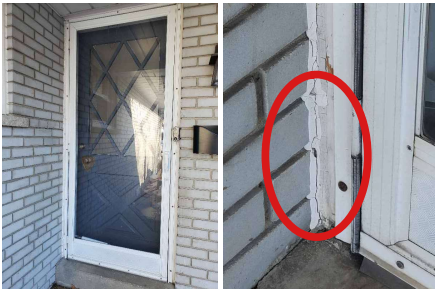
6. Marginal

Entry Doors: Metal., Wood.

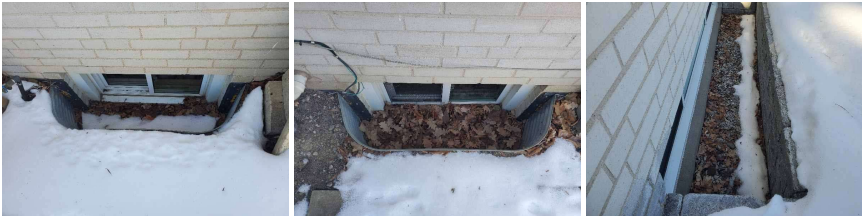
10. Marginal **Basement Windows:** Sliders .

11. Marginal **Window Wells:** Metal, Flagstone.

Recommend using a window well cover. This will help prevent rainwater from entering.

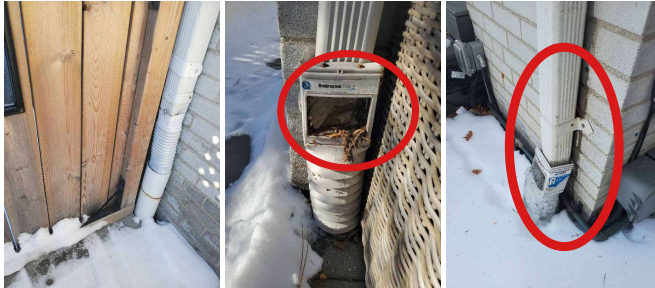
12. Marginal **Downspouts:** Aluminum.

Remove the debris found within the open downspout filter.

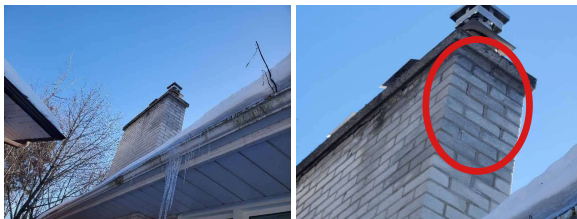
13. Acceptable **Leader/Extension:** Aluminum.

14. Marginal **Chimney:** Brick.

Inspect brick chimneys annually for loose or missing mortar. Maintenance of brick and mortar (ie. tuckpointing) is normally required every few years to protect the chimney structure. Consult a qualified masonry specialist, with experience in brick chimney repair.

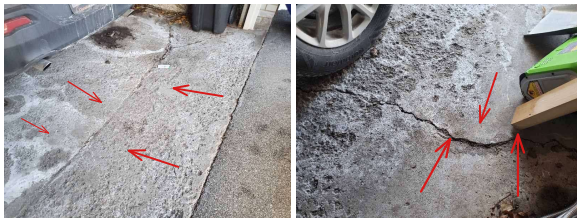
Garage (Continued)

10. Marginal **Floor/Foundation:** Poured concrete.

Unable to inspect due to homeowners belongings being in the way.
