# Your Inspection Report

266 Roselawn Ave  
Toronto, ON M4R 1E9

**PREPARED BY:**  
Jonathan Dube, RHI

RE: Report No. 96359  
266 Roselawn Ave  
Toronto, ON  
M4R 1E9

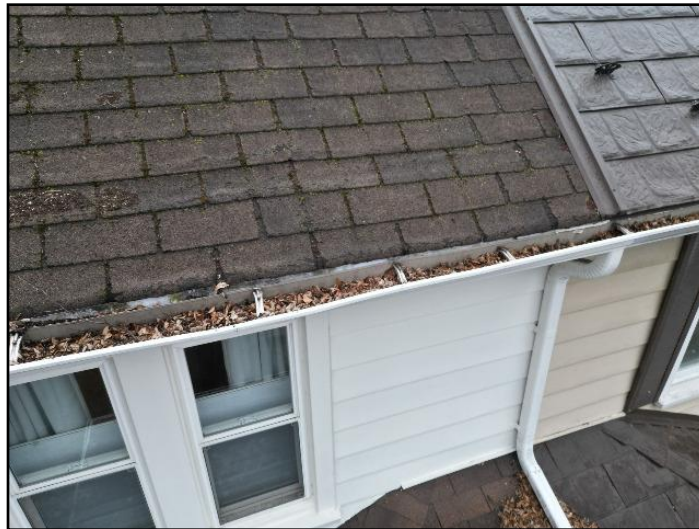
**Condition:** • At or near end of life

*Deteriorating shingles*

**Task:** Replace

**Time:** Less than 1 year

**Cost:** \$8,000-\$16,000

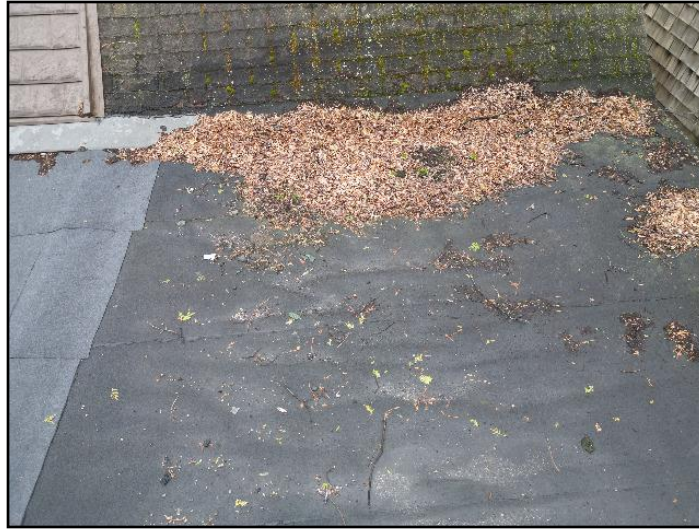
**Condition:** • Debris/moss

*Debris/moss*

**Task:** Clean

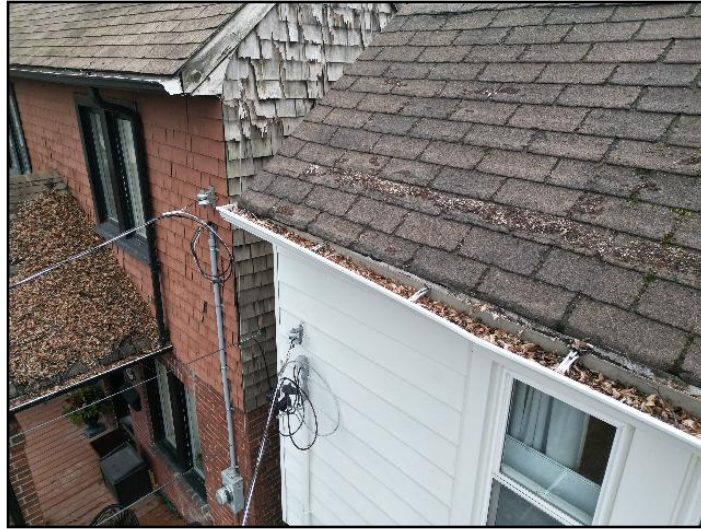
Condition: • [Clogged](#)

Location: Various

*Clogged*

Task: Clean

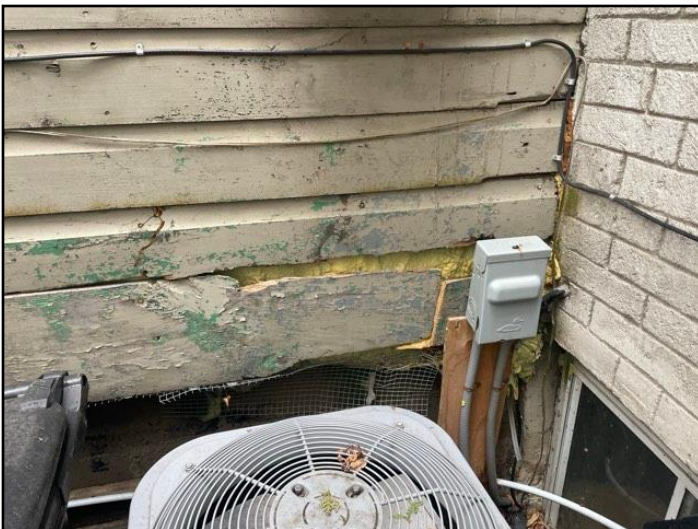
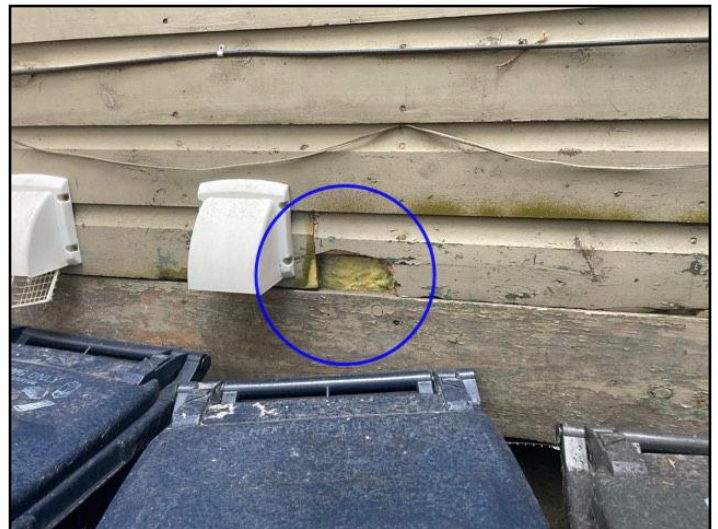
**Condition:** • [Cracked, split or broken](#)

**Location:** Rear

*Cracked, split or broken*

**Task:** Repair/Replace

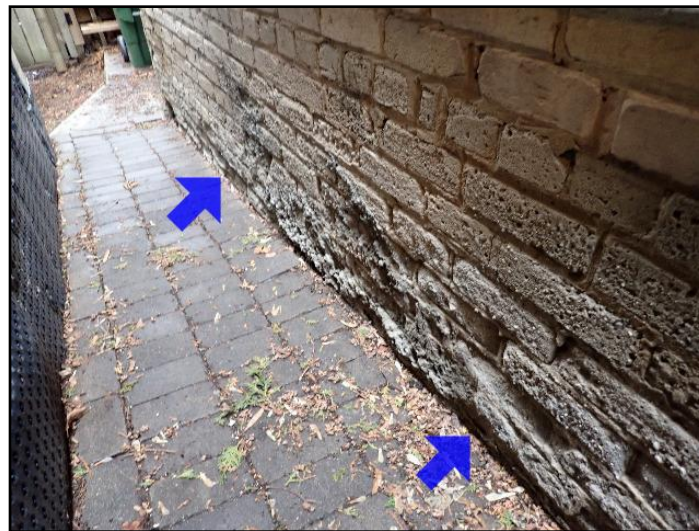
**Condition:** • Masonry deterioration

This is typically caused by snow clearing activities and/or rain over shooting the gutters.

**Location:** Left side

*Masonry deterioration*

**Task:** Parging/Repair

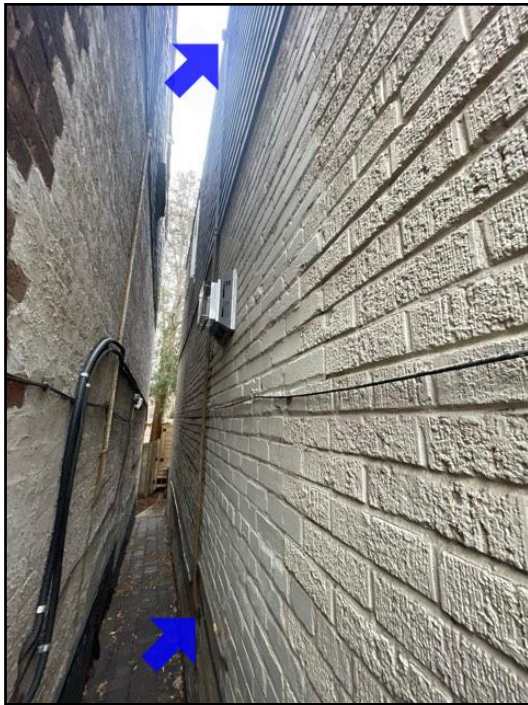
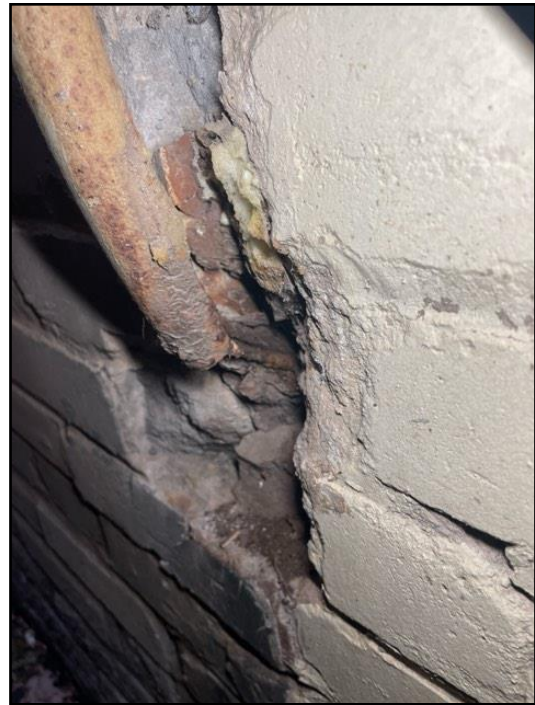
**Condition:** • Unsealed penetrations  
**Location:** Left side at abandoned service entrance.  
**Task:** Improve/patch  
**Time:** As soon as practical

*Left side*

*Unsealed gap*

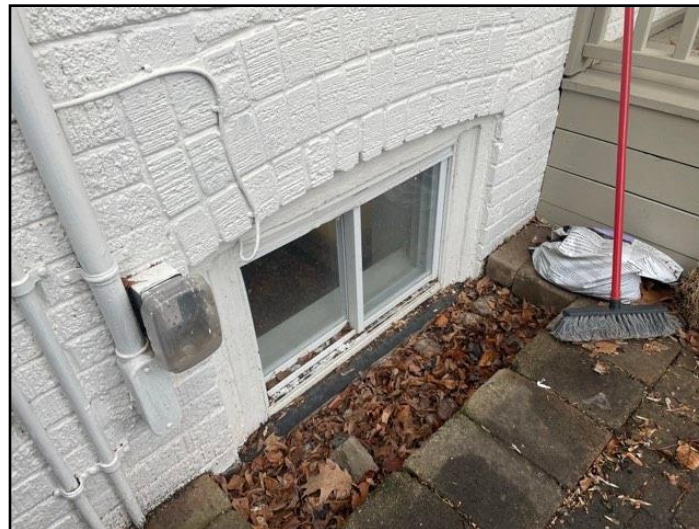
**Condition:** • Window close to grade in well

**Location:** Front

*Window close to grade in well*

**Task:** Improve

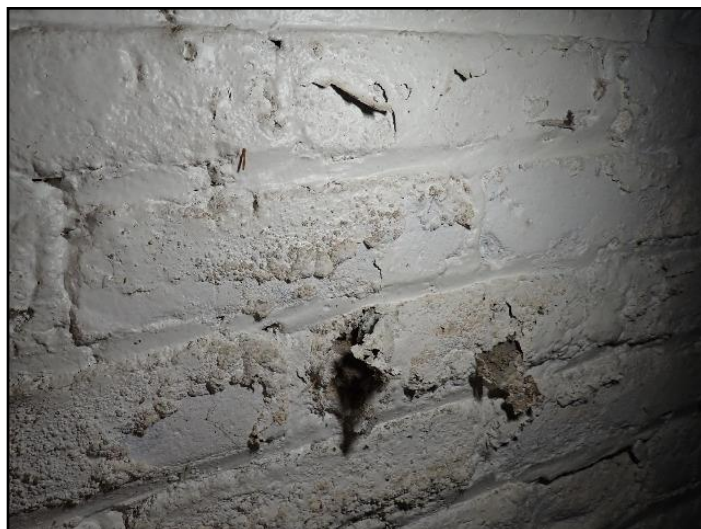
**Condition:** • [Efflorescence](#)

This is typical of brick foundations of this age.

**Location:** Utility room

*Efflorescence / Peeling paint*

**Task:** Ensure gutters and downspouts are working properly and exterior grade slopes down away from the home. Monitor the area for evidence of moisture, particularly in the spring when snow melts or after heavy or persistent rains.

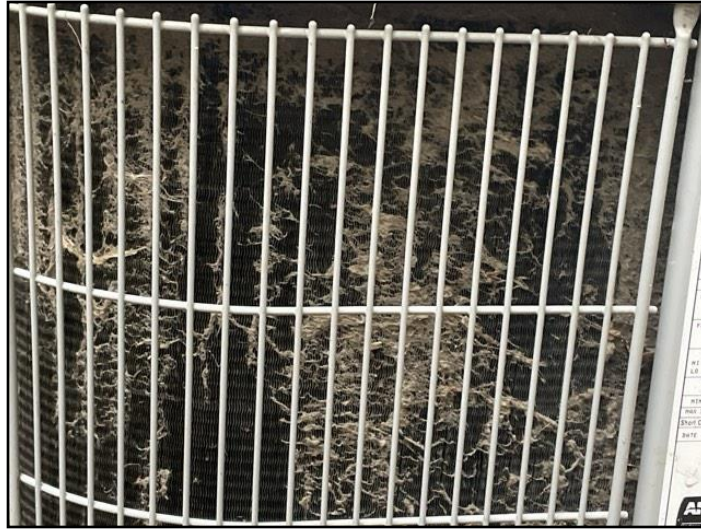
**Condition:** • [Dirty](#)

*Dirty*

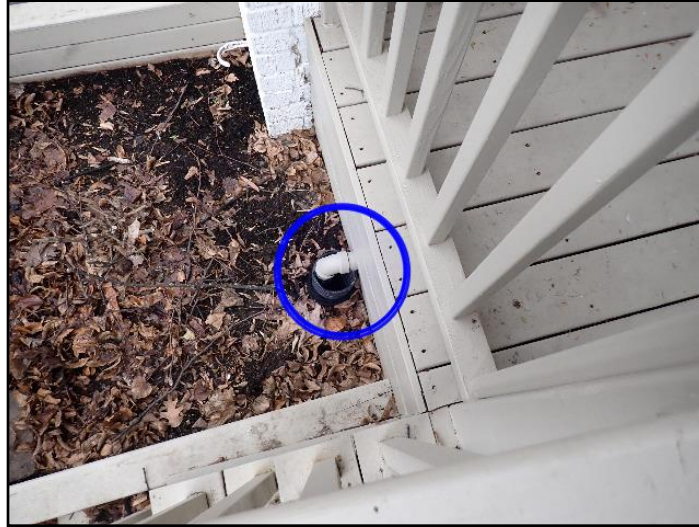
**Condition:** • [Discharges less than 6 feet from home](#)

Below grade

*Discharges less than 6 feet from home*

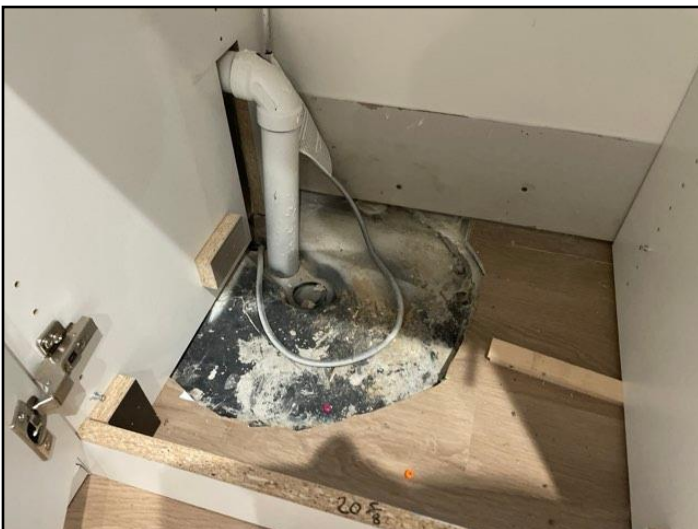
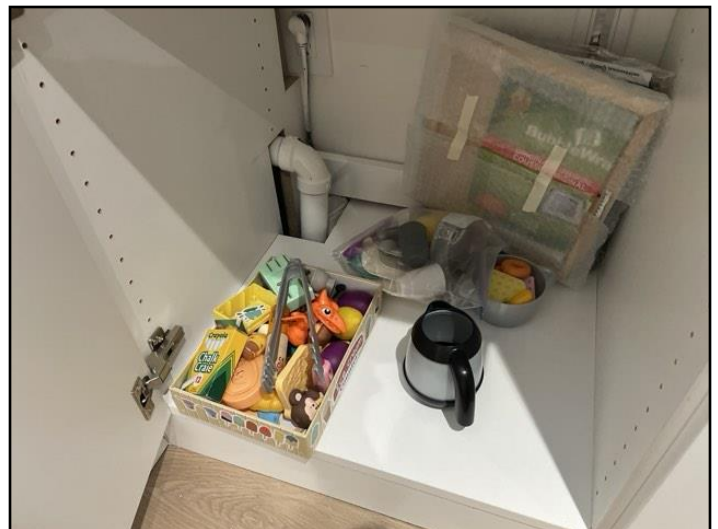
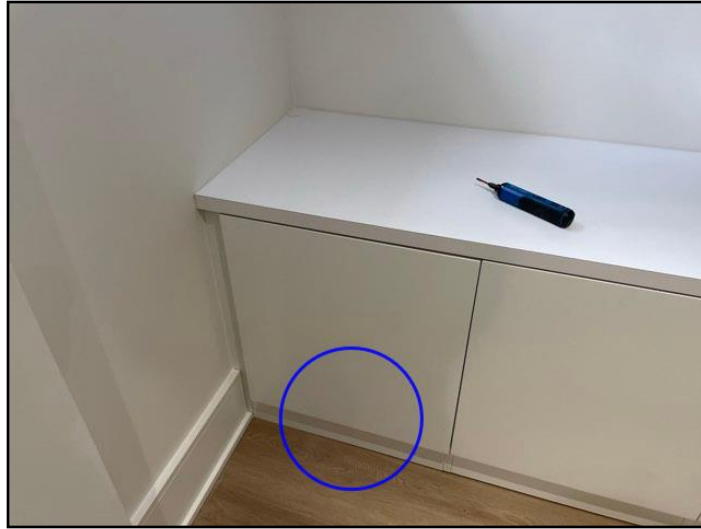
**Condition:** • Unable to remove lid to test sump pump. Ideally it should remain easily accessible for regular maintenance and testing.

*Sump*

*Located below cabinet base*

*In basement cabinet*

**Task:** Improve access, Test pump

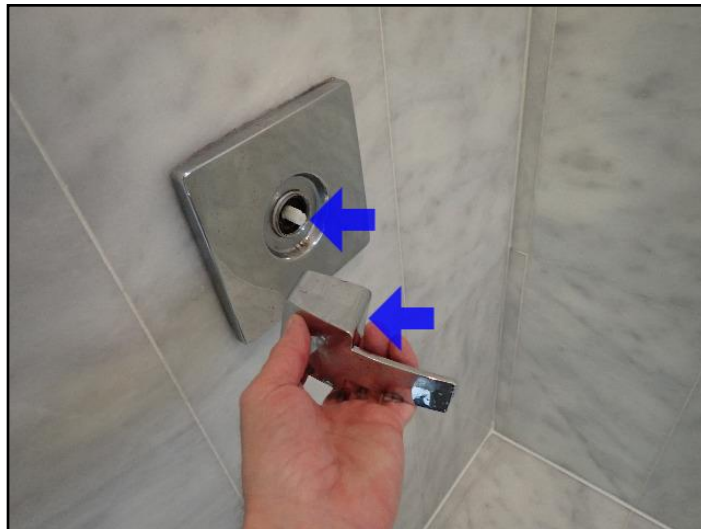
**Condition:** • Loose faucet

Handle is loose/broken

*Loose faucet*

**Task:** Repair/replace
