Your Inspection Report

140 Jones Ave
Toronto, ON M4M 3A1

PREPARED BY:
Gordon Mathieu, B.Sc Elec Eng., RHI

RE: Report No. 96443, v.2
140 Jones Ave
Toronto, ON
M4M 3A1

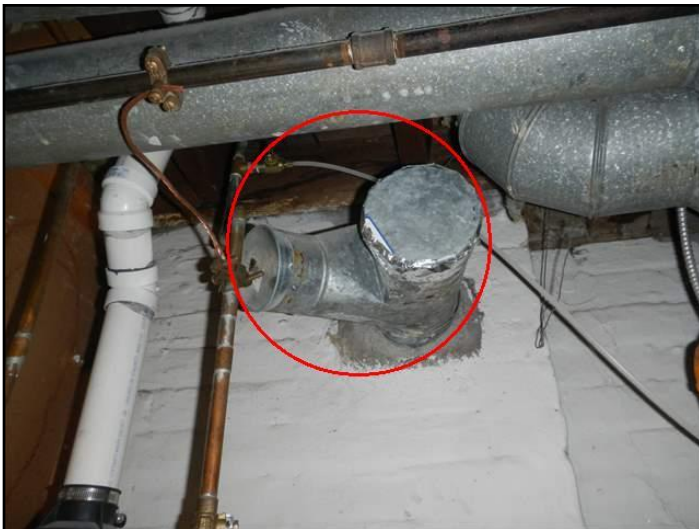
Rear: no longer in use by this semi.

Blocked off in the basement
