INSPECTION REPORT

57 GRACEY BOULEVARD

Inspection Date: Tuesday, July 8, 2025

Prepared by: Anthony Veltri, CPI

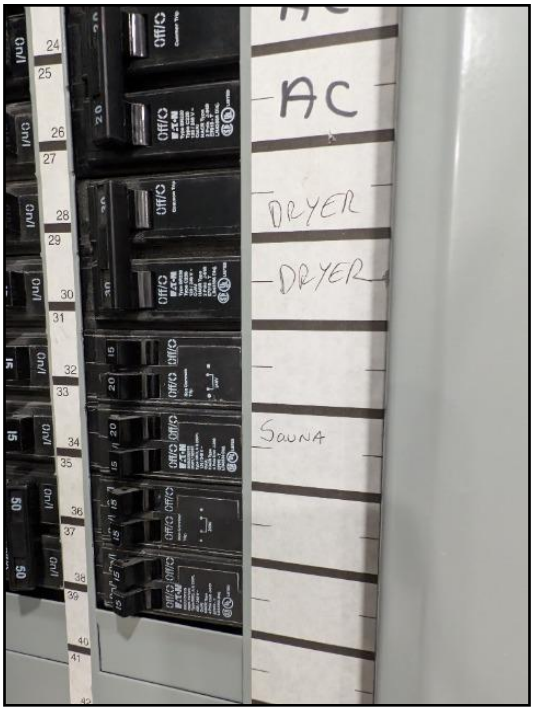
Condition: • Recommend having a qualified specialist further evaluate the electrical issues noted and correct/repair/improve if or as required.

5. *Panel is full - further evaluate*

6. *Improve circuit label*

7. *Repair loose plug in bathroom*

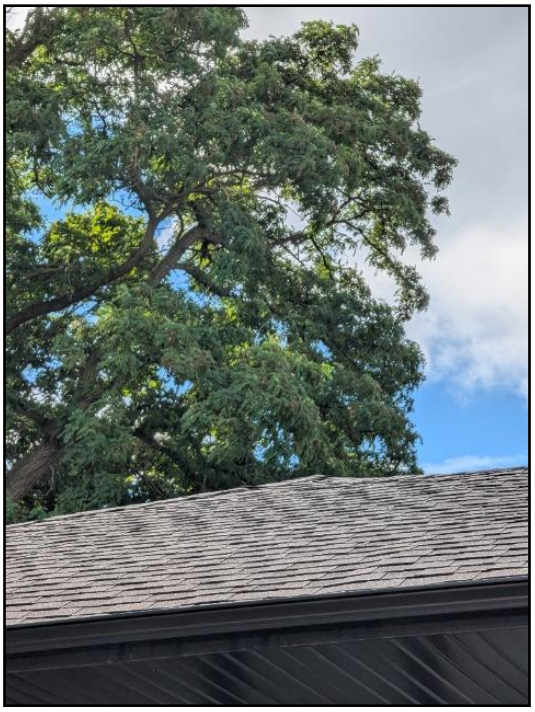
14. *Asphalt shingles*

1. Condition: • The roof shingles are in good overall condition.
Annual inspections are recommended (on any roof) to take care of any roof damage and/or regular maintenance items (flashings/caulking).

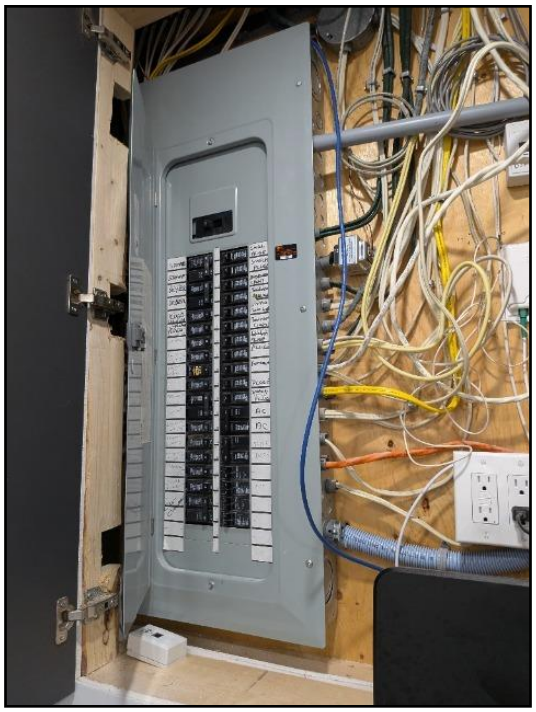
15. *200 Amps (240 Volts)*

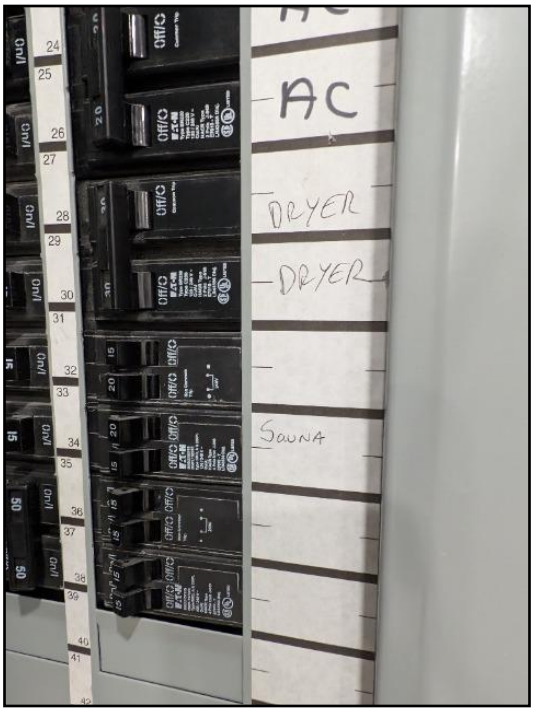
6. Condition: • Recommend having a qualified specialist further evaluate the electrical issues noted and correct/repair/improve if or as required.

20. *Panel is full - further evaluate*

21. *Improve circuit label*

22. *Repair loose plug in bathroom*

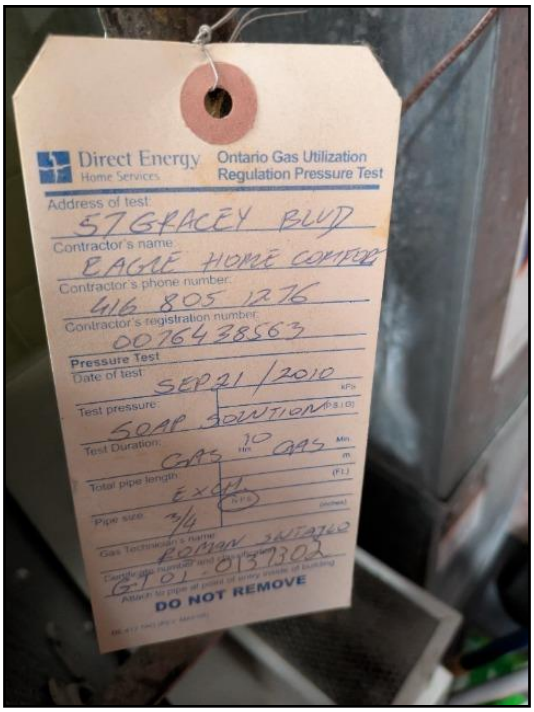
23. *Furnace*

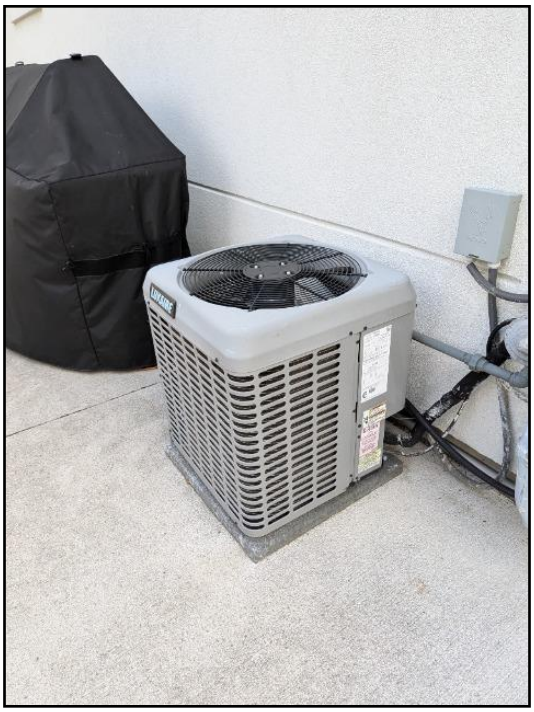
28. *Air cooled condenser*

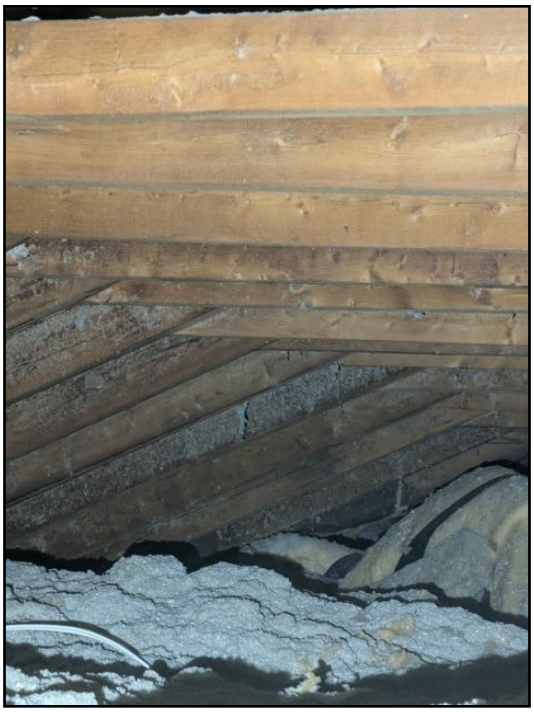
30. *Attic Photos*
