32 Mendota Rd Toronto, ON M8Y 1E8

INSPECTION DATE: Sunday, November 7, 2021

Excellence in home inspection

RE: Report No. 79516 32 Mendota Rd Toronto, ON M8Y 1E8

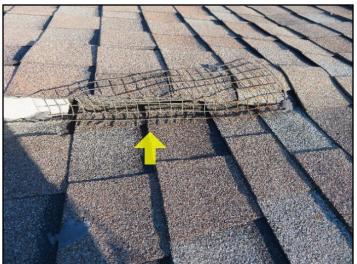
Condition: • Animal activity or damage (screens added to flashings/roof vents) Task: Monitor / repair Time: Ongoing / regular maintenance

Animal activity or damage (screens added to ...

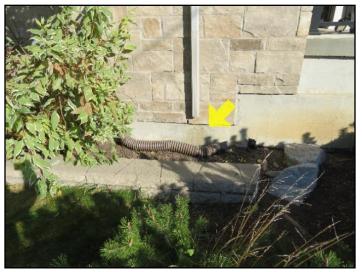
Condition: • <u>Connections loose</u> Location: Front Left Side Task: Re - connect Cost: Minor

Connections loose

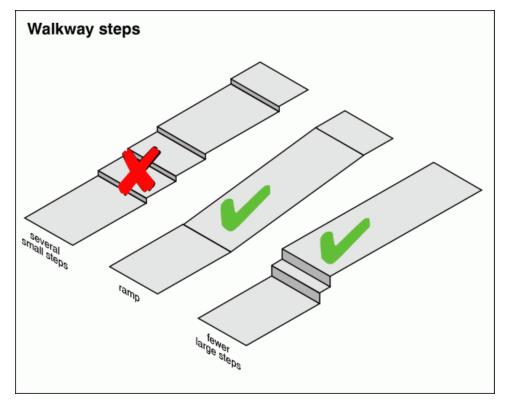
Condition: • <u>Uneven (trip hazard)</u> Even the level difference between the garage and the driveway Task: Correct Time: Discretionary Cost: Minor

Uneven (trip hazard)

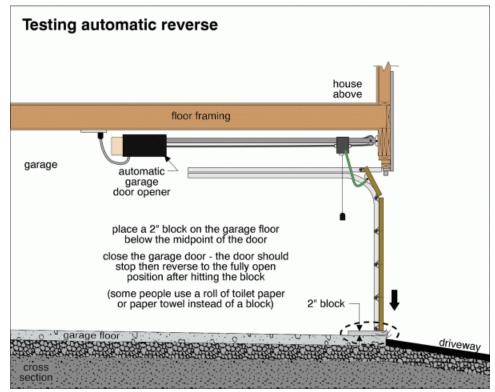
Condition: • Fails to auto reverse Task: Adjust / Repair Time: If necessary

Garage Door Operators: • The auto reverse mechanism on your garage door opener should be tested monthly. The door should also reverse when it meets reasonable resistance, or if the 'photo eye' beam is broken.

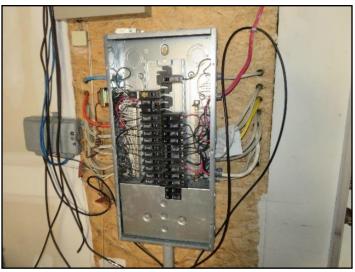
<u>Breakers - garage</u>

Breakers - garage

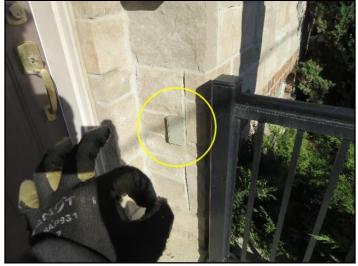
The reset button of all GFCI sockets at the rear exterior wall is located at the GFCI socket at the front exterior wall.

Reset button near front door

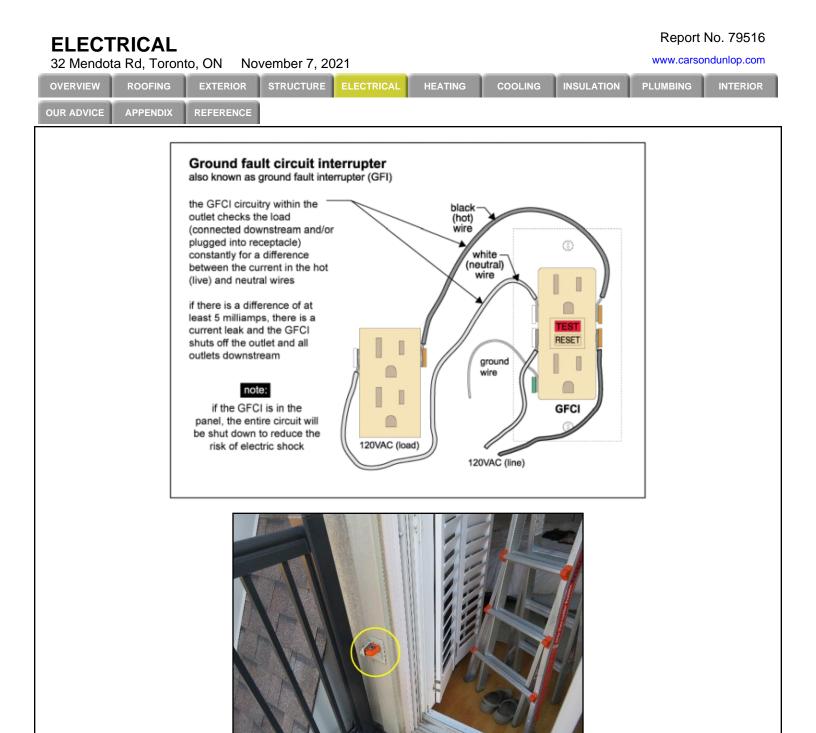
Condition: • <u>No GFCI/GFI (Ground Fault Circuit Interrupter)</u> Location: Third Floor Deck Task: Correct Time: As soon as possible Cost: Minor

No GFCI/GFI (Ground Fault Circuit...

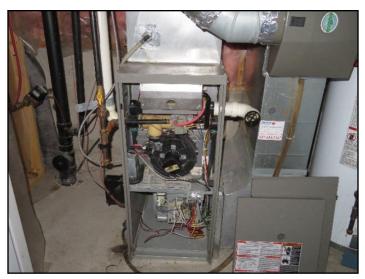
• Furnace

Furnace

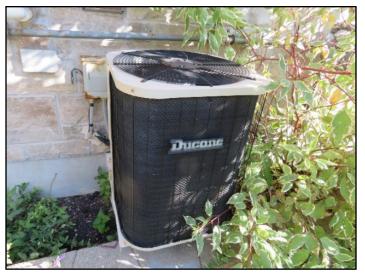
• <u>Air cooled</u>

Air cooled

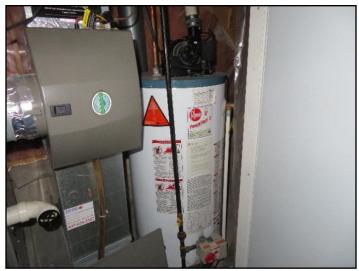
Induced draft

Water heater fuel/energy source: • Gas Water heater tank capacity: • 189 liters Water heater approximate age: • 15 years Water heater typical life expectancy: • 10 to 15 years Waste and vent piping in building: • Plastic Pumps: • Sump pump Floor drain location: • Utility room

Condition: • Near end of life expectancy Task: Replace Time: When necessary Cost: \$1,000 - \$3,000 (Depends on several variables)

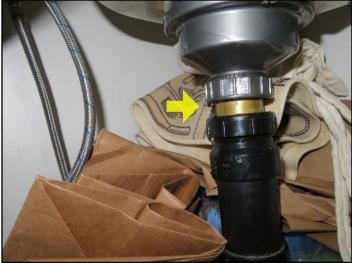
Condition: • Leak Location: First Floor Kitchen Task: Repair Time: As soon as possible Cost: Minor

Leak

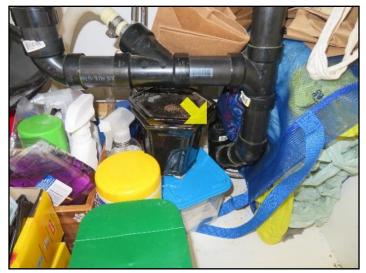
Condition:
 Not visible

Not visible

Task: Monitor for drain performance

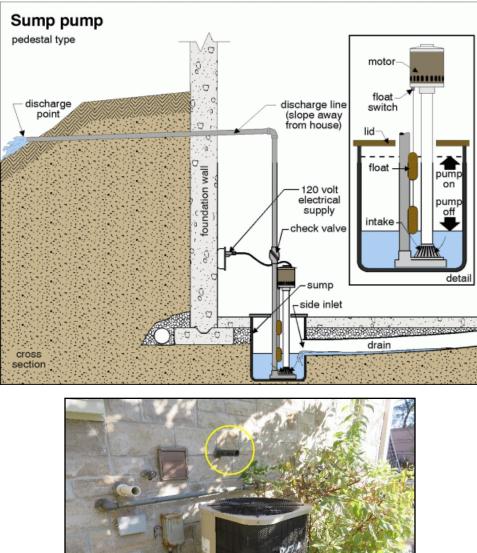
Condition: • Discharge pipe problems

Discharge point too close to the air conditioner. Relocate the discharge point further away from the air condition unit.

Discharge pipe problems

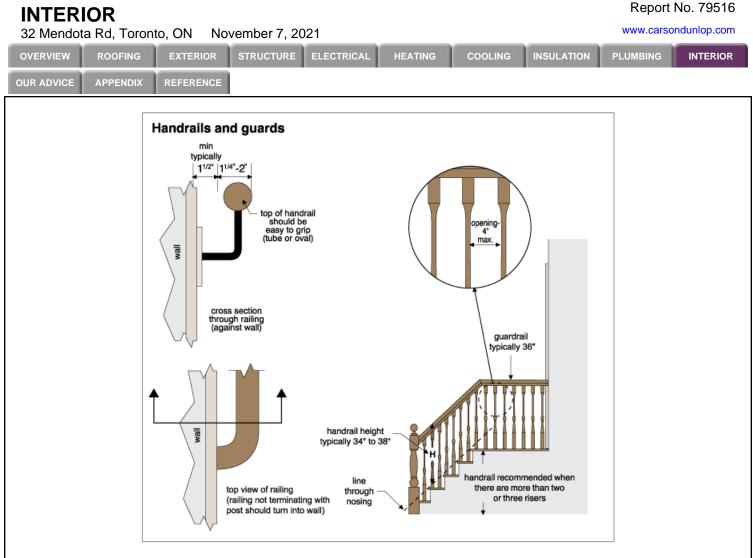
STAIRS \ Handrails and guards Condition: • Missing Railing missing a t top of wall. Fall hazard for children. Location: First Floor Task: Provide Time: As soon as practical
