INSPECTION REPORT

277 CEDARVALE AVENUE

Inspection Date: Thursday, December 5, 2024

RE: Report No. 1363 277 Cedarvale Avenue Toronto, ON M4C 4K3

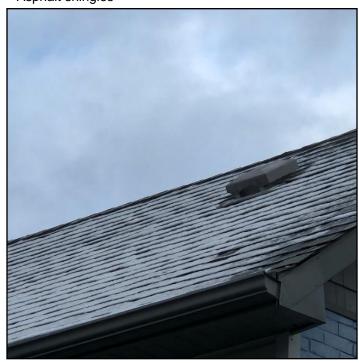
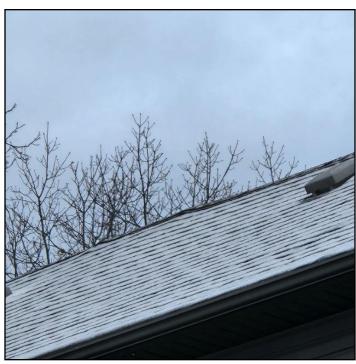
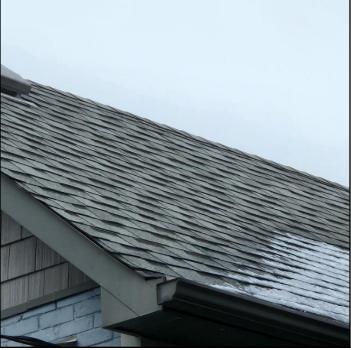
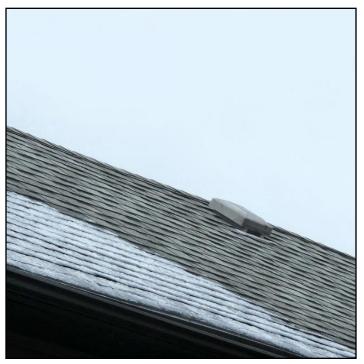
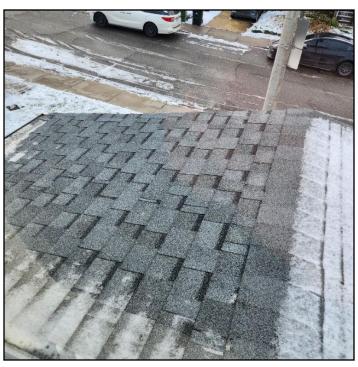
1. Asphalt shingles

3. Asphalt shingles

4. Asphalt shingles

5. Asphalt shingles

1. Condition: • The roof shingles are in good overall condition.

Annual inspections are recommended (on any roof) to take care of any roof damage and/or regular maintenance items (flashings/caulking).

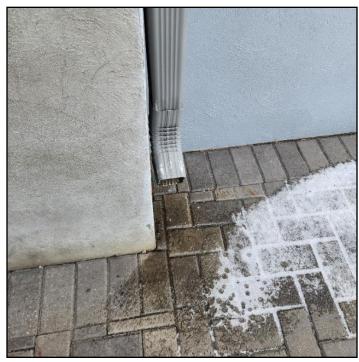
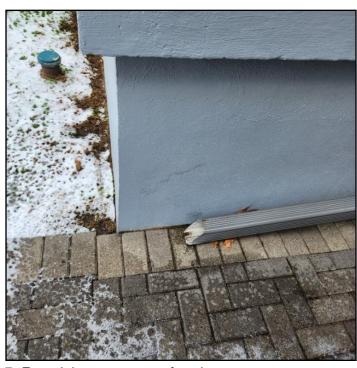
2. Condition: • Discharge locations:

It is always preferable to discharge the water as far away from the house as practical. At the same time, they should be located where they will not cause erosion, be a trip hazard or create an ice problem.

6. Extend downspout away from home

7. Extend downspout away from home

Time: As soon as practical

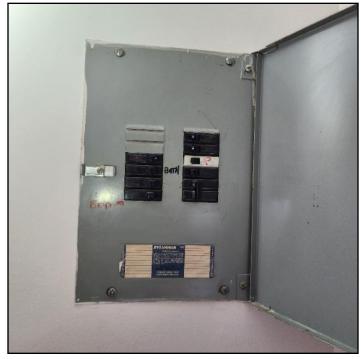
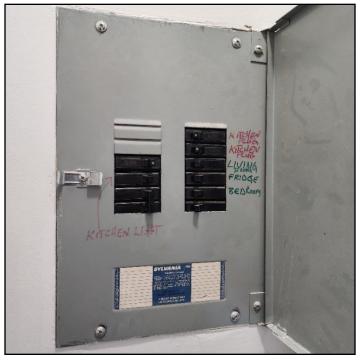
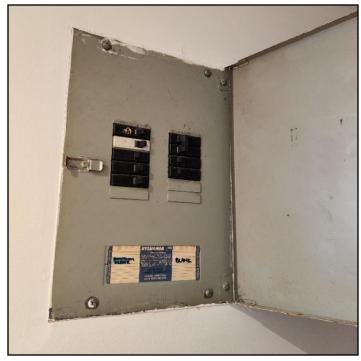
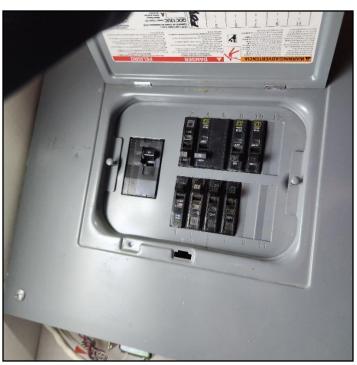
Each floor has been designated 60amps

8. 60 Amps

9. 60 Amps

10. 60 Amps **11.** 60 Amps

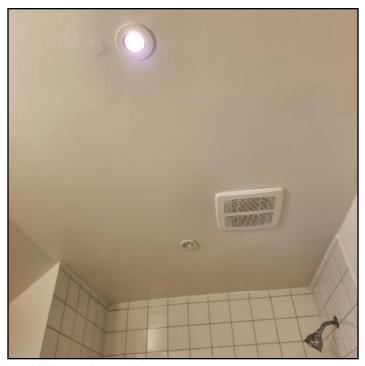
14. Light requires replacement

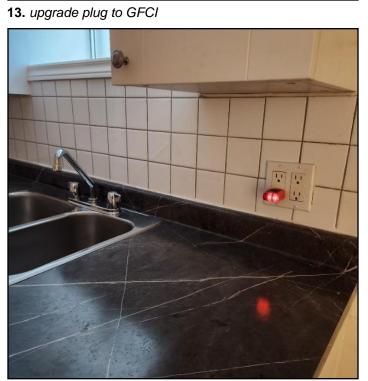
12. upgrade plug to GFCI

15. upgrade plug to GFCI

5. Condition: • Recommend having a qualified specialist further evaluate the electrical issues noted and correct/repair/improve if or as required.

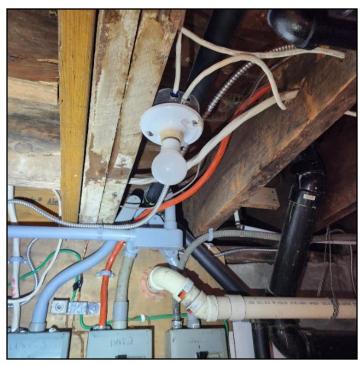
16. install a protective lens or cage at light

17. install a protective lens or cage at light

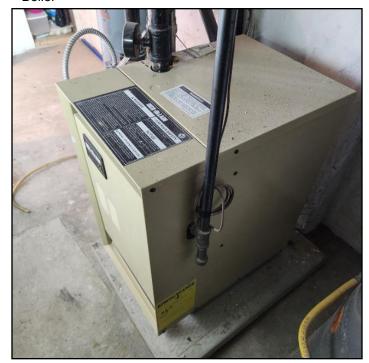
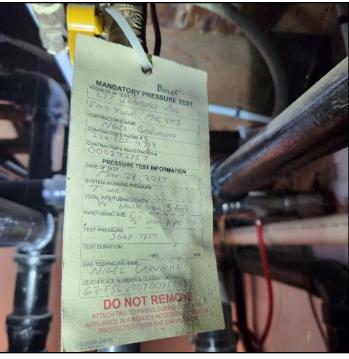
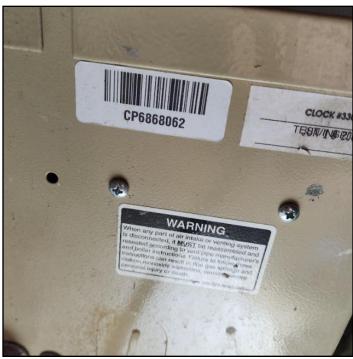
18. Boiler

19. Boiler installation tag

20. Boiler Serial Number

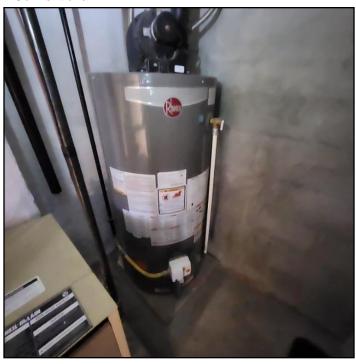
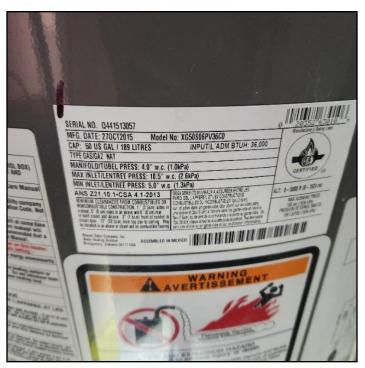
25. Conventional Hot water Tank

26. Hot water tank data plate

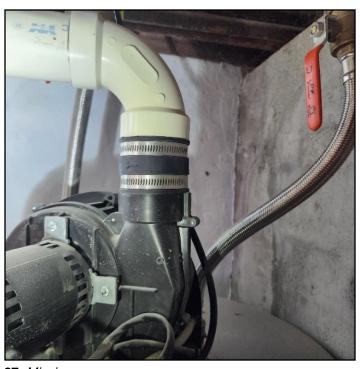
12. Condition: • Missing **Implication(s)**: Scalding

27. Missing

Task: Upgrade **Time**: Discretionary

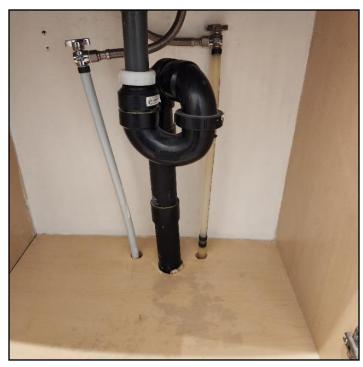
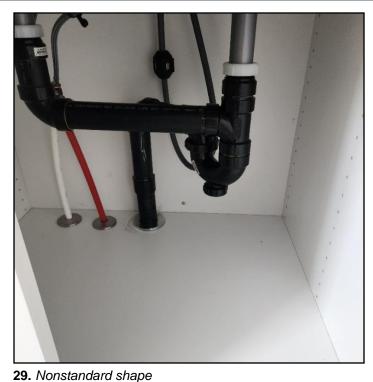
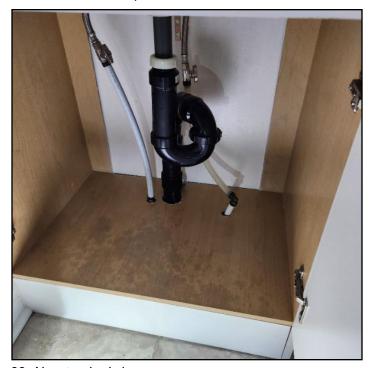
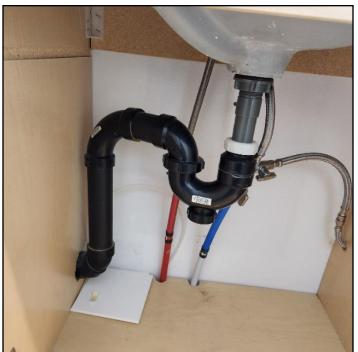
14. Condition: • Nonstandard shape or material

S-trap configuration noted at sink drains. S traps can allow sewer gases to enter the home due to siphonage. Consult a licensed plumber for repair

28. Nonstandard shape

30. Nonstandard shape

31. Nonstandard shape

Location: Various **Task**: Improve

Time: As soon as possible

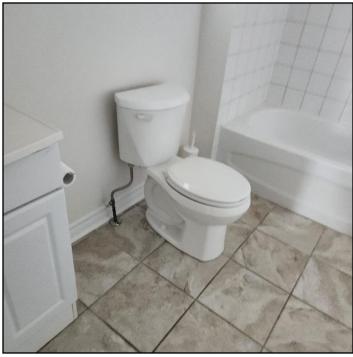
15. Condition: • Loose

Implication(s): Chance of water damage to structure, finishes and contents | Sewage entering the building |

Possible hidden damage **Location**: Third Floor

32. Loose

Task: Repair
Time: Immediate

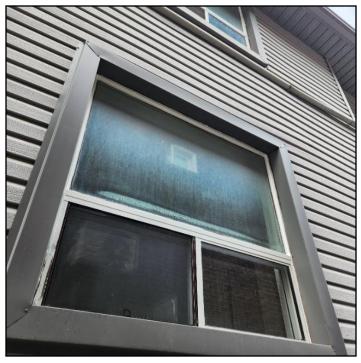
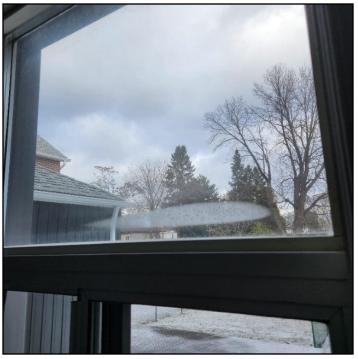
17. Condition: • Lost seal on double or triple glazing **Implication(s)**: Shortened life expectancy of material

33. Lost seal on double glazing

34. Lost seal on double glazing

Location: First Floor Task: Repair or replace Time: As soon as possible
