# INSPECTION REPORT

For the Property at:  
**125 MARIA STREET**  
TORONTO, ON M6P 1W5

RE: Report No. 5961  
125 Maria Street  
Toronto, ON  
M6P 1W5

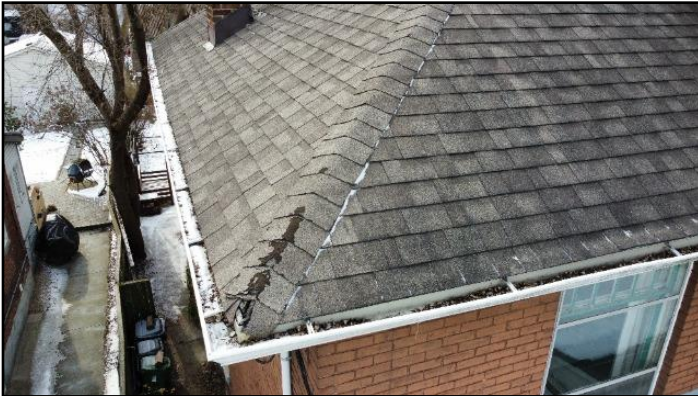
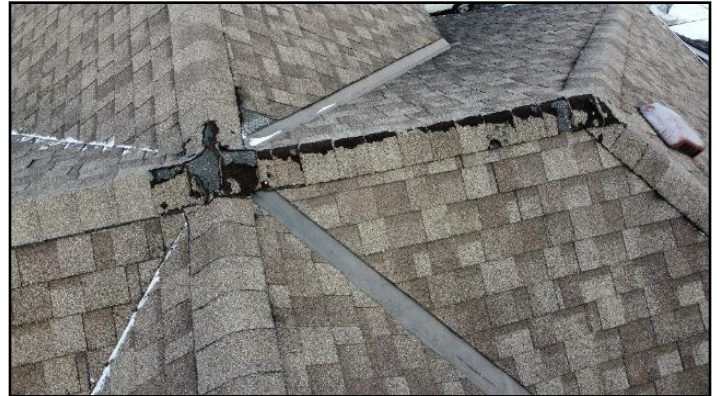
1. **Condition:** • [Missing, loose or torn](#)

**Implication(s):** Chance of water damage to structure, finishes and contents

22. *Missing, loose or torn*

23. *Missing, loose or torn*

**Task:** Repair

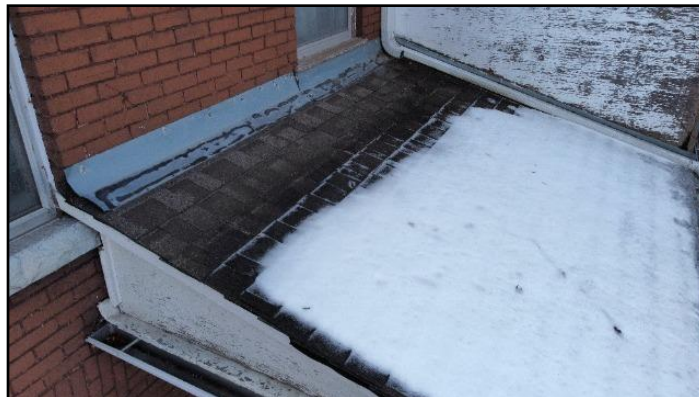
4. **Condition:** • [Damage, loose, open seams, patched](#)

**Implication(s):** Chance of water damage to structure, finishes and contents

24. *Damage, loose, open seams, patched*

**Task:** Correct

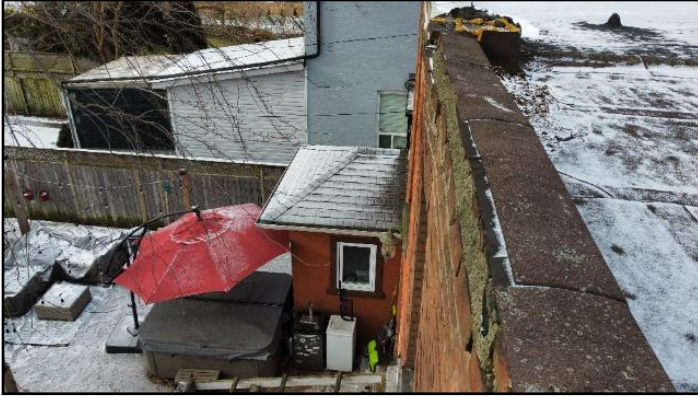
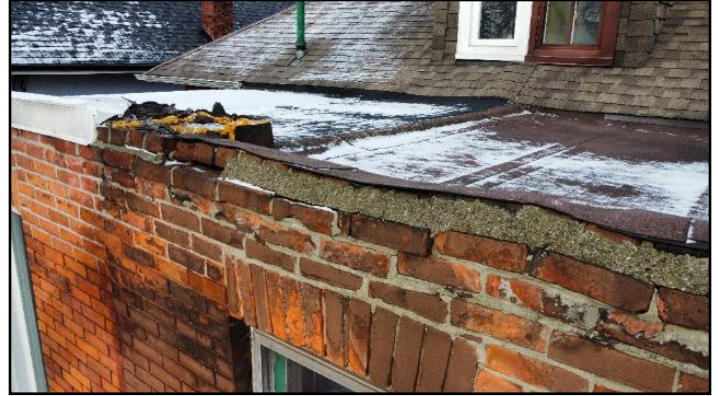
5. **Condition:** • Missing

25. Missing

26. Missing

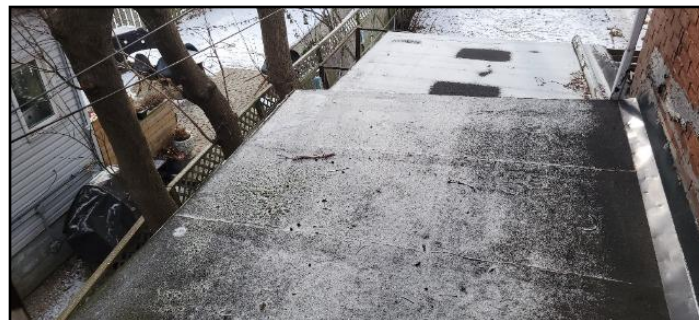
30.

**7. Condition:** • No Guardrail, handrail on flat room.

**Task:** Provide

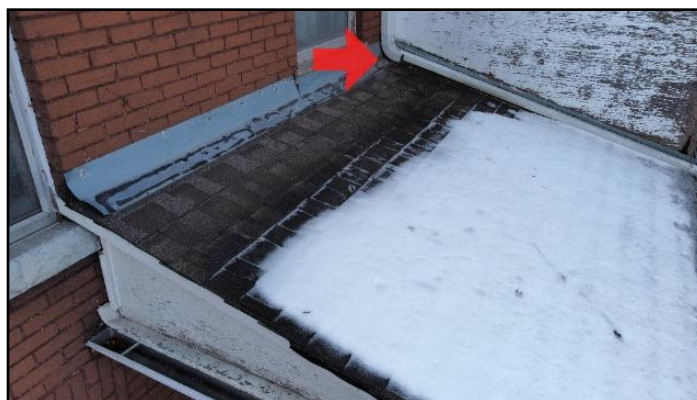
9. Condition: • [Discharge onto roofs](#)

Implication(s): Chance of water damage to structure, finishes and contents

31. Discharge onto roofs

Task: Correct

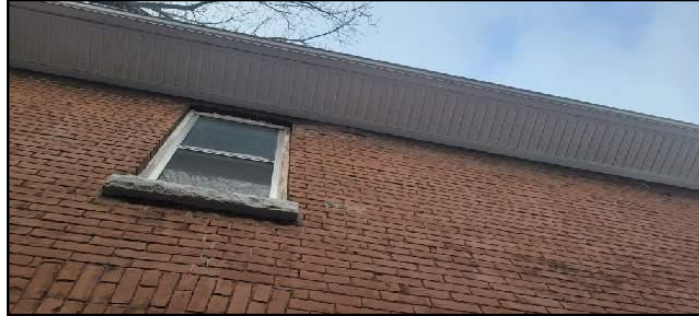
**11. Condition:** • Prior repairs

**32.** *Prior repairs*

**Task:** Monitor

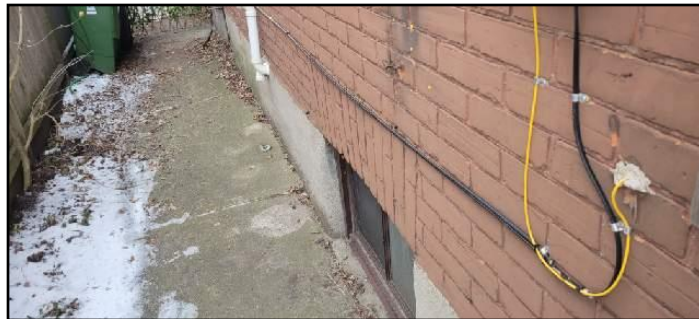
**12. Condition:** • Too close to grade

**33.** *Too close to grade*

**Task:** Improve Monitor

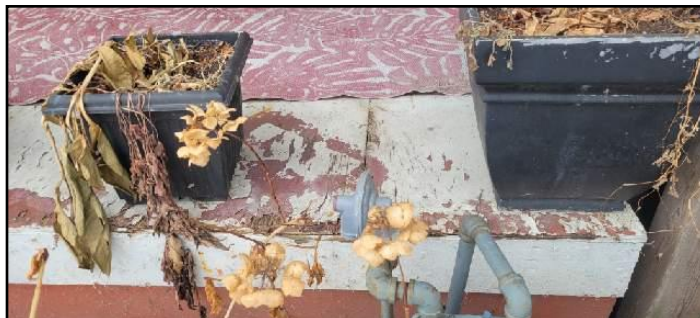
18. Condition: • [Rot or insect damage](#)

Implication(s): Weakened structure | Chance of movement | Material deterioration

35. *Rot or insect damage*

Task: Repair or replace

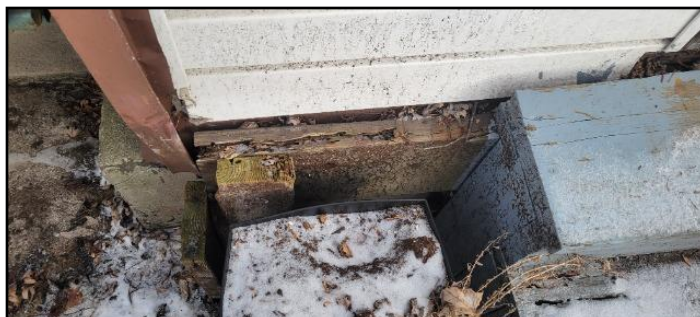
19. Condition: • [Rot or insect damage](#)

Implication(s): Weakened structure | Material deterioration

36. *Rot or insect damage*

Task: Repair or replace

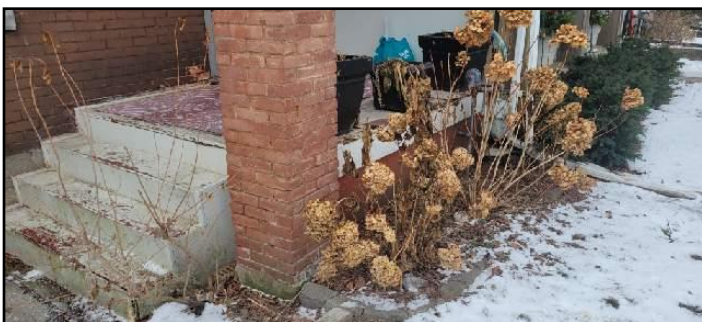
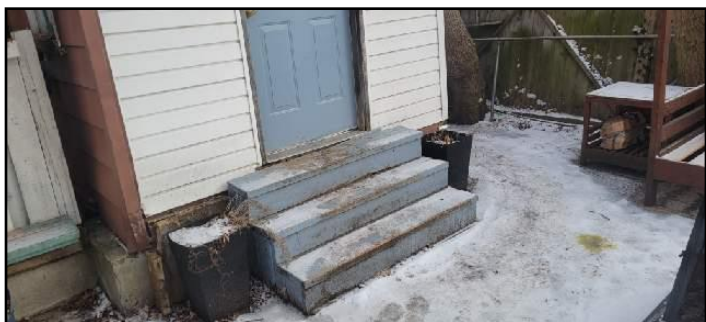
20. Condition: • [Missing](#)

Implication(s): Fall hazard

37. Missing

38. Missing

Task: Provide

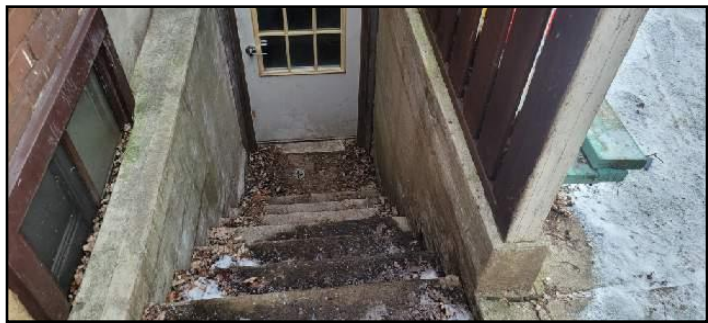
21. Condition: • [Guard and handrail problems](#)

Implication(s): Fall hazard

39. Guard and handrail problems

Task: Correct

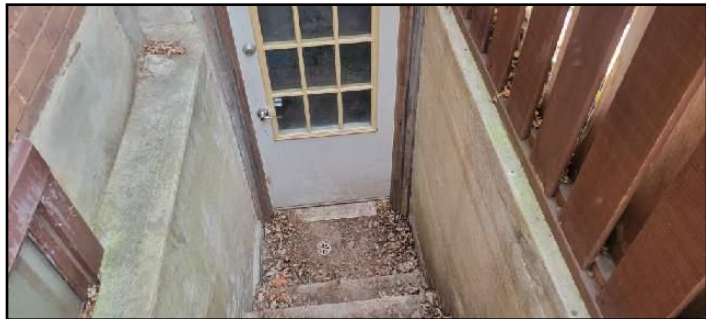
22. Condition: • [Door threshold missing, too low, not watertight](#)

Implication(s): Chance of water damage to structure, finishes and contents

40. Door threshold missing, too low, not...

Task: Improve

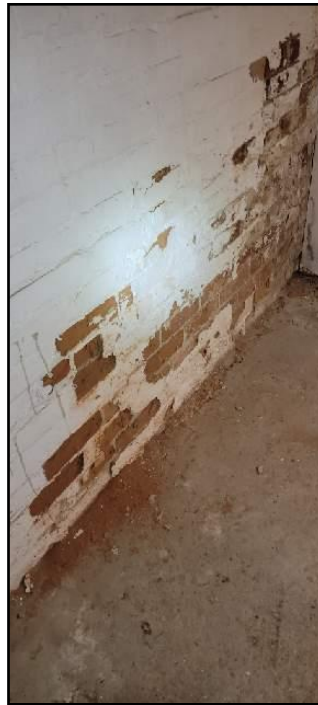
**24. Condition:** • [Spalling concrete or brick](#)

**Implication(s):** Weakened structure | Chance of structural movement

**45.** *Spalling concrete or brick*

**Task:** Repair Improve

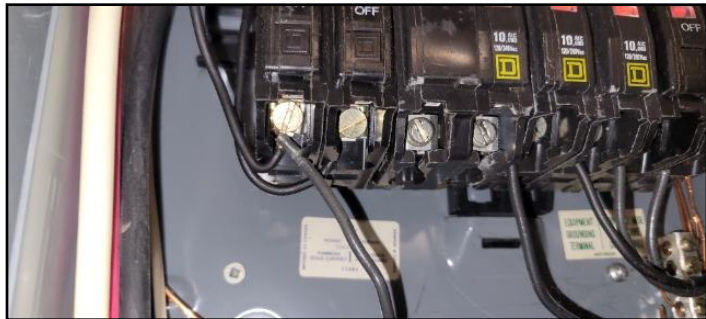
**28. Condition:** • [Double taps](#)

**Implication(s):** Fire hazard

49. Double taps

**Task:** Correct

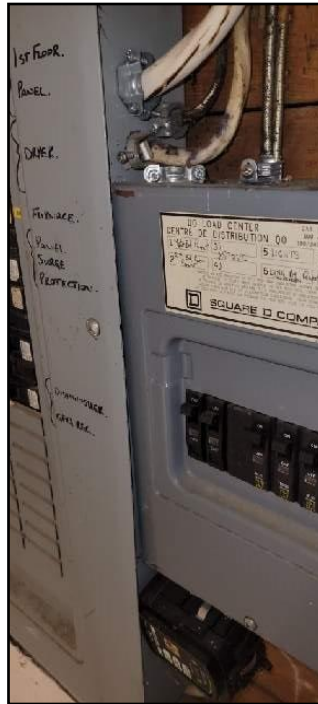
50.

29. Condition: • Too close to main panel

Task: Improve

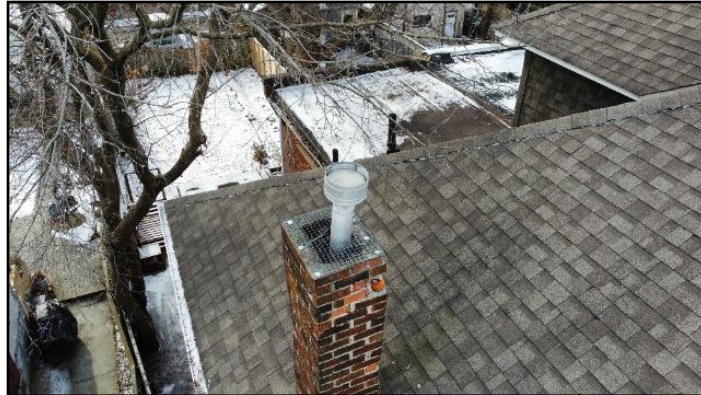
35. Condition: • [Missing](#)

Implication(s): Chance of water damage to structure, finishes and contents | Shortened life expectancy of material

55. *Missing*

Task: Provide

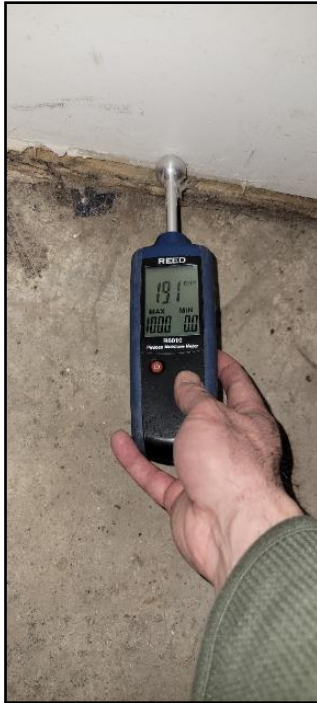
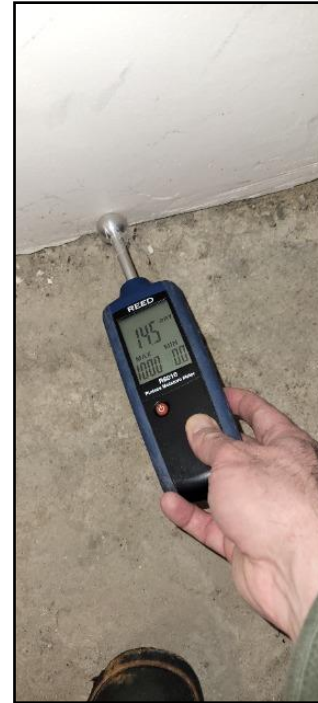
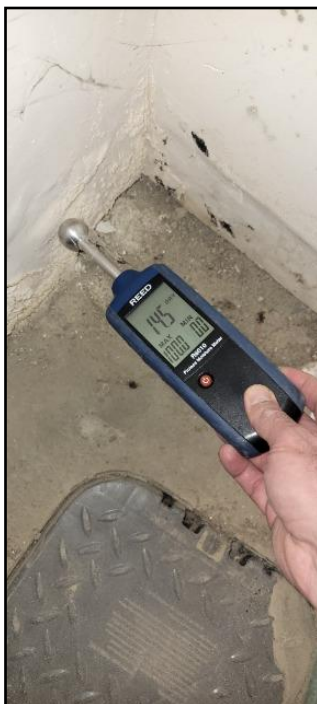
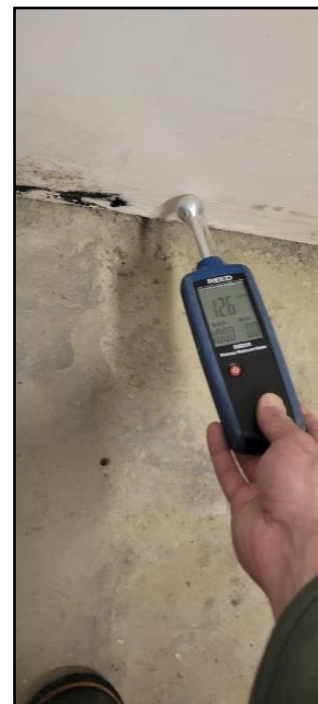
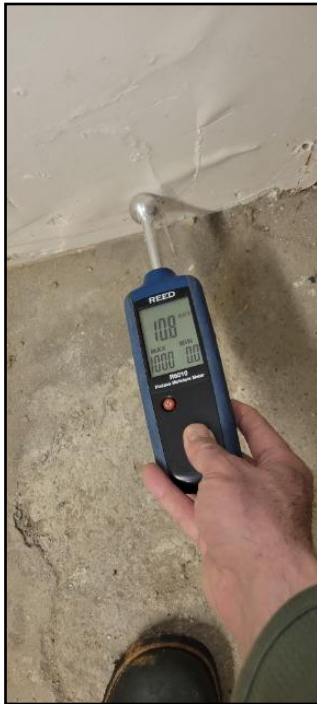
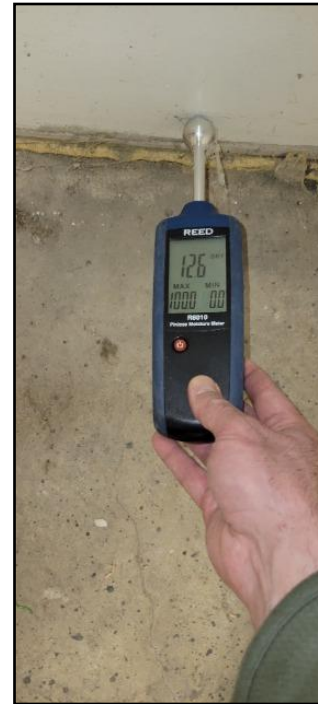
- Moisture meter results  
No moisture detected during inspection.

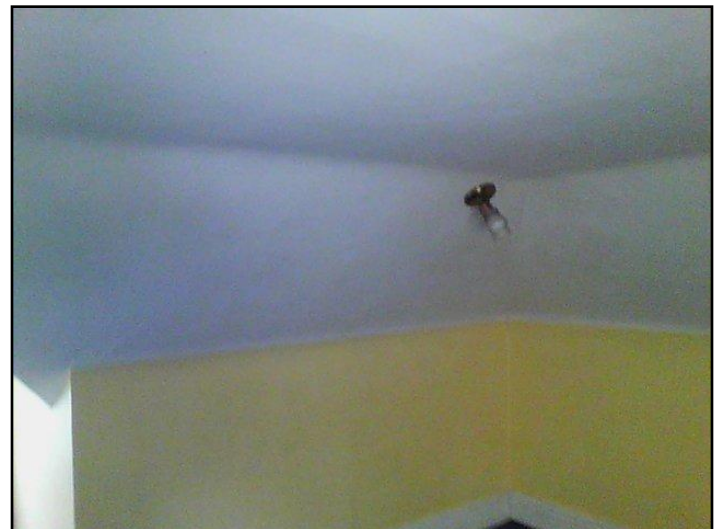
**General:** • Infrared photos.

No signs of moisture on the ceiling during inspection.
