Your Inspection Report

140 Jones Ave
Toronto, ON M4M 3A1

PREPARED BY:
Gordon Mathieu, B.Sc Elec Eng., RHI

RE: Report No. 96443, v.2
140 Jones Ave
Toronto, ON
M4M 3A1

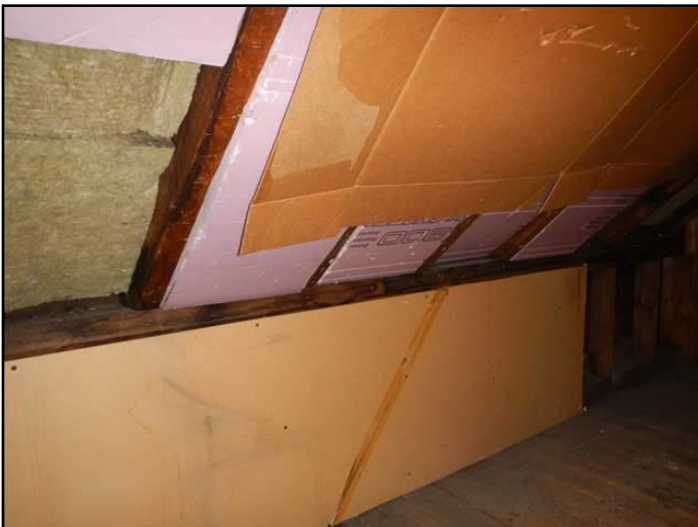
Rafters/roof joists

As seen in the rear knee wall.

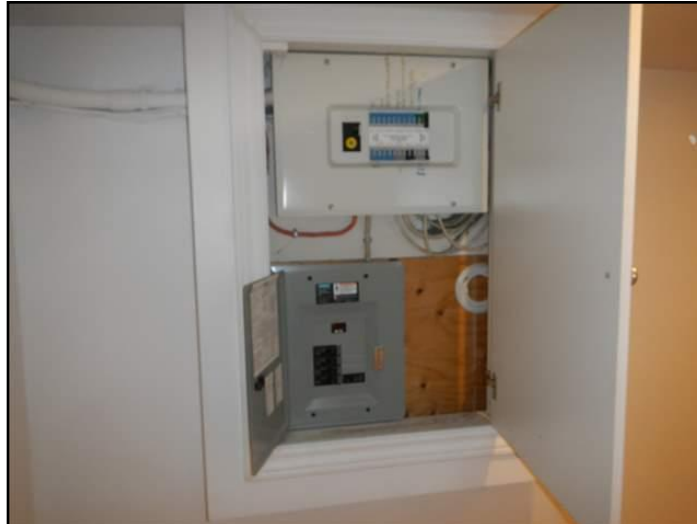
The electrical system has been s

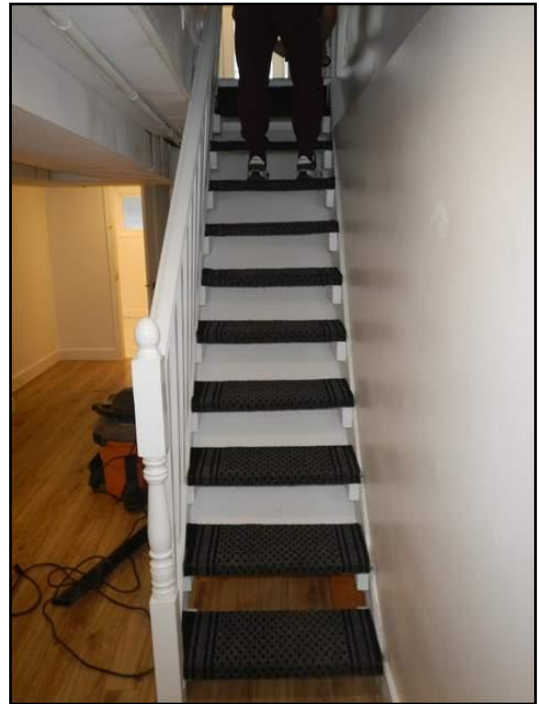
Condition: • Incomplete or not continuous railing

Location: Third Floor
